# Aviation Investigation Final Report

<b>Location:</b>	Wallis, Texas	<b>Accident Number:</b>	CEN23LA319
<b>Date &amp; Time:</b>	July 22, 2023, 16:00 Local	<b>Registration:</b>	N64JG
<b>Aircraft:</b>	ALISPORT SRL SILENT 2 ELECTRO	<b>Aircraft Damage:</b>	Substantial
<b>Defining Event:</b>	Aircraft structural failure	<b>Injuries:</b>	1 None
<b>Flight Conducted Under:</b>	Part 91: General aviation - Personal

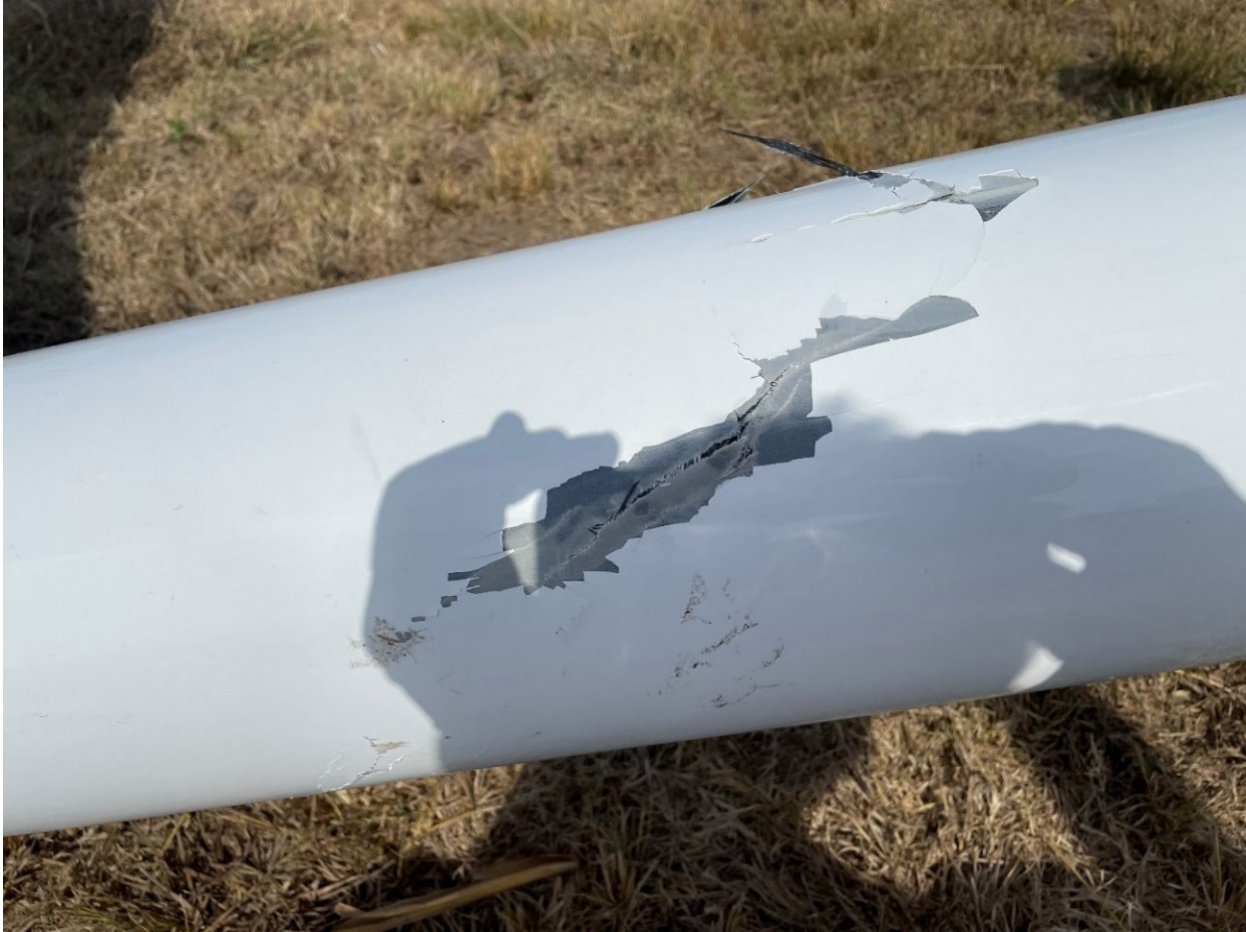
A materials examination of the tail boom structure revealed a damage pattern in the aft portion of the tail boom that contained multiple cracks orientated at  $\pm 45^\circ$  relative to the transverse plane, consistent with torsion loading in both clockwise and counterclockwise rotation directions. Thus, a flutter event likely produced high alternating torsion loads on the fuselage and subsequent damage. The examination found no clear evidence of preexisting damage or weakness that would have led to reduced stiffness of the fuselage structure.

The failure of the tail boom structure due to cyclic torsion overloading as of a result of flutter in the empennage. The reason for the flutter could not be determined.

According to the pilot, after completing a cross-country flight, he set up his final glide at 79 kts to descend from 6,000 ft. About 4,000 ft while in straight-and-level flight, he experienced a severe vibration and shaking of the glider. The pilot stated that the glider did not sustain a bird strike or encounter severe turbulence. The pilot slowed the glider, fearing elevator flutter, and deployed the spoilers to slow down. Upon reaching an airspeed around 60 kts, the vibration stopped. The pilot verified glider control and slowly increased the airspeed, at which time the vibration returned. About 2 miles from his gliderport, the pilot again slowed the glider and proceeded for a straight-in landing. The landing was uneventful, and the glider rolled to a stop. After exiting the glider, the pilot noticed the composite tail boom structure was cracked in multiple locations (see Figure 1).

Figure 1. Tail boom structure cracks

Skin cracks were located about 20 inches forward of the vertical stabilizer and were oriented about 45° relative to the transverse plane on both the left and right side. Additionally, longitudinal cracks were observed on the upper and lower sides of the skin. The 45° cracks intersected the longitudinal crack at the upper side of the skin, and on the lower side the 45° cracks were separated from the longitudinal crack.
