# Aviation Investigation Final Report

<b>Location:</b>	Oshkosh, Wisconsin	<b>Accident Number:</b>	CEN23FA333
<b>Date &amp; Time:</b>	July 29, 2023, 12:27 Local	<b>Registration:</b>	N193AZ (A1); N221EL (A2)
<b>Aircraft:</b>	Rotorway 162F (A1); ELA ECLIPSE 10 (A2)	<b>Aircraft Damage:</b>	Destroyed (A1); Destroyed (A2)
<b>Defining Event:</b>	Midair collision	<b>Injuries:</b>	2 Fatal (A1); 2 Serious (A2)
<b>Flight Conducted Under:</b>	Part 91: General aviation - Personal (A1); Part 91: General aviation - Personal (A2)

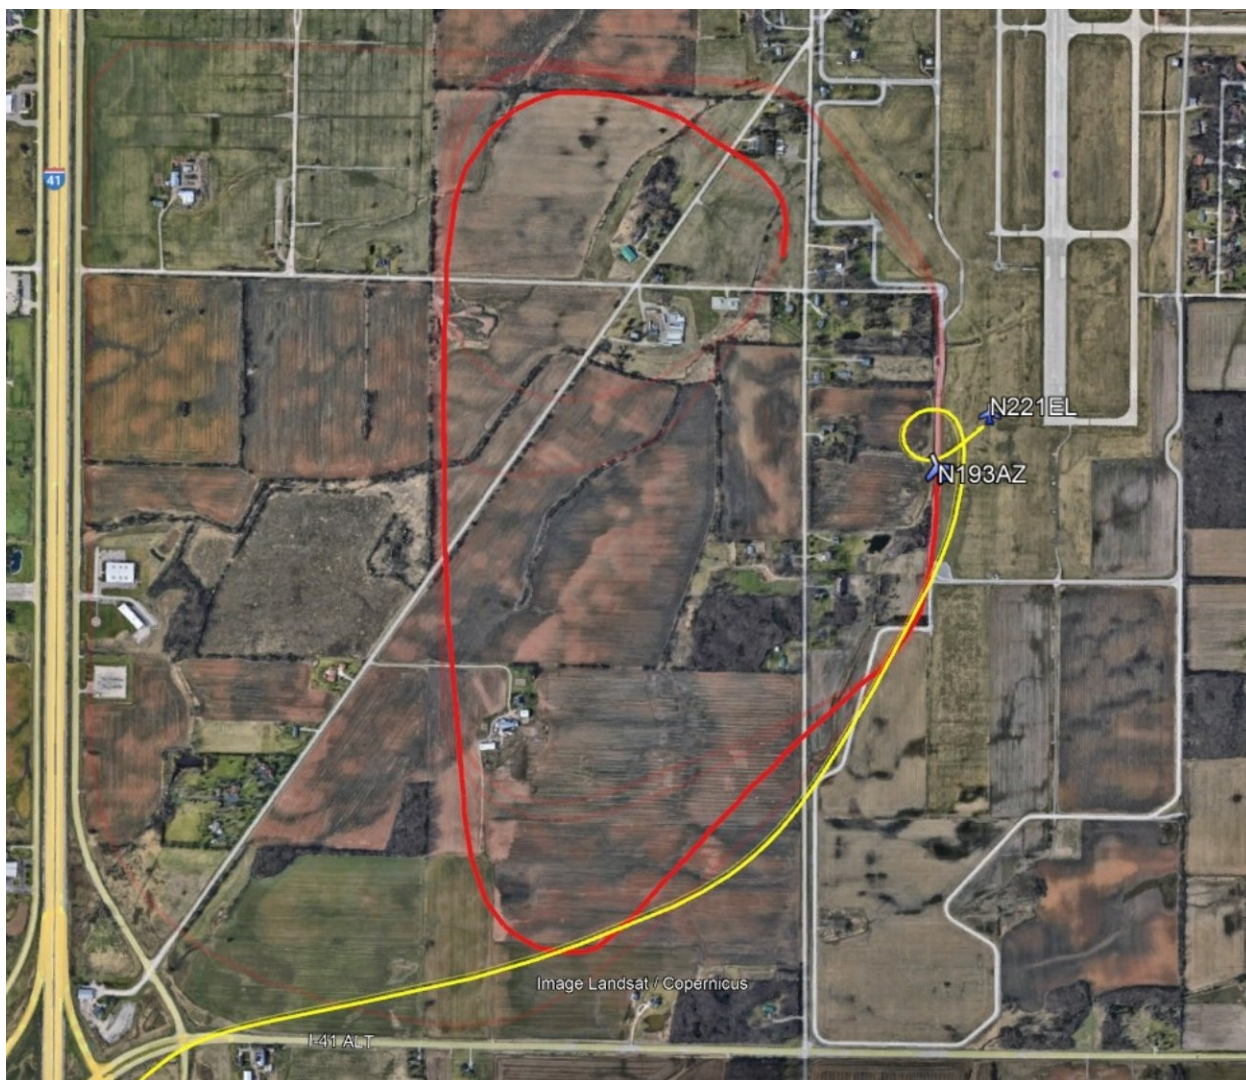
About 35 seconds before the collision, the rear seat passenger in the gyroplane began taking a video with his cellular phone camera. At this time, the gyroplane was on the base leg from the south and began a 360° left turn. The helicopter, which was positioned behind the gyroplane in the traffic pattern, was also approaching the runway on the base leg from the south, following the north/south paved road (see figure 1).

Figure 1. Flight tracks of the helicopter (red) and gyroplane (yellow).

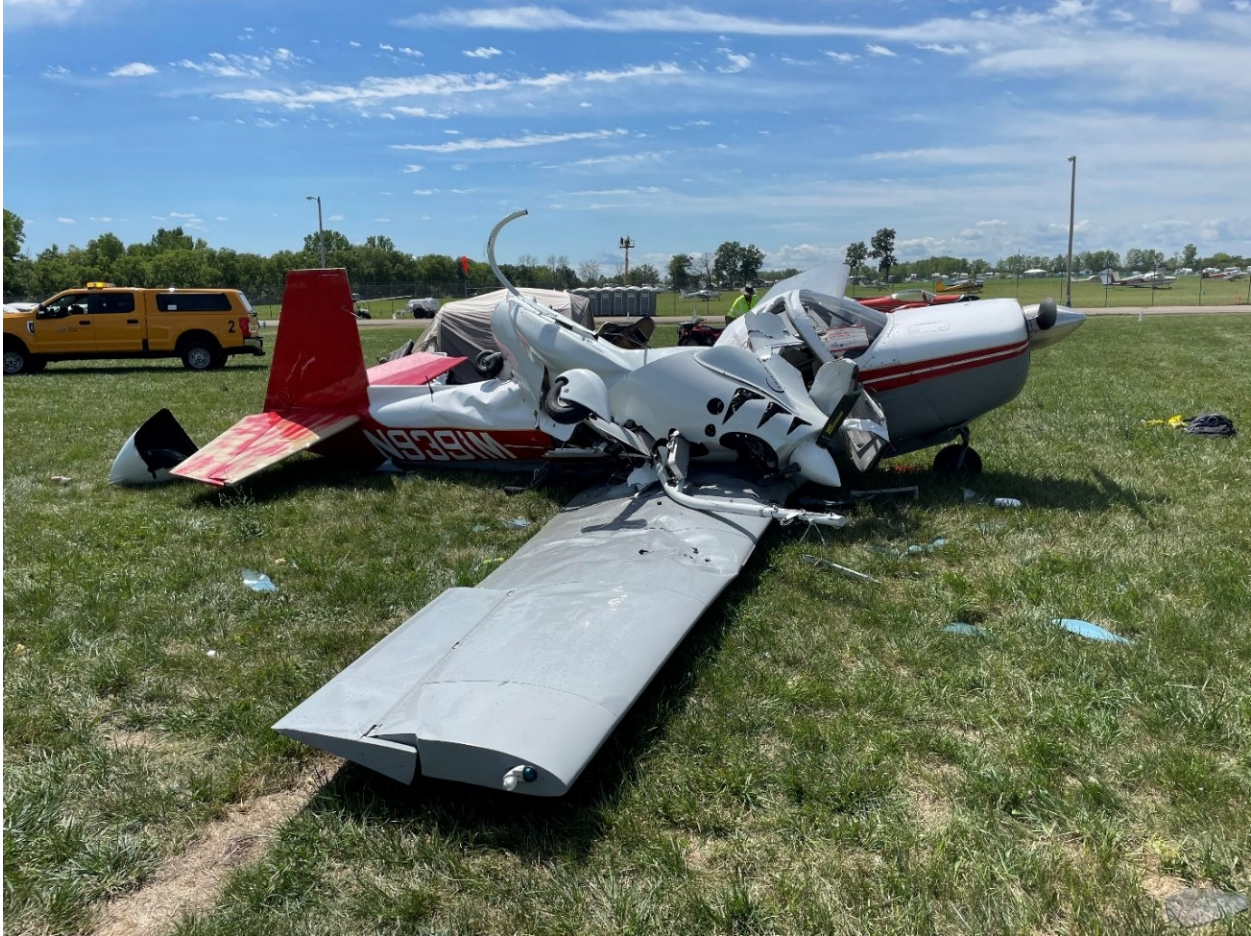
Both aircraft descended in a near-vertical attitude with debris separating from both aircraft. The helicopter impacted terrain, came to rest inverted, and a postaccident fire ensued (see figure 2). The gyroplane impacted an unoccupied airplane that was parked between the north/south paved road and runway 36L (see figure 3). No ground injuries were reported.

Figure 3. Gyroplane and unoccupied parked airplane

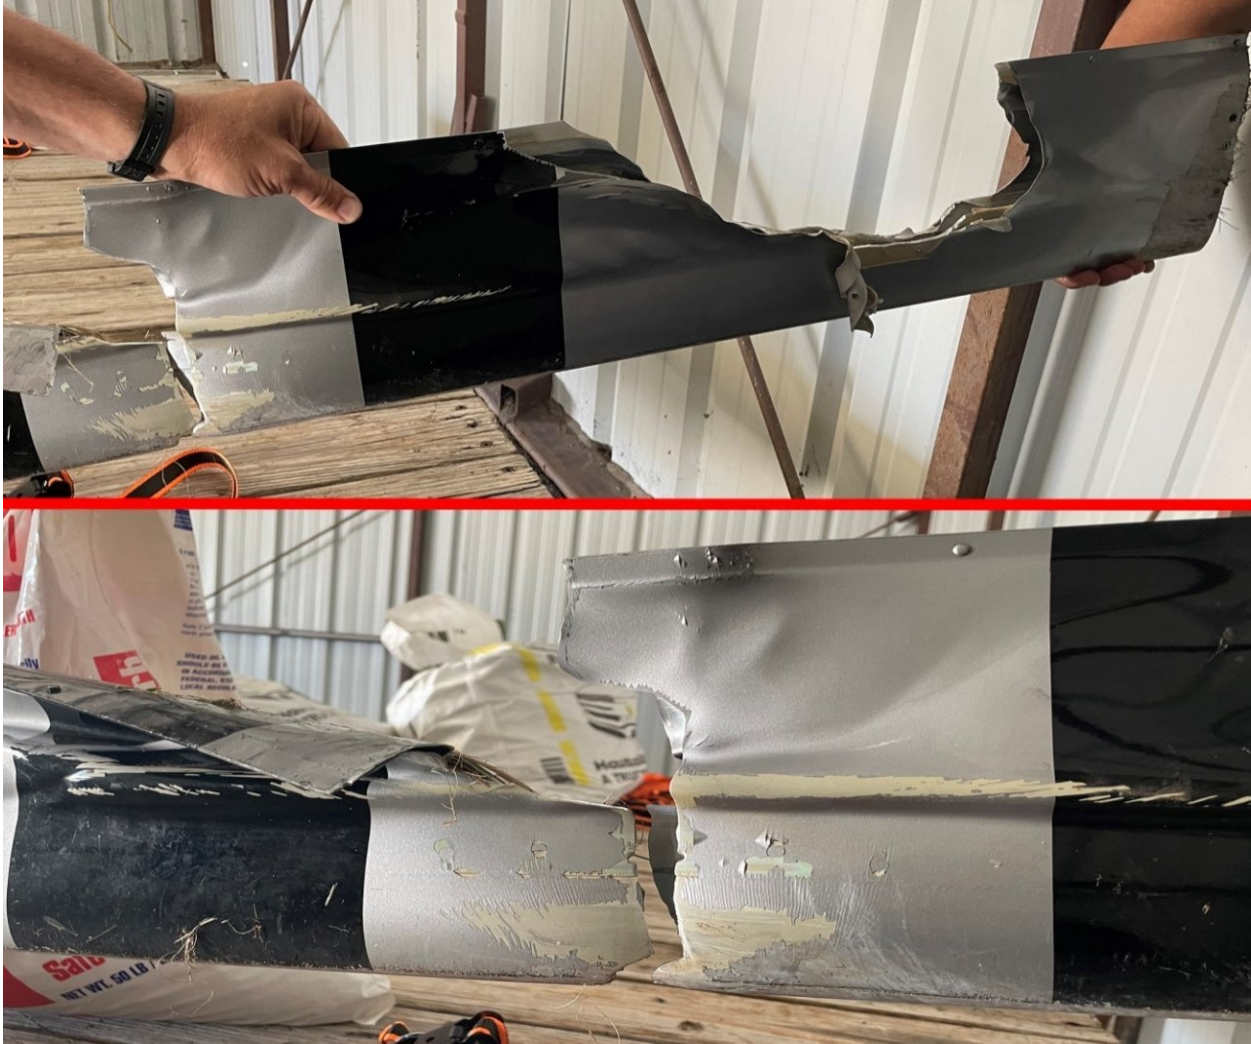
Postaccident examination of the helicopter revealed that both outboard sections of the main rotor blades were separated and came to rest in the debris field (see figure 4). The main rotor blade's structure displayed impact marks and white paint transfers, consistent with the gyroplane's structure and paint color.

Figure 4. Separated outboard sections of the helicopter's main rotor blades.

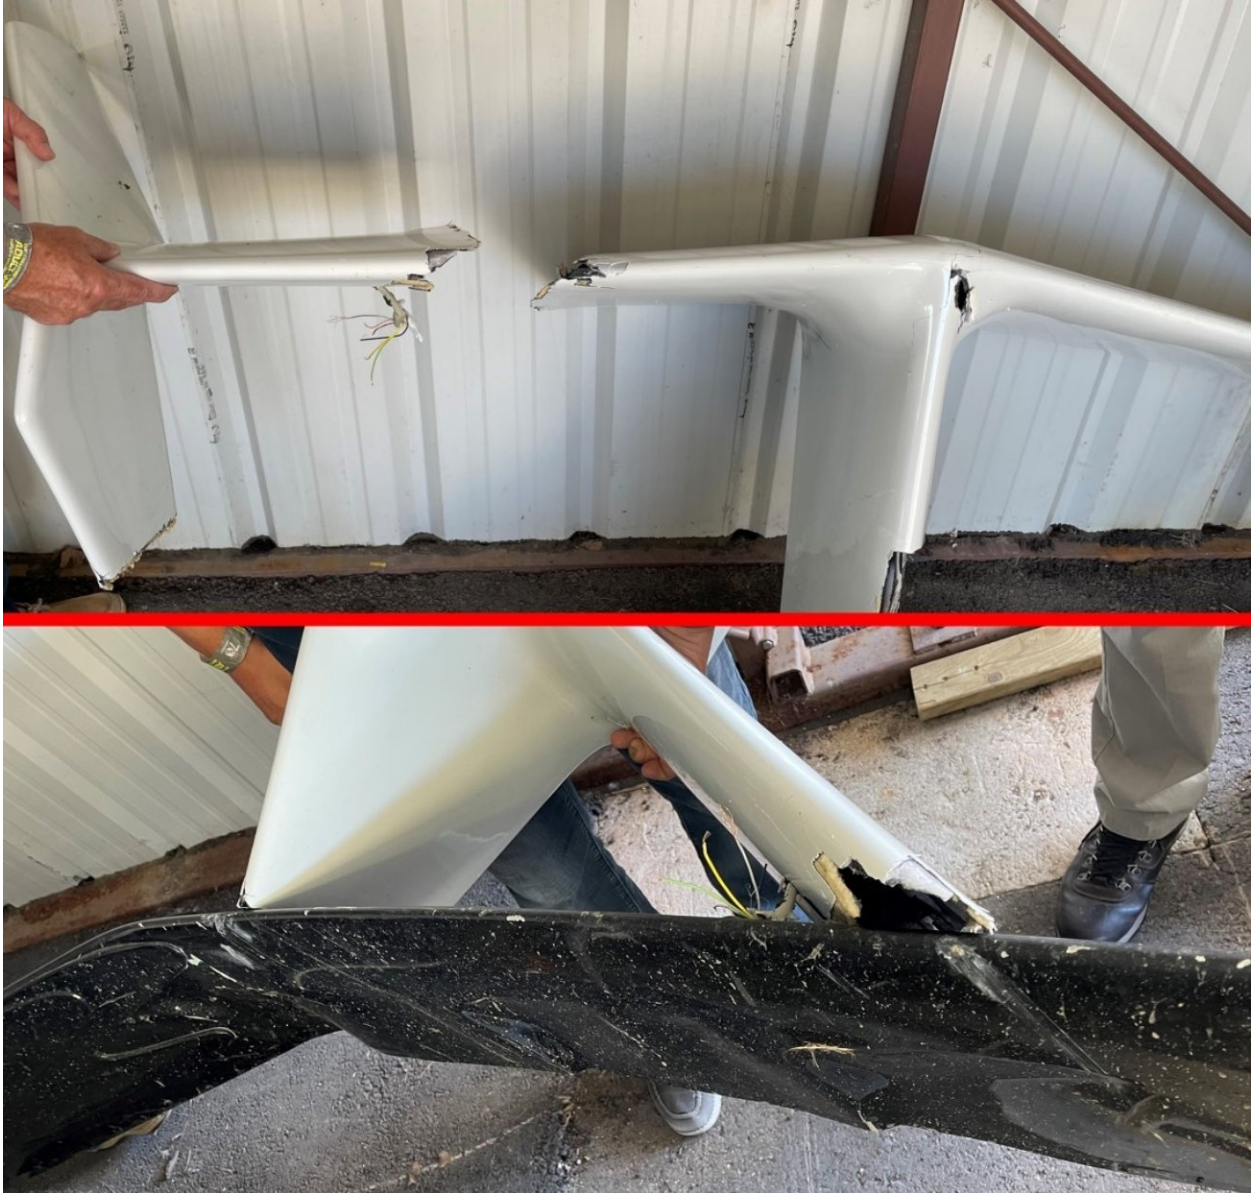
The gyroplane's right horizontal and vertical stabilizers displayed shear cuts and separated structure consistent with helicopter main rotor blade contact (see figure 5). The gyroplane's main rotor mast was separated about mid-length with an impact signature consistent with the helicopter's main rotor blade (see figure 6).

Figure 5. The upper photograph depicts the gyroplane's separated right horizontal stabilizer and lower vertical stabilizer. The lower photograph depicts the separated stabilizer section in comparison with the helicopter main rotor blade contact witness marks and white paint transfer.

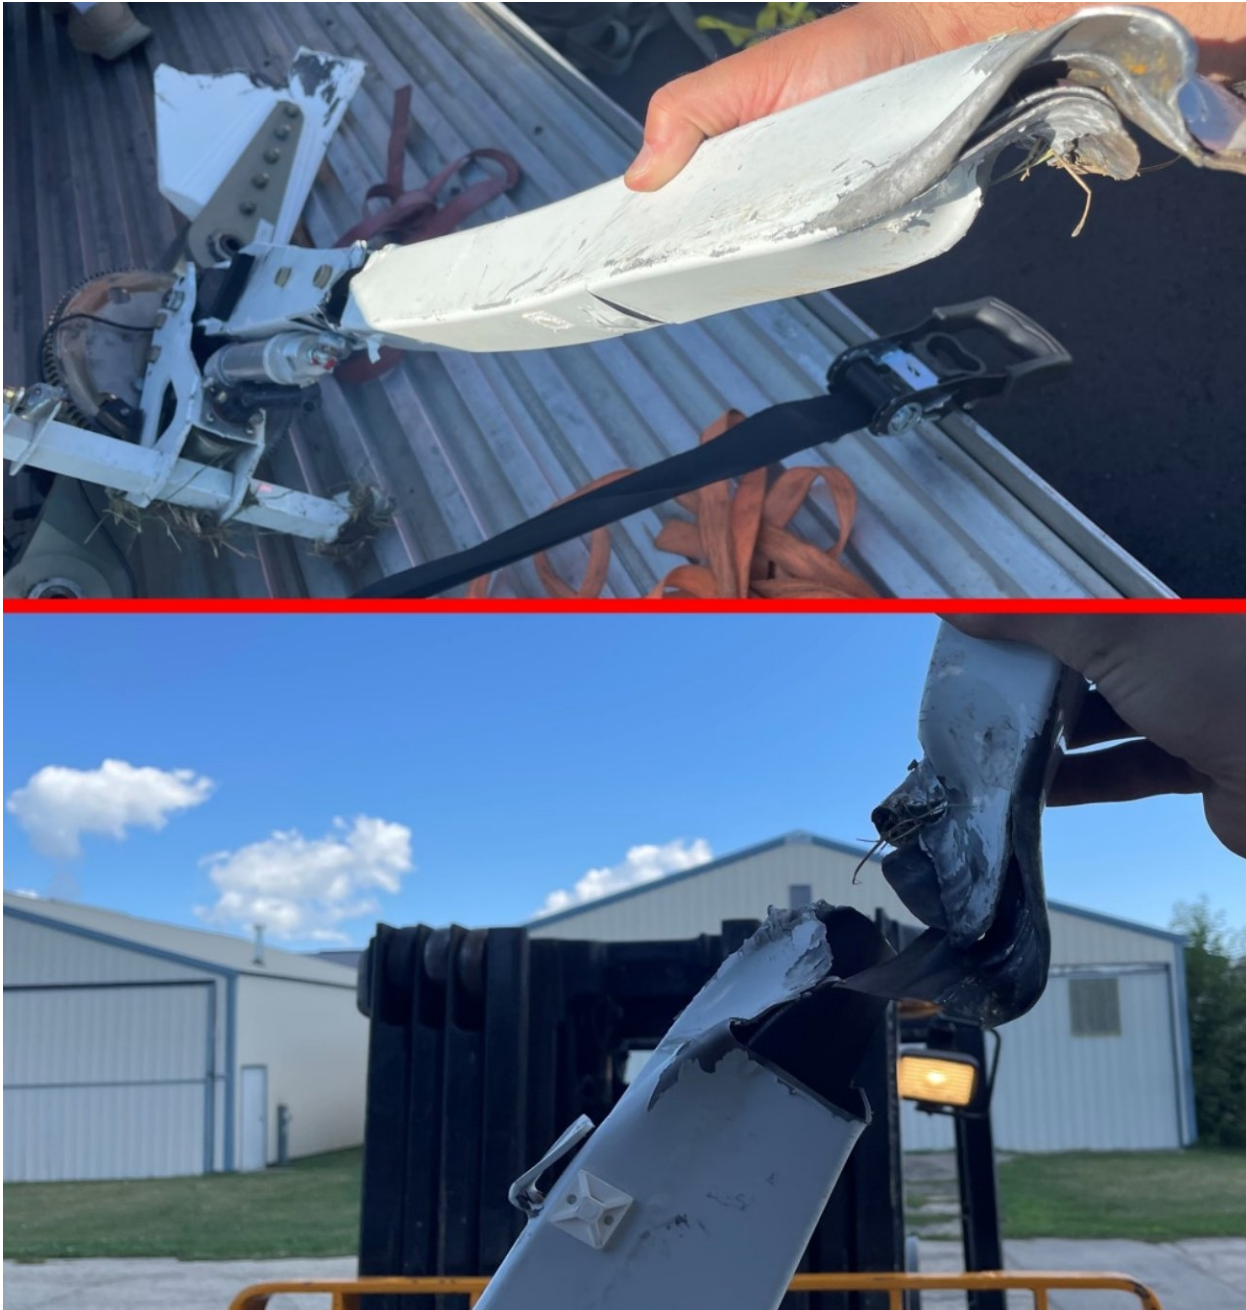
Figure 6. Gyroplane's separated rotor mast section and the helicopter's main rotor blade contact witness mark.
