Aviation Investigation Final Report

Location:	Oshkosh, Wisconsin	Accident Number:	CEN23FA333
Date & Time:	July 29, 2023, 12:27 Local	Registration:	N193AZ (A1); N221EL (A2)
Aircraft:	Rotorway 162F (A1); ELA ECLIPSE 10 (A2)	Aircraft Damage:	Destroyed (A1); Destroyed (A2)
Defining Event:	Midair collision	Injuries:	2 Fatal (A1); 2 Serious (A2)
Flight Conducted Under:	Part 91: General aviation - Personal (A1); Part 91: General aviation - Personal (A2)

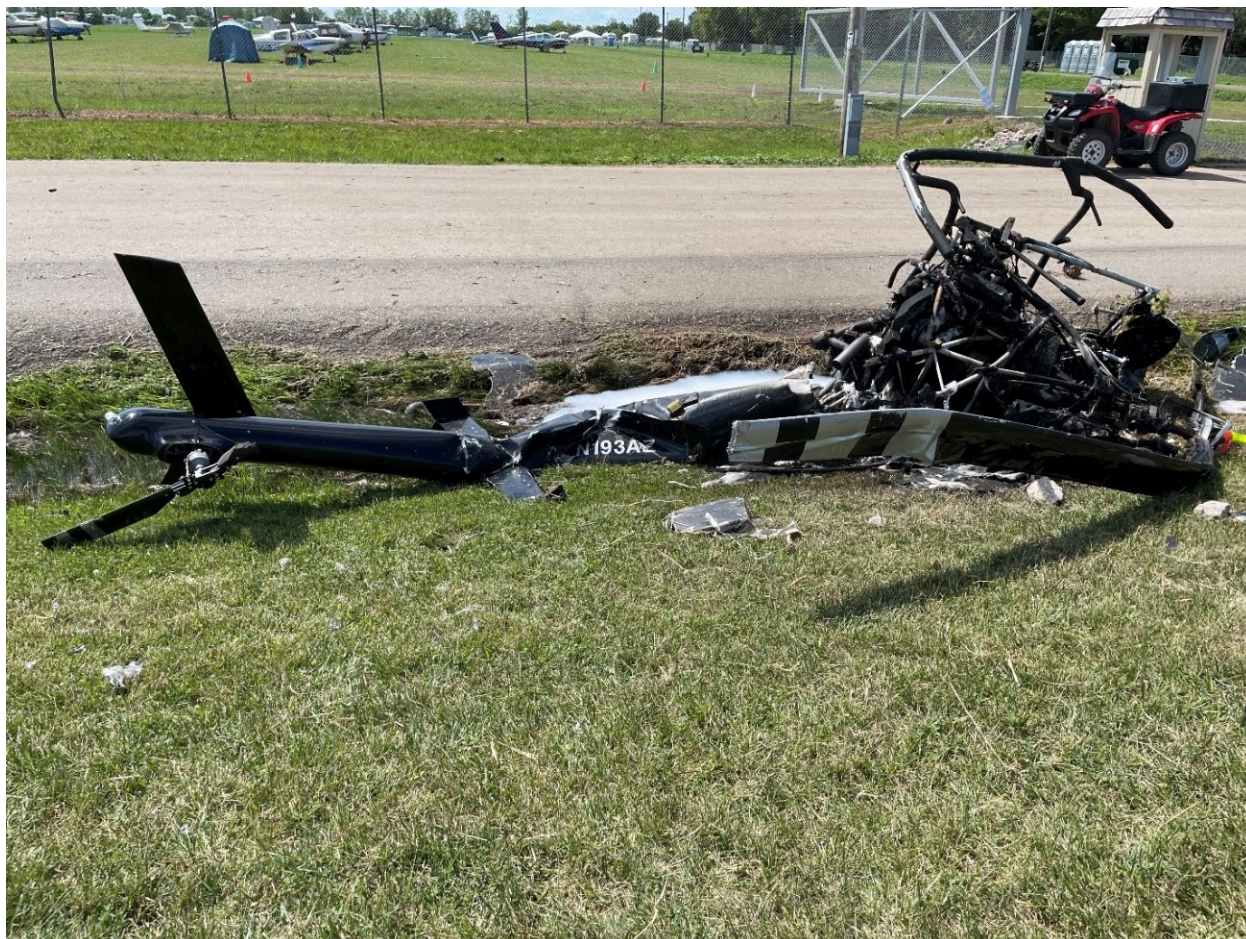
Both aircraft descended in a near-vertical attitude with debris separating from both aircraft. The helicopter impacted terrain, came to rest inverted, and a postaccident fire ensued (see figure 2). The gyroplane impacted an unoccupied airplane that was parked between the north/south paved road and runway 36L (see figure 3). No ground injuries were reported.

Figure 2. Helicopter as it came to rest
