Aviation Investigation Final Report

Location:	Houston, Texas	Accident Number:	DCA23LA384
Date & Time:	July 29, 2023, 10:34 Local	Registration:	N641UA
Aircraft:	Boeing 767-322	Aircraft Damage:	Substantial
Defining Event:	Hard landing	Injuries:	202 None
Flight Conducted Under:	Part 121: Air carrier - Scheduled

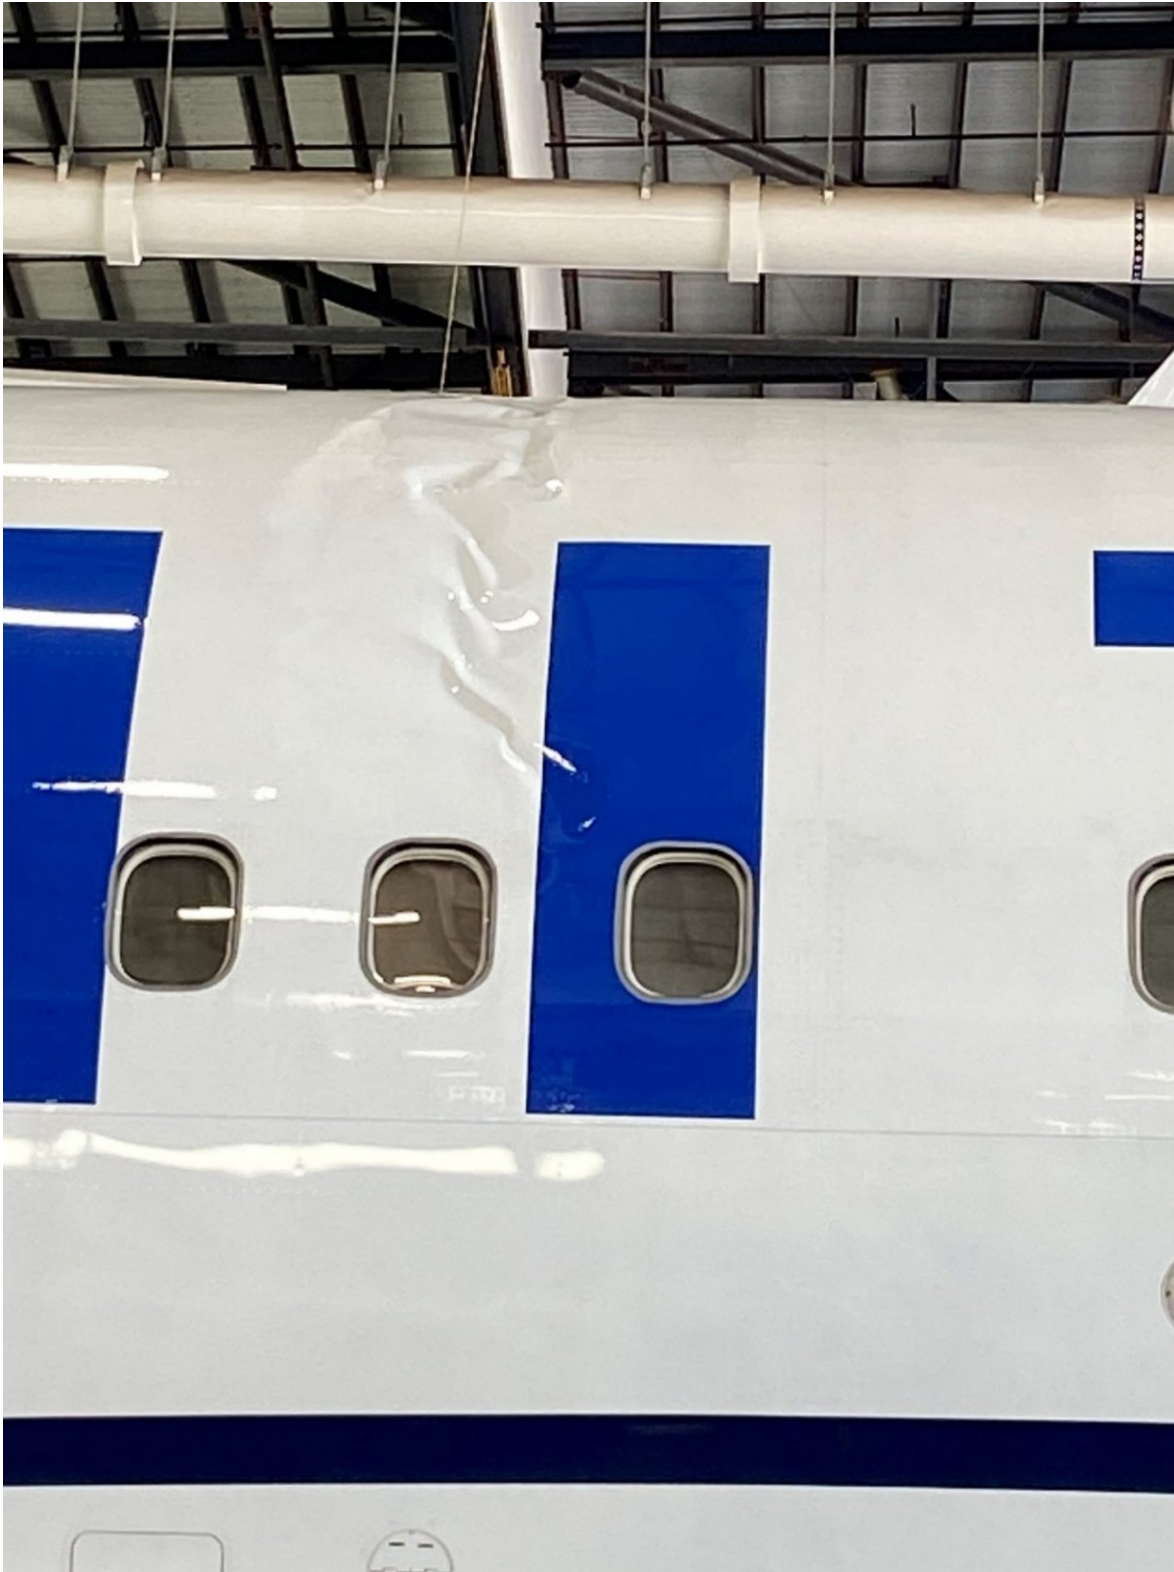
After a stabilized approach, the main landing gear of United Airlines flight 702 touched down and the nosewheel contacted the runway harder than expected. The airplane then bounced, and the first officer (the pilot flying) reacted by pulling the control yoke aft to keep the nosewheel from impacting the runway a second time. The first officer applied the thrust reversers, the speed brakes deployed, and the nosewheel bounced a second time. Subsequently, the nosewheel impacted the runway a third time and, the airplane began to decelerate normally. The abnormal nosewheel impacts with the runway resulted in substantial damage to the fuselage.

A postaccident examination of the airplane revealed damage to the crown of the upper fuselage. The fuselage skin was buckled and fractured, as shown in figure 1, with damage to the underlying stringers and frames.

Figure 1. Close-up view of the airplane damage on the left side of the fuselage (Source: United Airlines).

These accidents occurred when the pilots applied large nose-down control column deflections after main landing gear touchdown, which resulted in large nose-down pitch rates and high vertical velocities at the nose gear. It was this combination of vertical velocity and pitch rate that resulted in compression loads that exceeded the design loads of the forward fuselage crown structure.

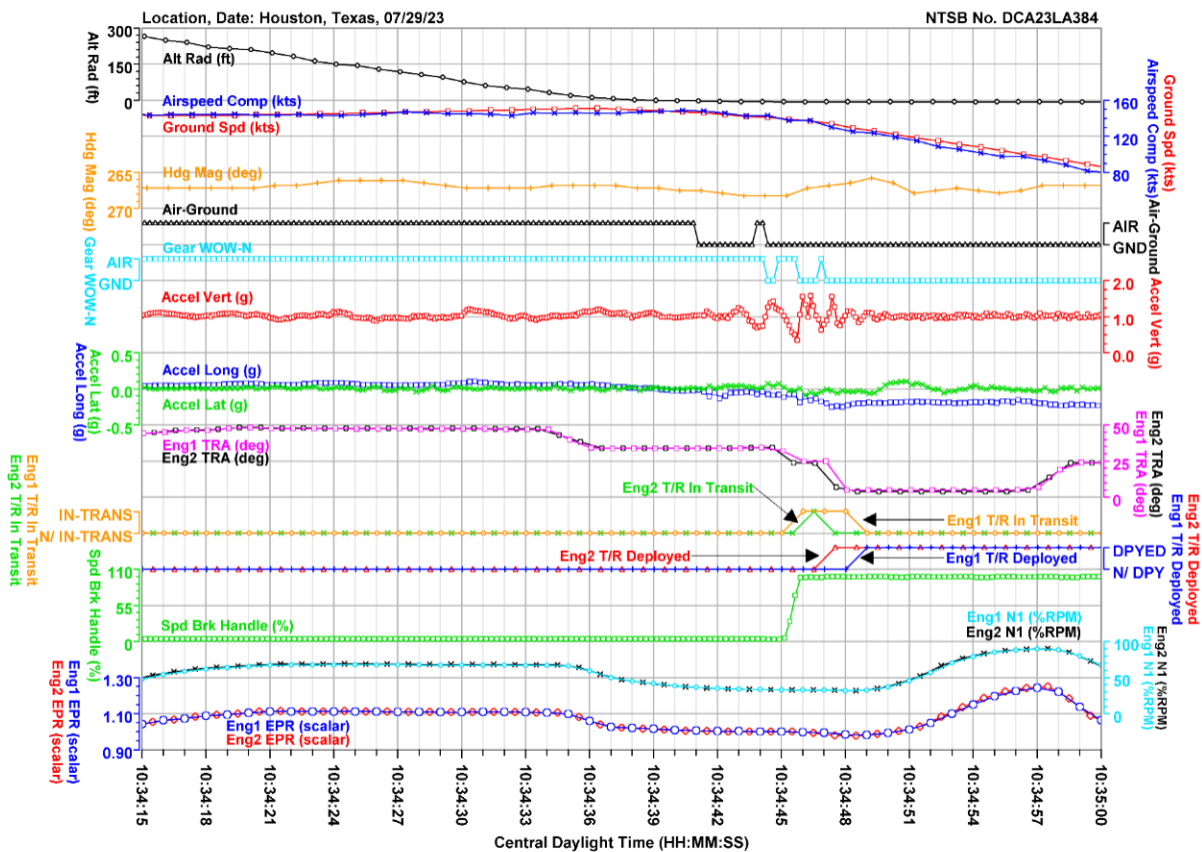
Flight data recorder (FDR) data indicated that control column inputs ranged from about 5° nose high to 5° nose low during the landing. Data also indicated that the speedbrakes deployed simultaneously as the thrust reversers transitioned from not deployed to deployed, and the nosewheel bounced a second time. Subsequently, the nosewheel contacted the runway a third time and the airplane began to decelerate.

A review of FDR data revealed that the airplane touched down on both main wheels, with a control column position of about 0.35° and the speedbrake handle in the down (unarmed) position. After the initial touchdown, the maximum recorded control column positions during the landing sequence were 5.71° to -4.75° , as shown in figure 2. FDR data also showed that the airplane rolled to the left and that the right main landing gear lifted off the runway's surface. Subsequently, the nosewheel impacted the runway with a force equivalent of about 1.4 gravitational force equivalent (G). The thrust reversers were in transit as the speedbrakes deployed, and the nosewheel impacted the runway a second time with a force of about 1.6 G and bounced. Subsequently, the nosewheel impacted the runway a third time with a force of about 1.6 G.

Figure 2. FDR data pertinent to the circumstances of this accident.
