# Aviation Investigation Preliminary Report

<b>Location:</b>	Houston, TX	<b>Accident Number:</b>	DCA23LA384
<b>Date &amp; Time:</b>	July 29, 2023, 10:34 Local	<b>Registration:</b>	N641UA
<b>Aircraft:</b>	Boeing 767-322	<b>Injuries:</b>	202 None
<b>Flight Conducted Under:</b>	Part 121: Air carrier - Scheduled

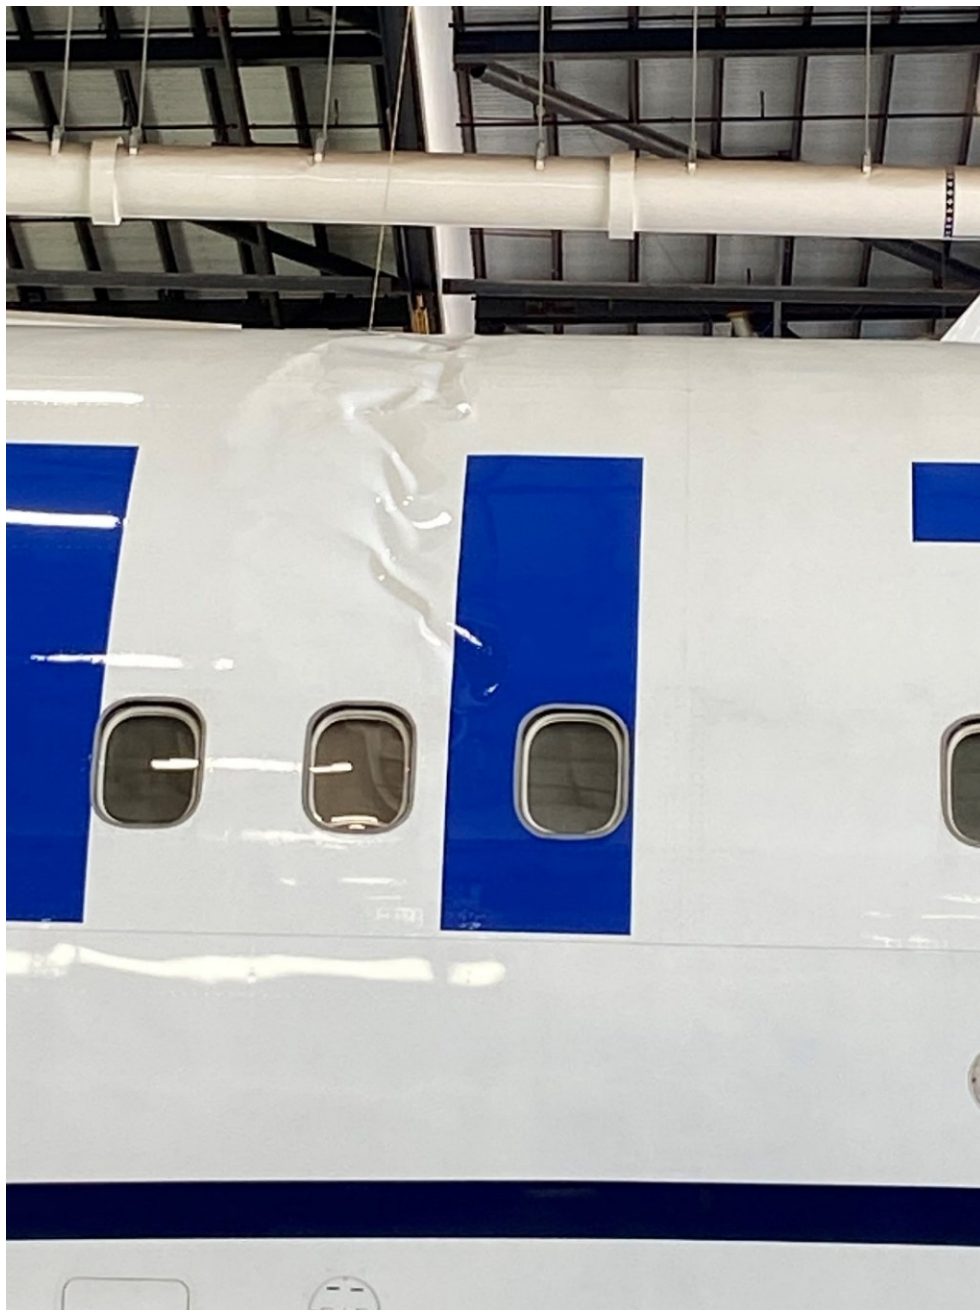
A preliminary review of the flight data recorder (FDR) revealed that after the initial touchdown on both main wheels, the airplane rolled to the left and right main gear lifted off the runway's surface. Subsequently, the nose wheel touched down with a gravitational force equivalent (g) of about 1.4 g and bounced. The speed brakes deployed, and the nose wheel impacted the runway a second time with a force of about 1.6 g followed by another bounce. The right thrust

reverser (TR) deployed, and the nose wheel impacted the runway again with a force of about 1.6 g followed by the deployment of the left TR.

A postaccident examination of the airplane revealed substantial damage to the crown of the upper fuselage, see figure 1.

**Figure 1.** Close up view of damage to the airplane (source: United Airlines).
