Aviation Investigation Final Report

Location:	Houston, Texas	Accident Number:	DCA23LA384
Date & Time:	July 29, 2023, 10:34 Local	Registration:	N641UA
Aircraft:	Boeing 767-322	Aircraft Damage:	Substantial
Defining Event:	Hard landing	Injuries:	202 None
Flight Conducted Under:	Part 121: Air carrier - Scheduled

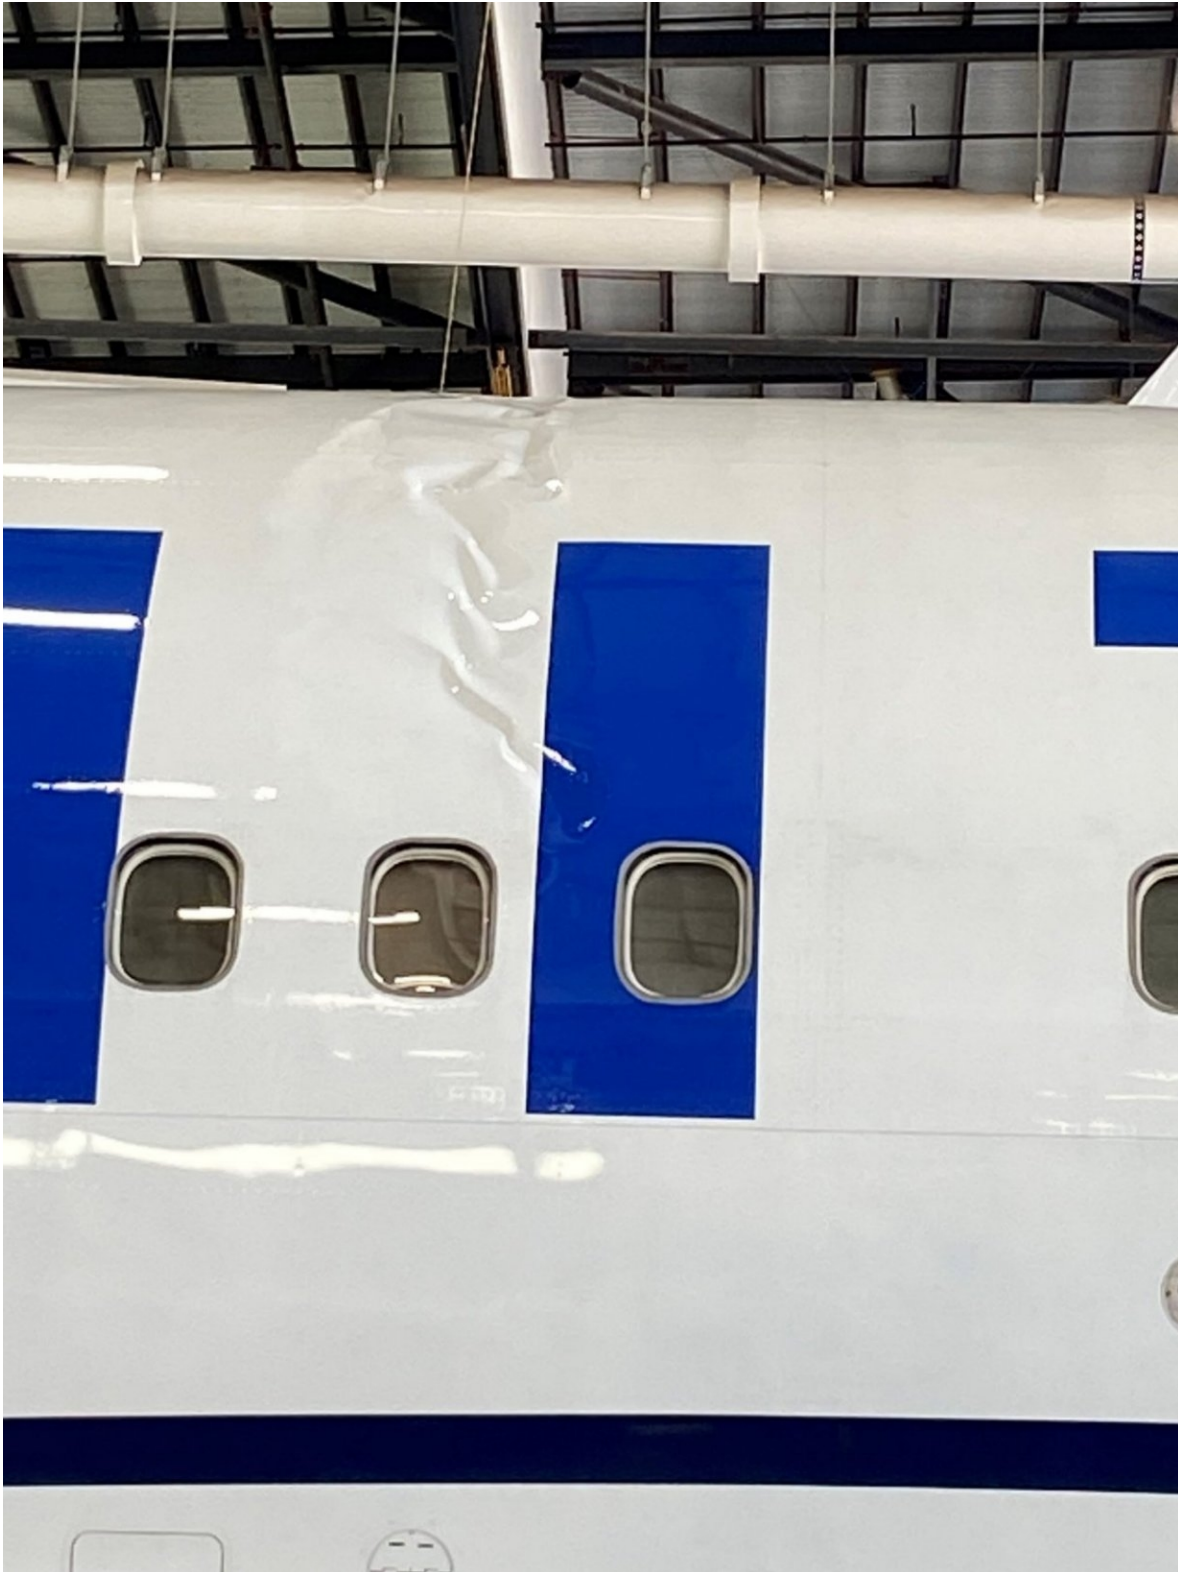
A postaccident examination of the airplane revealed damage to the crown of the upper fuselage. The fuselage skin was buckled and fractured, as shown in figure 1, with damage to the underlying stringers and frames.

Figure 1. Close-up view of the airplane damage on the left side of the fuselage (Source: United Airlines).

These accidents occurred when the pilots applied large nose-down control column deflections after main landing gear touchdown, which resulted in large nose-down pitch rates and high vertical velocities at the nose gear. It was this combination of vertical velocity and pitch rate that resulted in compression loads that exceeded the design loads of the forward fuselage crown structure.

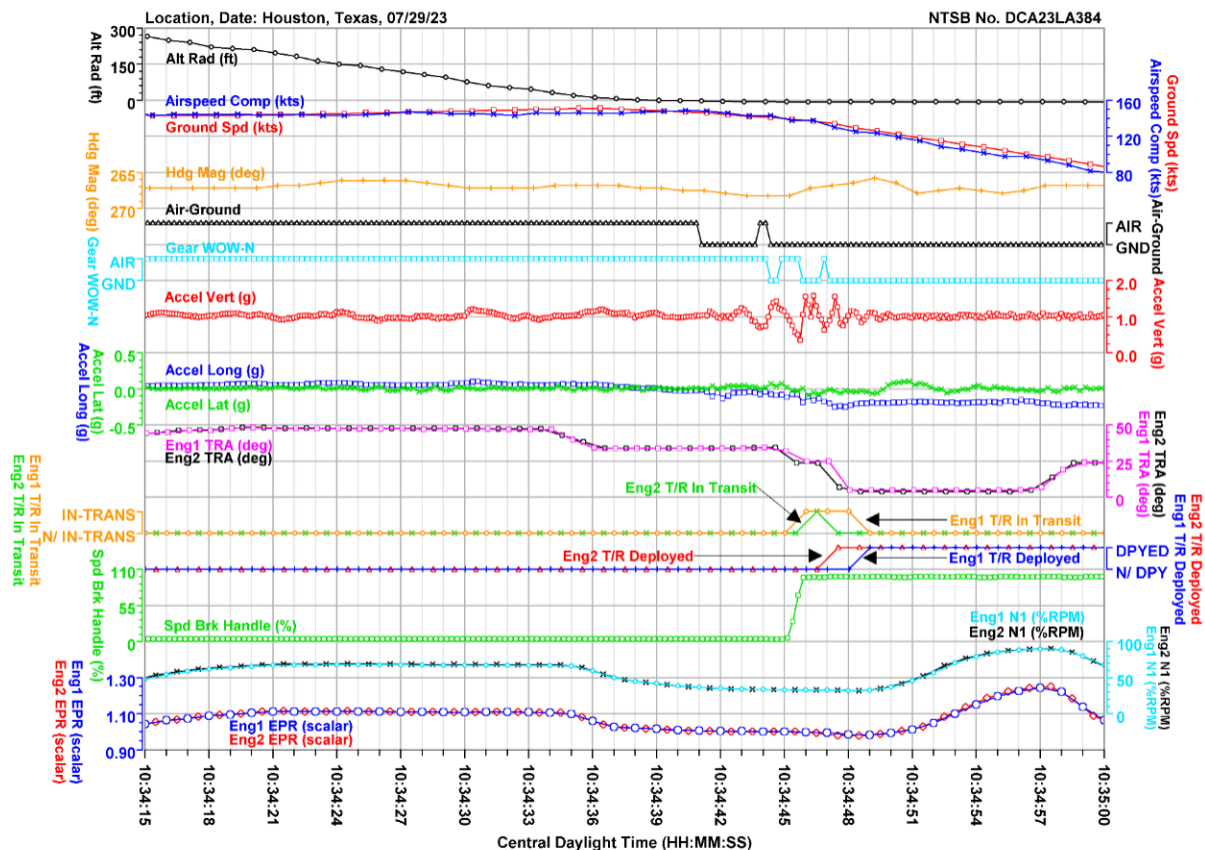
A review of FDR data revealed that the airplane touched down on both main wheels, with a control column position of about 0.35° and the speedbrake handle in the down (unarmed) position. After the initial touchdown, the maximum recorded control column positions during the landing sequence were 5.71° to -4.75° , as shown in figure 2. FDR data also showed that the airplane rolled to the left and that the right main landing gear lifted off the runway's surface. Subsequently, the nosewheel impacted the runway with a force equivalent of about 1.4 gravitational force equivalent (G). The thrust reversers were in transit as the speedbrakes deployed, and the nosewheel impacted the runway a second time with a force of about 1.6 G and bounced. Subsequently, the nosewheel impacted the runway a third time with a force of about 1.6 G.

Figure 2. FDR data pertinent to the circumstances of this accident.
