Aviation Investigation Final Report

| Location: | North Charleston, South Carolina | Accident Number: | ERA23LA319 |
| Date & Time: | August 1, 2023, 15:30 Local | Registration: | N31PB |
| Aircraft: | BELL HELICOPTER TEXTRON CANADA 407 | Aircraft Damage: | Substantial |

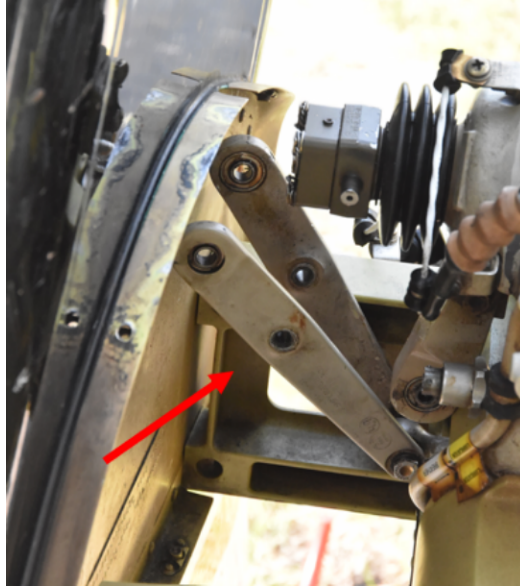
A postaccident examination of the helicopter found one of the two bolts that secured the tail rotor pitch change lever assembly was missing. The lever assembly was disconnected from the trunnion, resulting in the loss of tail rotor control. The other bolt that connected the levers to the rod assembly was in place, but loose; the cotter pin for its attachment nut was missing.

Inspectors with the Federal Aviation Administration (FAA) responded to the accident site and examined the wreckage. They confirmed substantial damage to the fuselage, main rotor system, and tail rotor system. They found 1 of the 2 bolts that secured the tail rotor pitch change lever assembly was missing (Photo 1). The lever assembly was disconnected from the trunnion. The other bolt that connected the levers to the rod assembly was in place, but loose; the cotter pin for its attachment nut was missing (Photo 2).

Photo 1: Tail rotor Pitch Change Lever Assembly. Red arrow points to area of missing bolt.

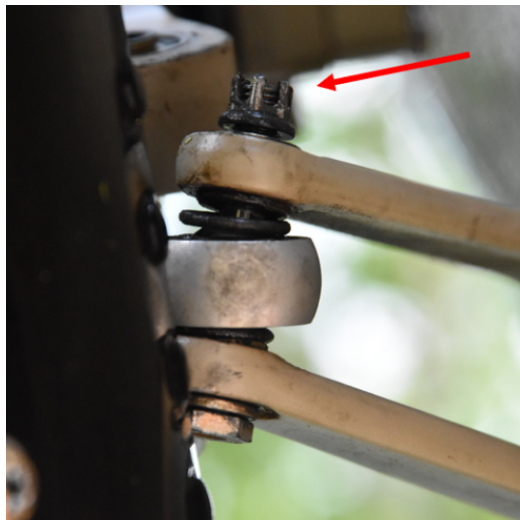
Photo 2: Pitch Change Lever Assembly. Red arrow points to loose nut on bolt; cotter pin was missing.

A review of the maintenance records by FAA inspectors revealed that a 300 hour/3 month inspection was performed on the helicopter on June 28, 2023. The helicopter had been flown about 15.4 hours since this inspection. According to Bell Helicopter technical support personnel, the inspection/lubrication procedure that was accomplished on June 28 would not require removal of the lever assembly bolts; however, the nuts and bolts should have been clearly visible during the inspection of the area. The mechanic who performed the inspection stated that he must have overlooked them.
