Aviation Investigation Preliminary Report

Location:	Cabazon, CA	Accident Number:	WPR23FA302
Date & Time:	August 6, 2023, 18:44 Local	Registration:	N555AS (A1); N4037S (A2)
Aircraft:	Bell 407 (A1); Sikorsky S-64E (A2)	Injuries:	3 Fatal (A1); 2 None (A2)
Flight Conducted Under:	Public aircraft (A1); Public aircraft (A2)

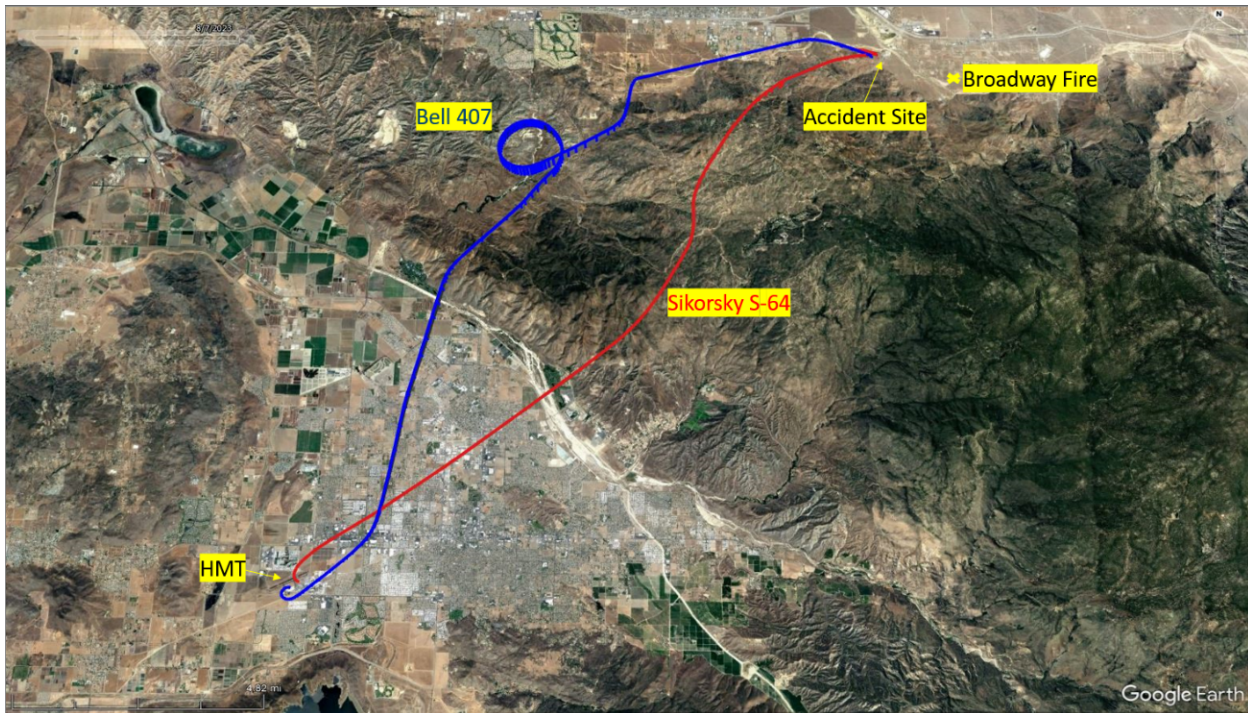
Figure 1. Overlay of Bell and Sikorsky ADS-B Flight Path on Google Earth terrain map

Preliminary Automatic Dependent Surveillance – Broadcast (ADS-B) data (figure 1), revealed that the Bell departed Hemet-Ryan Airport (HMT) in Hemet, California, about 1834 and traveled about 9 nm to the north-northeast. The Bell then completed a left 360° turn and maneuvered northeast towards Cabazon. The Sikorsky departed HMT about 3 minutes after the Bell and travelled northeast through mountainous terrain and continued northeast following descending terrain towards Cabazon. ADS-B data showed both helicopters on a converging flight path, until the time of collision, located about 2 nm west of the Broadway Fire, at an altitude between 2,375 to 2,400 ft mean sea level (msl).

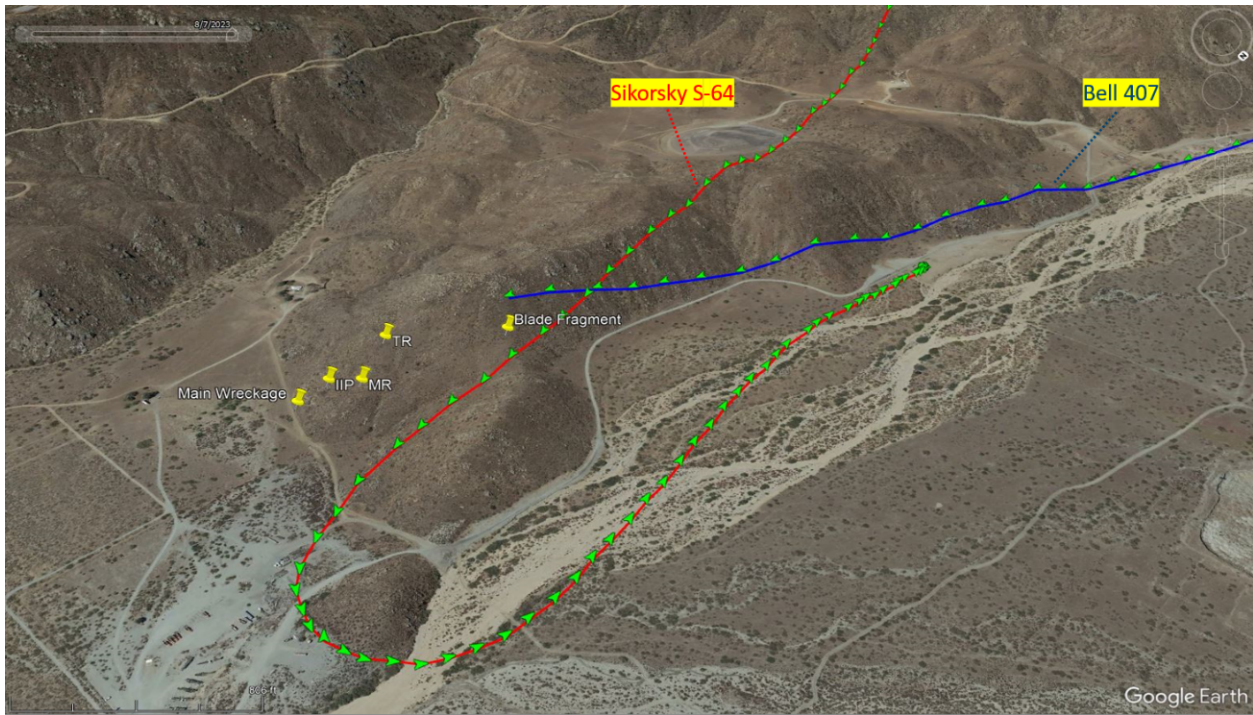
Figure 2. Zoomed in overlay of Bell and Sikorsky ADS-B flight path on Google Earth terrain map near the accident site.

The wreckage of the Bell came to rest on a steep and rocky hillside about 1050 ft off the last recorded ADS-B data point (figure 2). A post-crash fire ensued and consumed the fuselage. The debris path was about 950 ft by 550 ft, in which all major components of the helicopter were located. The beginning of the debris path was identified by a piece of delaminated main rotor blade, which was about 560 feet east of the approximate collision area. Subsequent fragments of the main rotor blade were identified within a 100 ft span to the east. A displaced skid and crosstube came to rest about 195 east of the main wreckage and was the eastern most piece of debris.

About 830 feet southeast of the first delaminated blade component, a ground scar was determined to be the fuselage's initial impact point (IIP). It was followed by a 20-foot-long ground scar, oriented on a 098° heading, that extended to the engine, which was displaced and located adjacent to rock boulders. The main wreckage was found about 45 ft east of the engine. The main rotor blades, mast, and transmission came to rest around 285 ft northwest of the main wreckage, upslope from the IIP. The tail cone and tail rotor blade assembly came to rest about 470 ft west of the main wreckage.
