Aviation Investigation Preliminary Report

Location:	Cabazon, CA	Accident Number:	WPR23FA302
Date & Time:	August 6, 2023, 18:44 Local	Registration:	N555AS (A1); N4037S (A2)
Aircraft:	Bell 407 (A1); Sikorsky S-64E (A2)	Injuries:	3 Fatal (A1); 2 None (A2)
Flight Conducted Under:	Public aircraft (A1); Public aircraft (A2)

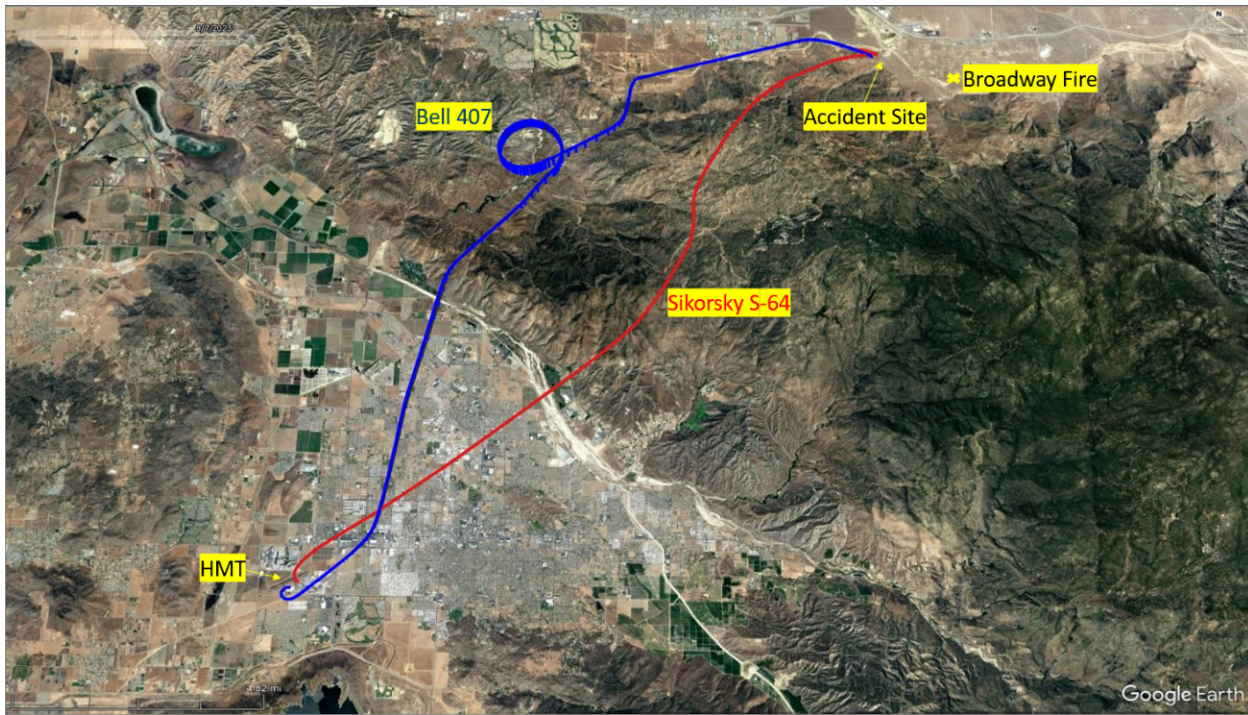
Preliminary Automatic Dependent Surveillance – Broadcast (ADS-B) data (figure 1), revealed that the Bell departed Hemet-Ryan Airport (HMT) in Hemet, California, about 1834 and traveled about 9 nm to the north-northeast. The Bell then completed a left 360° turn and maneuvered northeast towards Cabazon. The Sikorsky departed HMT about 3 minutes after the Bell and travelled northeast through mountainous terrain and continued northeast following descending terrain towards Cabazon. ADS-B data showed both helicopters on a converging flight path, until the time of collision, located about 2 nm west of the Broadway Fire, at an altitude between 2,375 to 2,400 ft mean sea level (msl).

Figure 1. Overlay of Bell and Sikorsky ADS-B Flight Path on Google Earth terrain map
