Aviation Investigation Final Report

Location:	Red Lodge, Montana	Accident Number:	WPR23LA307
Date & Time:	August 8, 2023, 09:00 Local	Registration:	N56907
Aircraft:	Boeing A75N1(PT17)	Aircraft Damage:	Substantial
Defining Event:	Loss of engine power (partial)	Injuries:	2 None
Flight Conducted Under:	Part 91: General aviation - Personal

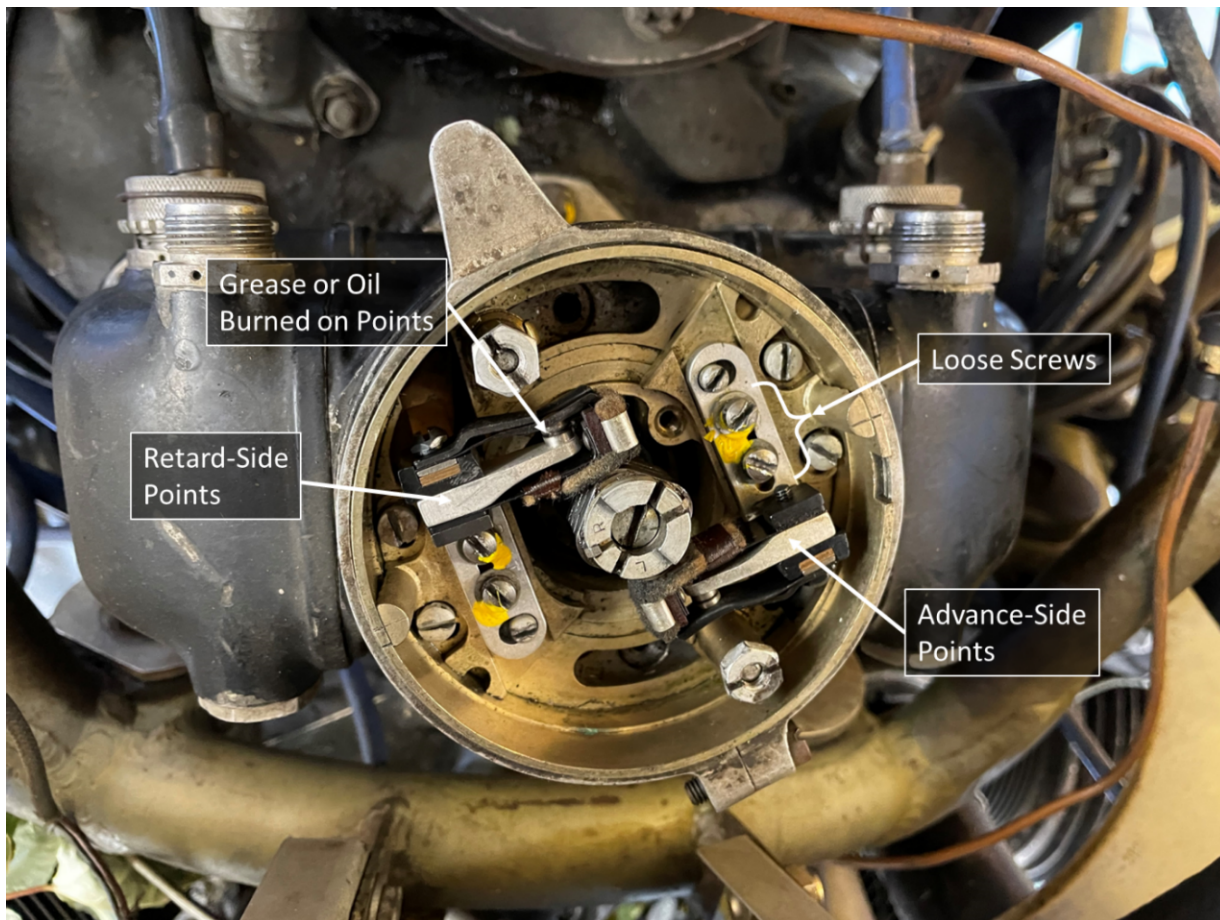
Figure 1. Bendix-Scintilla Magneto with dual points.

Given the improper maintenance to the magneto, it is likely that the engine ignition system did not provide adequate spark at the correct timing, which resulted in a partial loss of power and subsequent descent into terrain.

The components of the magneto were identified as belonging to the advance-side or retard-side of the magneto. Examination of the magneto revealed that the retard points had a coat of grease or oil burned onto them, but the points themselves were not burned. The screws that held the advance points in place were loose, which caused the advance-side points to back away from the cam and not open. The yellow tamper indicator was still intact but fell off when the screw was tightened before the bench test run. Figure 1o is a view of the magneto and the dual points configuration.

Upon removal of the advance-side coil cover, a P-lead spring fell out. Examination of this spring indicated that it was not the correct part and appeared to be modified to fit the magneto.

A test run of the magneto revealed that the retard-side points began firing at 400 to 500 rpm. According to the maintenance manual, the points should begin firing consistently at 280 rpm. The advance-side points did not fire at all but should have fired at 180 rpm.

Both coils were removed and checked to be operating within tolerance. The advance-side condenser was checked and was not functional. The retard-side condenser was checked and found to be functional.

The magneto drive was placed on a timing wheel to check for internal timing. Examination revealed the advance-side timing was so far off that it could not be properly measured. The retard-side timing was dependent on correct advance-side timing, so as a control, the advance-side was timed properly, and the retard-side timing was then checked. The retard-side timing was found to be 7.5° from the advance-side timing. The correct timing was 4.5° from the advance-side timing for this model of magneto.
