Aviation Investigation Preliminary Report

Location:	Santa Ana, CA	Accident Number:	DCA23FA417
Date & Time:	August 20, 2023, 23:15 Local	Registration:	N516AS
Aircraft:	Boeing 737-890	Injuries:	112 None
Flight Conducted Under:	Part 121: Air carrier - Scheduled

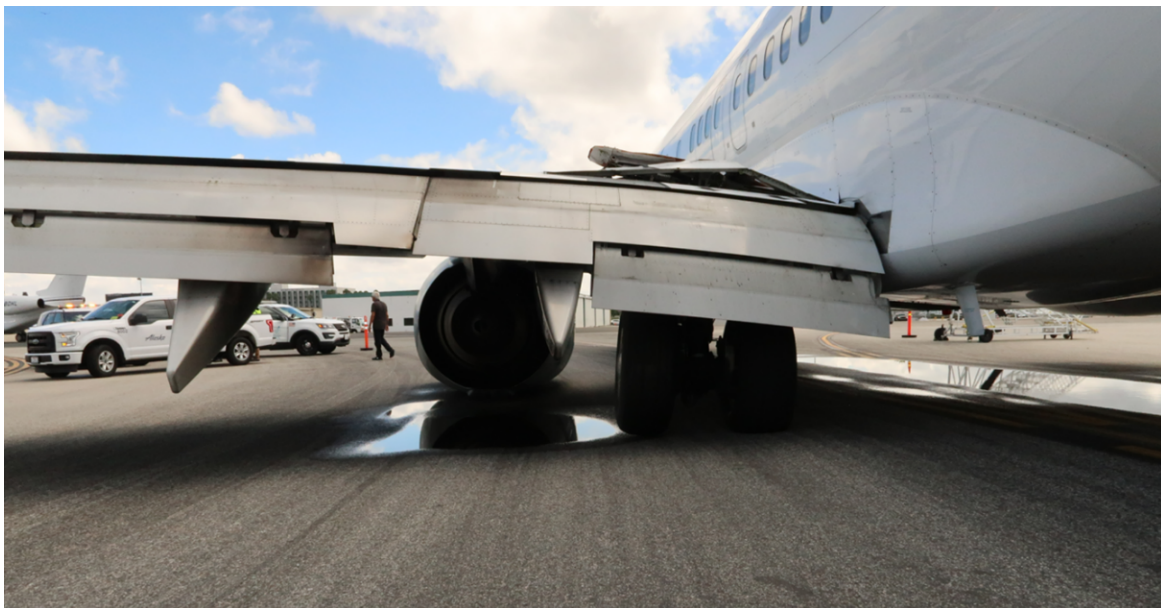
The captain stopped the airplane on the taxiway and set the parking brake. He opened his window, looked outside, and noticed that the aircraft was resting on the left engine cowling (Figure 1), and it appeared to be still running normally. He immediately shut down the left engine. The captain also noted that the left landing gear position indicator light was not green anymore; it had gone completely dark, whereas the nose and right MLG position indicator lights were still green. After confirming the APU was running, he shut down the right engine. He made announcements to the passenger cabin and briefed the flight attendants. No injuries were reported.

Figure 1. Photograph showing collapsed left MLG and engine resting on the ground.

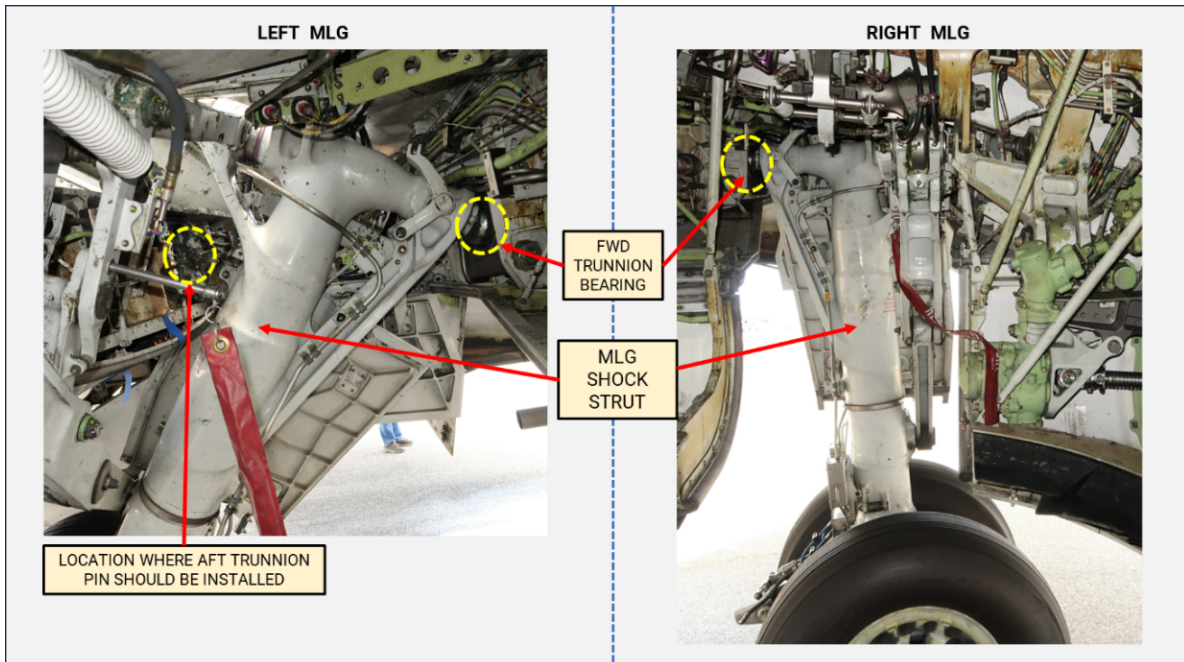
Postaccident examination of the airplane revealed that the MLG aft trunnion pin had fractured (Figures 2 and 3). The aft end of the left MLG had traveled up, puncturing the composite panels, and protruded out and above the wing's surface. The MLG walking beam was also protruding above the surface of the wing. The forward section of the aft trunnion pin was located inside the trunnion and was held in place by a damaged but intact cross bolt. The aft section of the pin had separated and was located in the MLG beam spherical bearing.

Figure 2. Photographs showing a comparison between the left and right MLG.

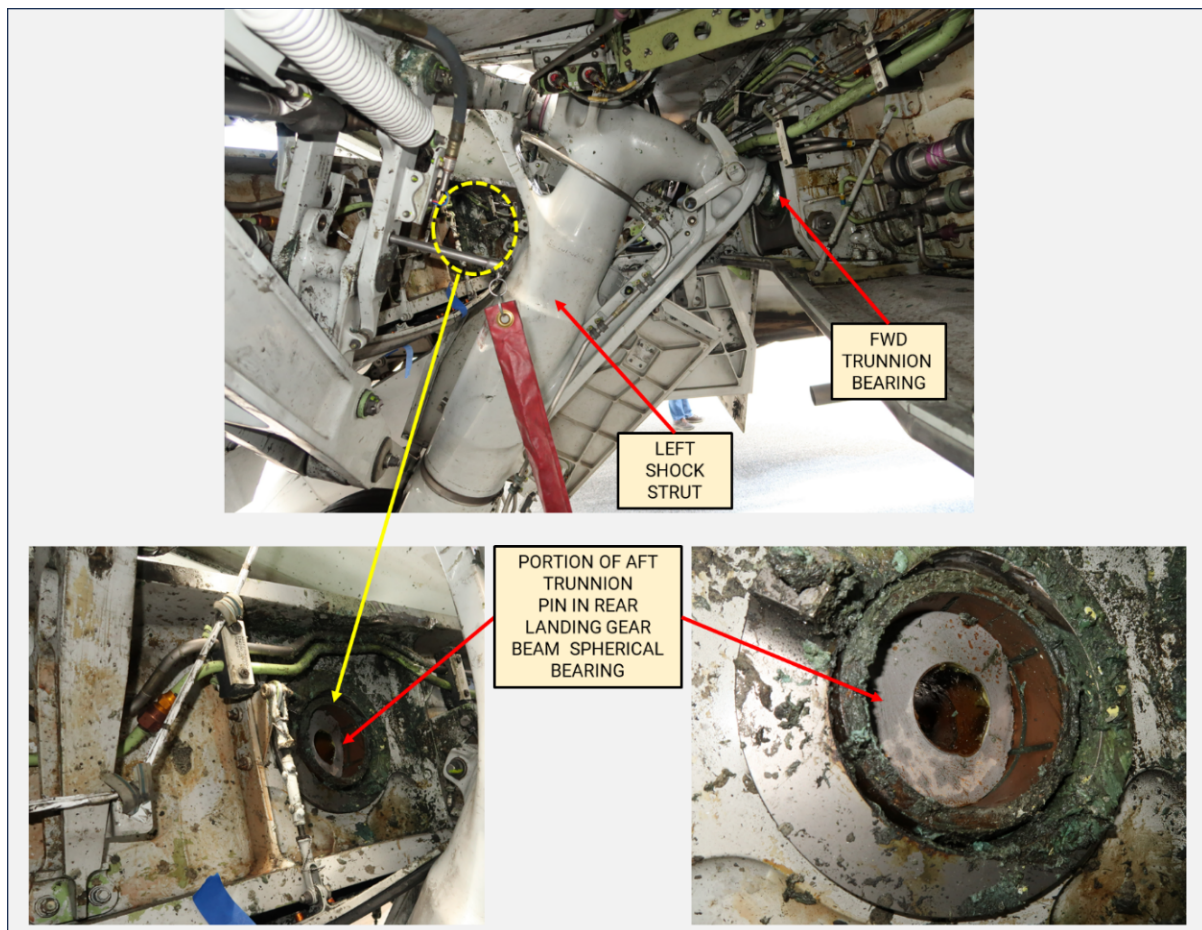
Figure 3. Photographs showing the broken aft trunnion pin on the left MLG.

The left MLG beam sustained damage as a result of the left MLG moving out of position and contacting the beam after the failure of the trunnion pin. The left-wing flap transmission drive unit, located in the left wheel well, separated from its mounting structure and was found on the runway near the airplane's initial touchdown point.
