Aviation Investigation Final Report

Location:	Santa Ana, California	Accident Number:	DCA23FA417
Date & Time:	August 20, 2023, 23:15 Local	Registration:	N516AS
Aircraft:	Boeing 737-890	Aircraft Damage:	Substantial
Defining Event:	Sys/Comp malf/fail (non-power)	Injuries:	112 None
Flight Conducted Under:	Part 121: Air carrier - Scheduled

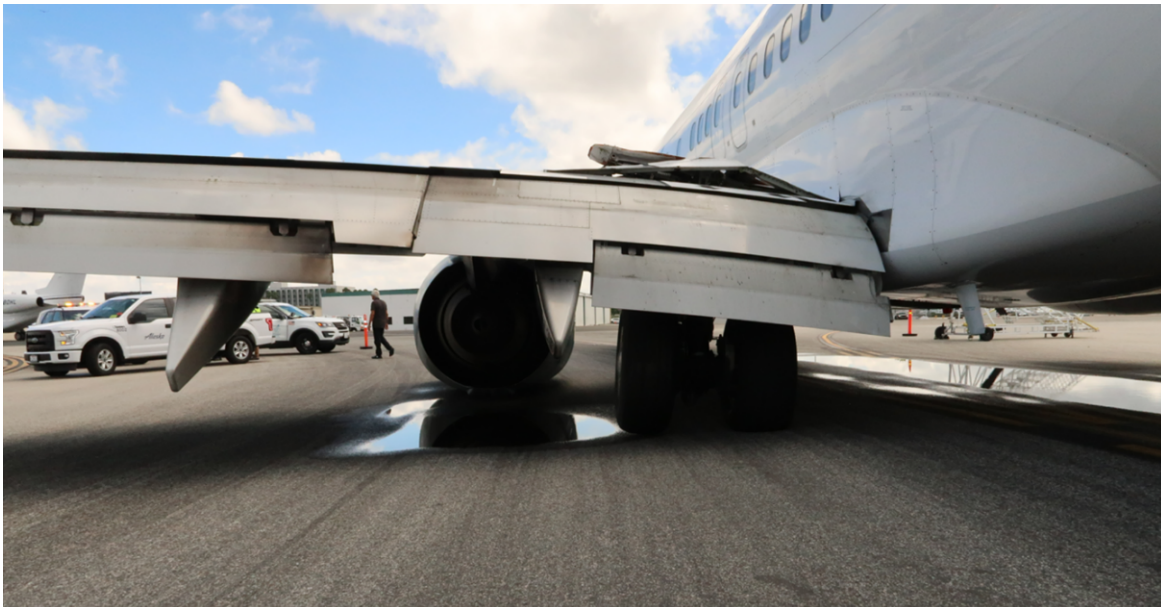
The captain stopped the airplane on the taxiway, set the parking brake, and opened his cockpit window to observe the airplane. He saw that the airplane was resting on its left engine cowling (see figure 1); as a result, he immediately shut down the left engine. Inside the cockpit, the captain noted that the left MLG green position indicator light had extinguished, whereas the nose

Figure 1. Collapsed left MLG and engine resting on the ground.
