# Aviation Investigation Preliminary Report

<b>Location:</b>	Santa Ana, CA	<b>Accident Number:</b>	DCA23FA417
<b>Date &amp; Time:</b>	August 20, 2023, 23:15 Local	<b>Registration:</b>	N516AS
<b>Aircraft:</b>	Boeing 737-890	<b>Injuries:</b>	112 None
<b>Flight Conducted Under:</b>	Part 121: Air carrier - Scheduled

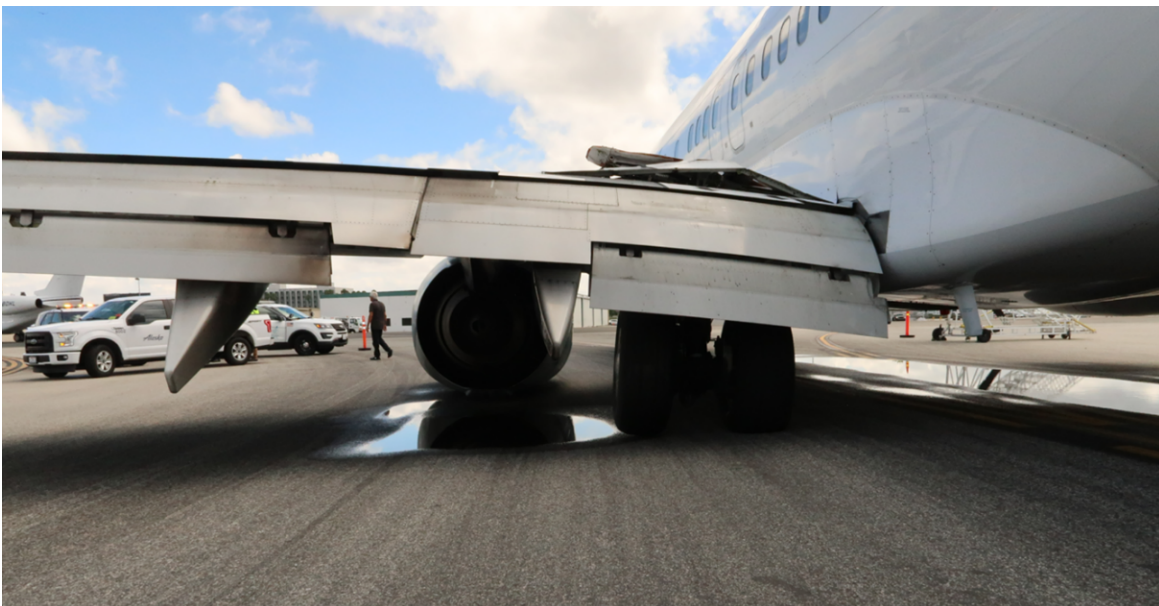
The captain stopped the airplane on the taxiway and set the parking brake. He opened his window, looked outside, and noticed that the aircraft was resting on the left engine cowling (Figure 1), and it appeared to be still running normally. He immediately shut down the left engine. The captain also noted that the left landing gear position indicator light was not green anymore; it had gone completely dark, whereas the nose and right MLG position indicator lights were still green. After confirming the APU was running, he shut down the right engine. He made announcements to the passenger cabin and briefed the flight attendants. No injuries were reported.

Figure 1. Photograph showing collapsed left MLG and engine resting on the ground.

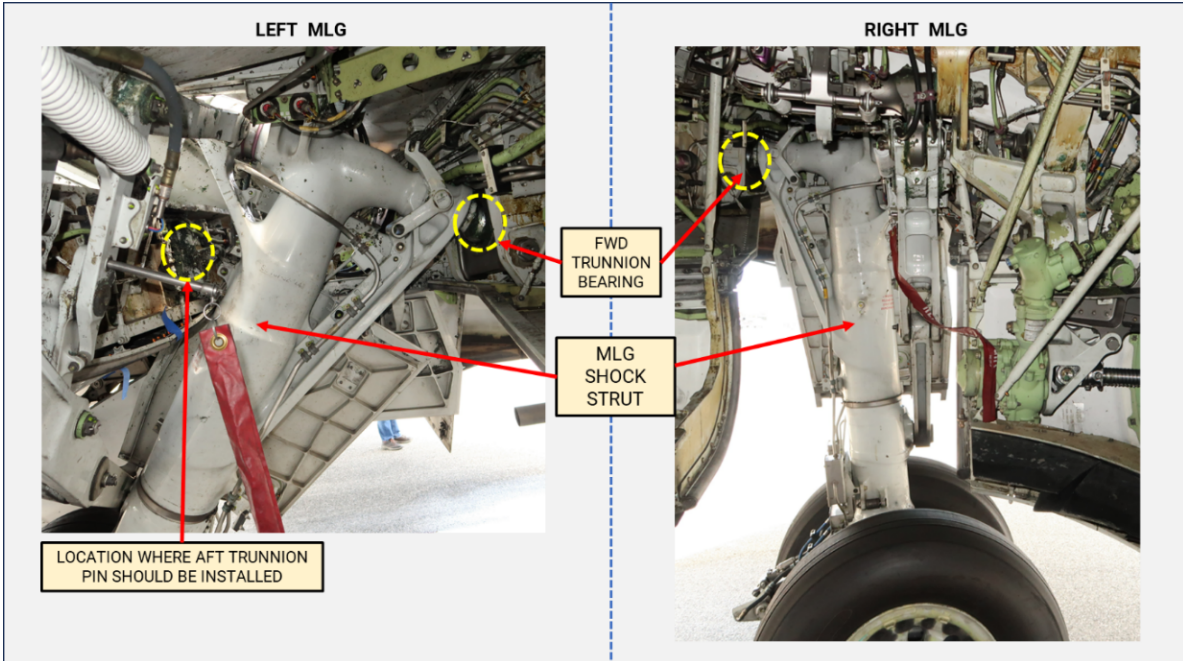
Postaccident examination of the airplane revealed that the MLG aft trunnion pin had fractured (Figures 2 and 3). The aft end of the left MLG had traveled up, puncturing the composite panels, and protruded out and above the wing's surface. The MLG walking beam was also protruding above the surface of the wing. The forward section of the aft trunnion pin was located inside the trunnion and was held in place by a damaged but intact cross bolt. The aft section of the pin had separated and was located in the MLG beam spherical bearing.

Figure 2. Photographs showing a comparison between the left and right MLG.

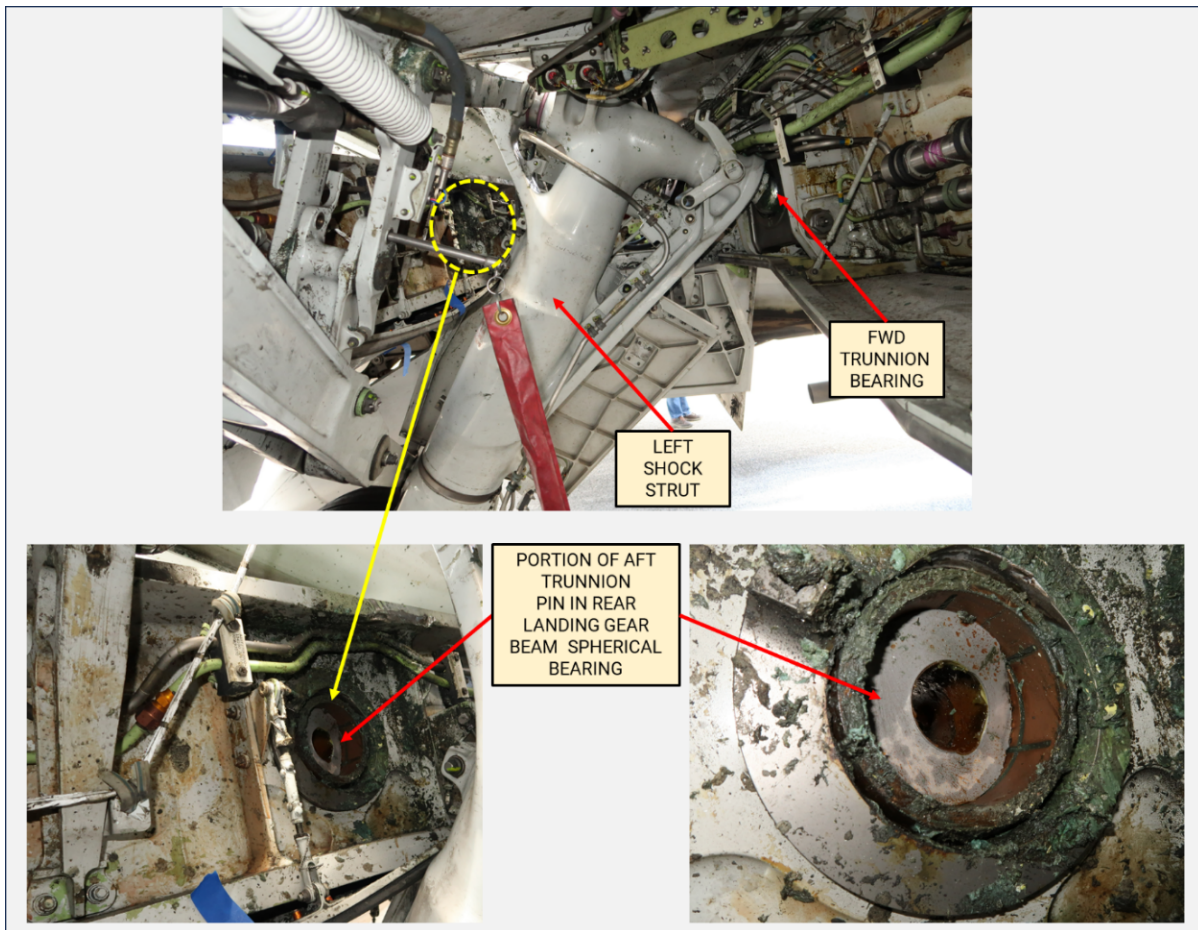
Figure 3. Photographs showing the broken aft trunnion pin on the left MLG.

The left MLG beam sustained damage as a result of the left MLG moving out of position and contacting the beam after the failure of the trunnion pin. The left-wing flap transmission drive unit, located in the left wheel well, separated from its mounting structure and was found on the runway near the airplane's initial touchdown point.
