Aviation Investigation Preliminary Report

Location:	Santa Ana, CA	Accident Number:	DCA23FA417
Date & Time:	August 20, 2023, 23:15 Local	Registration:	N516AS
Aircraft:	Boeing 737-890	Injuries:	112 None
Flight Conducted Under:	Part 121: Air carrier - Scheduled

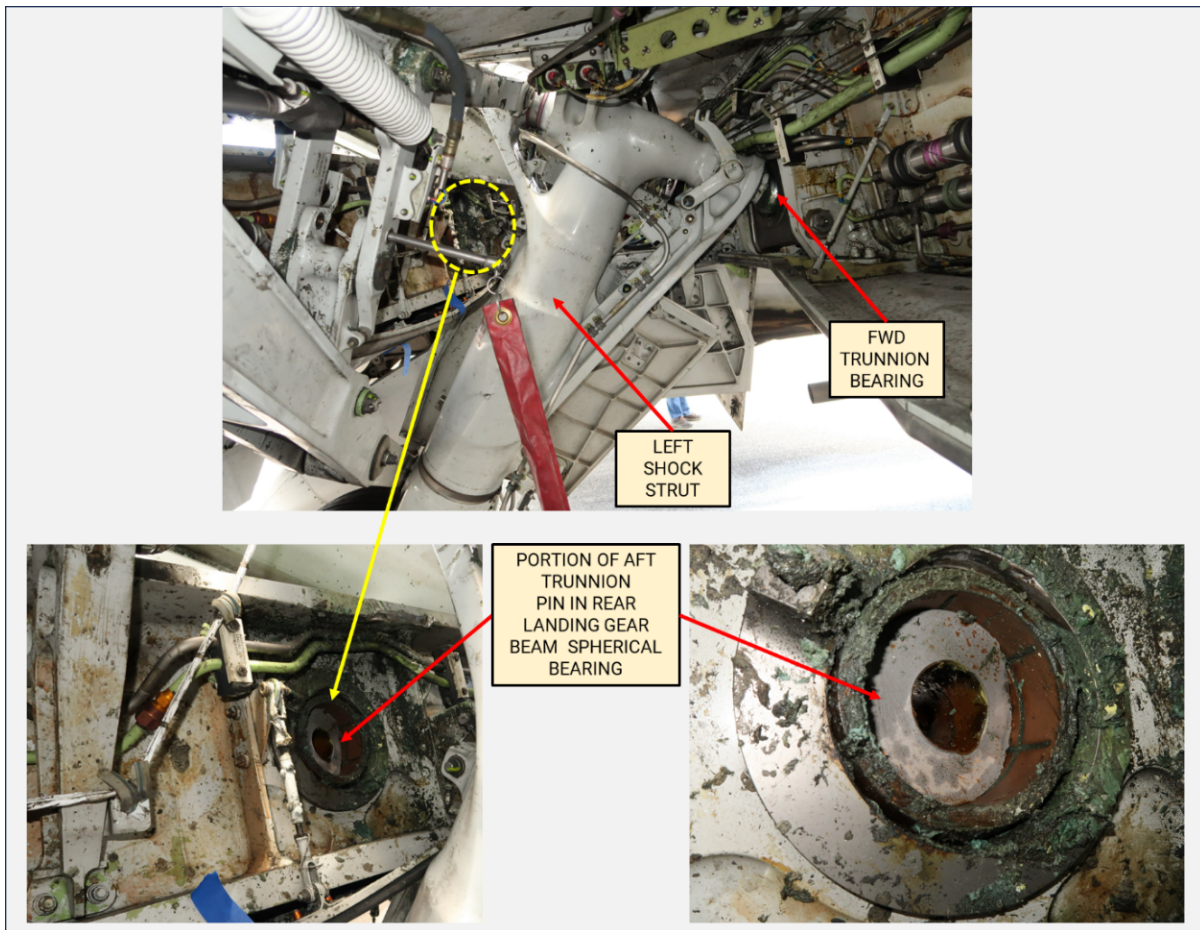
Postaccident examination of the airplane revealed that the MLG aft trunnion pin had fractured (Figures 2 and 3). The aft end of the left MLG had traveled up, puncturing the composite panels, and protruded out and above the wing's surface. The MLG walking beam was also protruding above the surface of the wing. The forward section of the aft trunnion pin was located inside the trunnion and was held in place by a damaged but intact cross bolt. The aft section of the pin had separated and was located in the MLG beam spherical bearing.

Figure 3. Photographs showing the broken aft trunnion pin on the left MLG.

The left MLG beam sustained damage as a result of the left MLG moving out of position and contacting the beam after the failure of the trunnion pin. The left-wing flap transmission drive unit, located in the left wheel well, separated from its mounting structure and was found on the runway near the airplane's initial touchdown point.
