Aviation Investigation Preliminary Report

| Location: | Santa Ana, CA | Accident Number: | DCA23FA417 |
| Date & Time: | August 20, 2023, 23:15 Local | Registration: | N516AS |
| Aircraft: | Boeing 737-890 | Injuries: | 112 None |

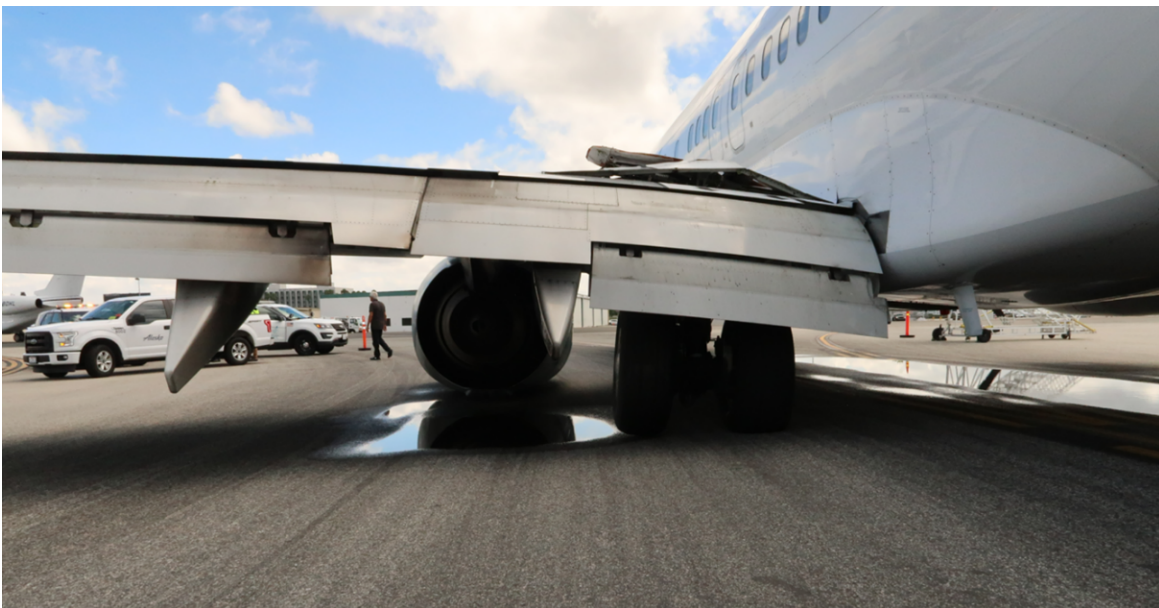
The captain stopped the airplane on the taxiway and set the parking brake. He opened his window, looked outside, and noticed that the aircraft was resting on the left engine cowling (Figure 1), and it appeared to be still running normally. He immediately shut down the left engine. The captain also noted that the left landing gear position indicator light was not green anymore; it had gone completely dark, whereas the nose and right MLG position indicator lights were still green. After confirming the APU was running, he shut down the right engine. He made announcements to the passenger cabin and briefed the flight attendants. No injuries were reported.

Figure 1. Photograph showing collapsed left MLG and engine resting on the ground.

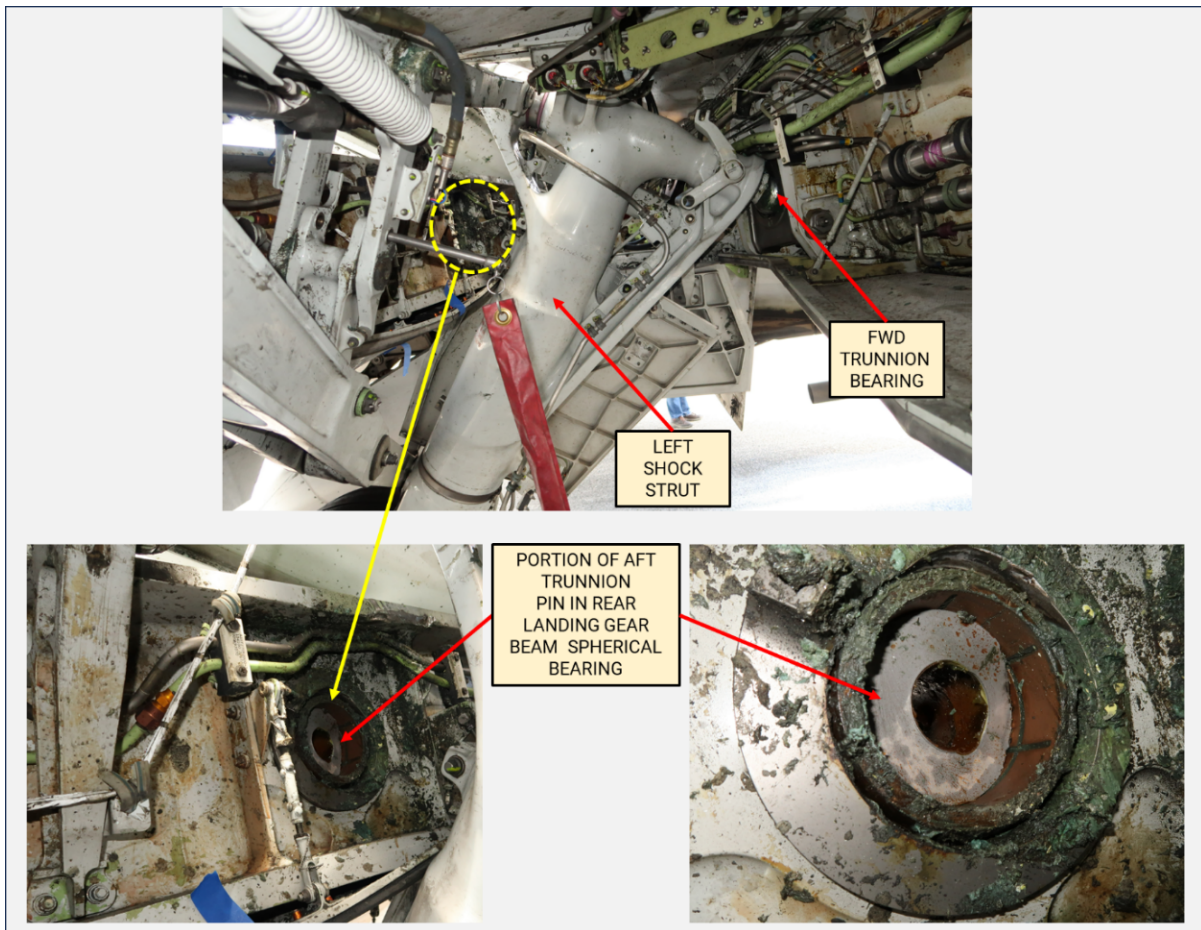
Postaccident examination of the airplane revealed that the MLG aft trunnion pin had fractured (Figures 2 and 3). The aft end of the left MLG had traveled up, puncturing the composite panels, and protruded out and above the wing's surface. The MLG walking beam was also protruding above the surface of the wing. The forward section of the aft trunnion pin was located inside the trunnion and was held in place by a damaged but intact cross bolt. The aft section of the pin had separated and was located in the MLG beam spherical bearing.

Figure 3. Photographs showing the broken aft trunnion pin on the left MLG.

The left MLG beam sustained damage as a result of the left MLG moving out of position and contacting the beam after the failure of the trunnion pin. The left-wing flap transmission drive unit, located in the left wheel well, separated from its mounting structure and was found on the runway near the airplane's initial touchdown point.
