Aviation Investigation Preliminary Report

Location:	Huntsville, TX	Accident Number:	CEN23FA401
Date & Time:	September 6, 2023, 11:48 Local	Registration:	N6059G
Aircraft:	Cessna 150K	Injuries:	2 Fatal
Flight Conducted Under:	Part 91: General aviation - Instructional

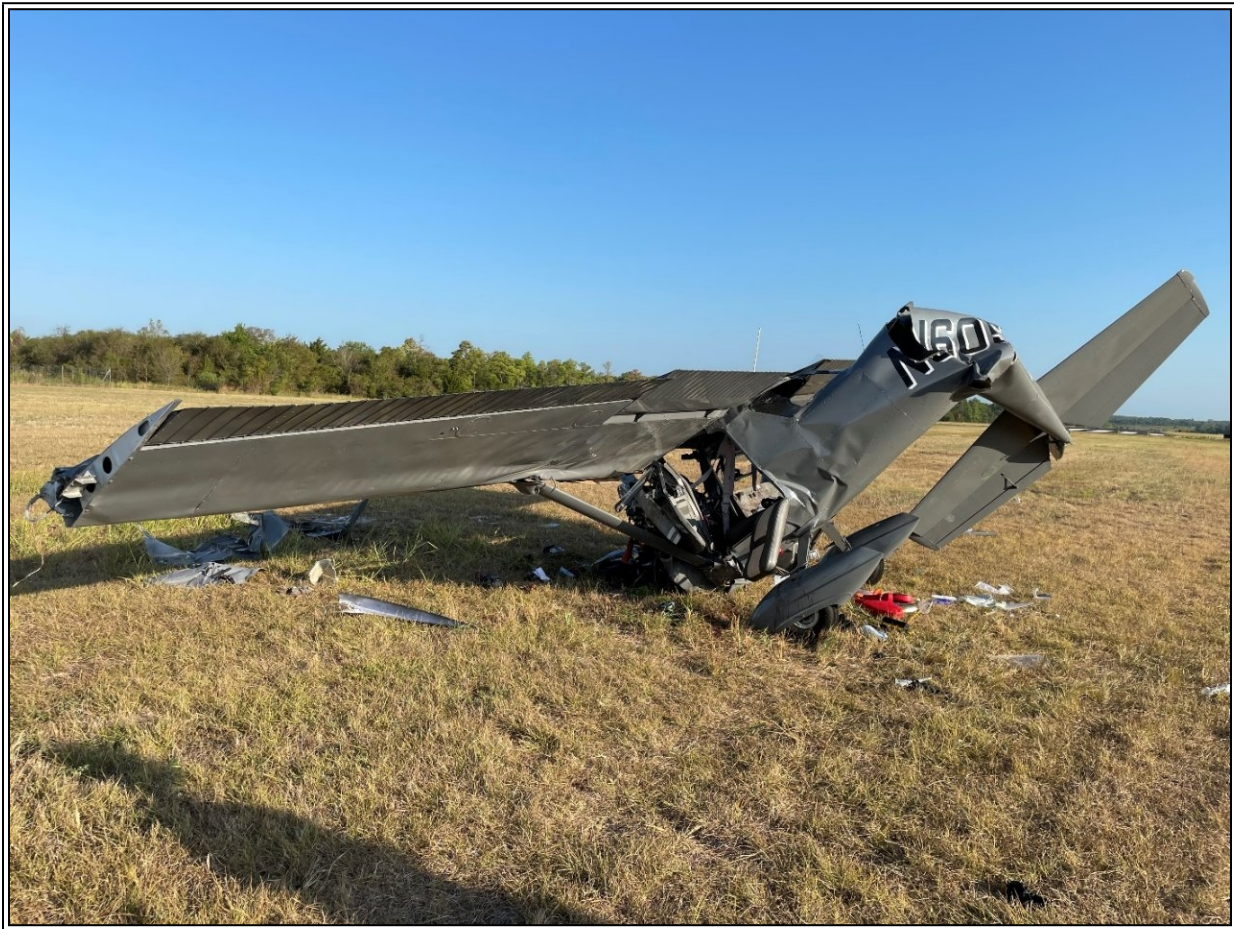
upright and nose down on a west heading, as shown in figure 1. The leading edge of both wings were crushed aft to their respective main spars.

Figure 1. Main wreckage at the accident site

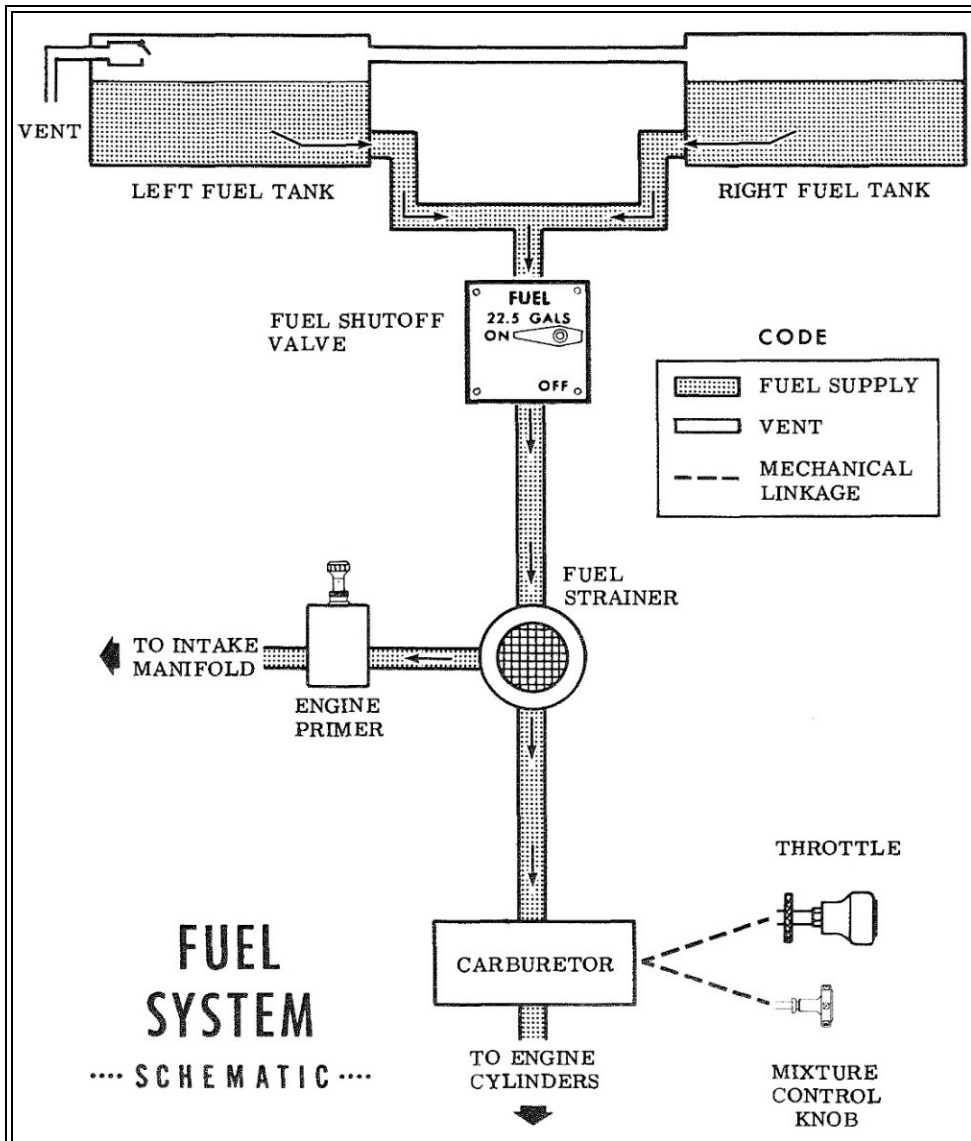
Figure 2. Fuel system schematic

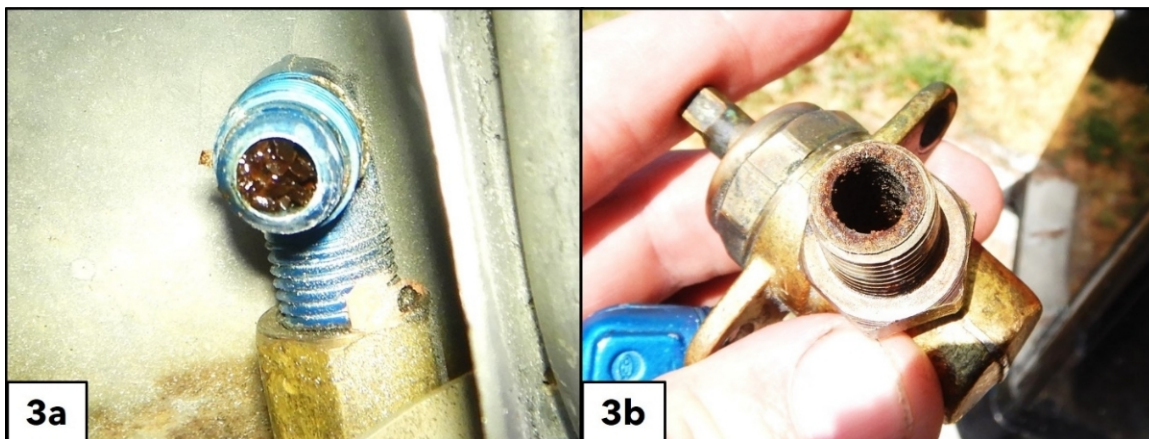
The fuel line connected to the inlet port of the fuel shutoff valve was removed and fuel-wetted debris was seen inside the elbow fuel fitting. The debris obstructed the elbow fuel fitting, as shown in figure 3a. The fuel shutoff valve outlet port exhibited accumulated debris affixed to its inside diameter, as shown in figure 3b. Additional debris was recovered from inside the shutoff valve when tapped on a table, as shown in figure 4.

Figure 3. Fuel shutoff valve inlet port (3a) and outlet port (3b)

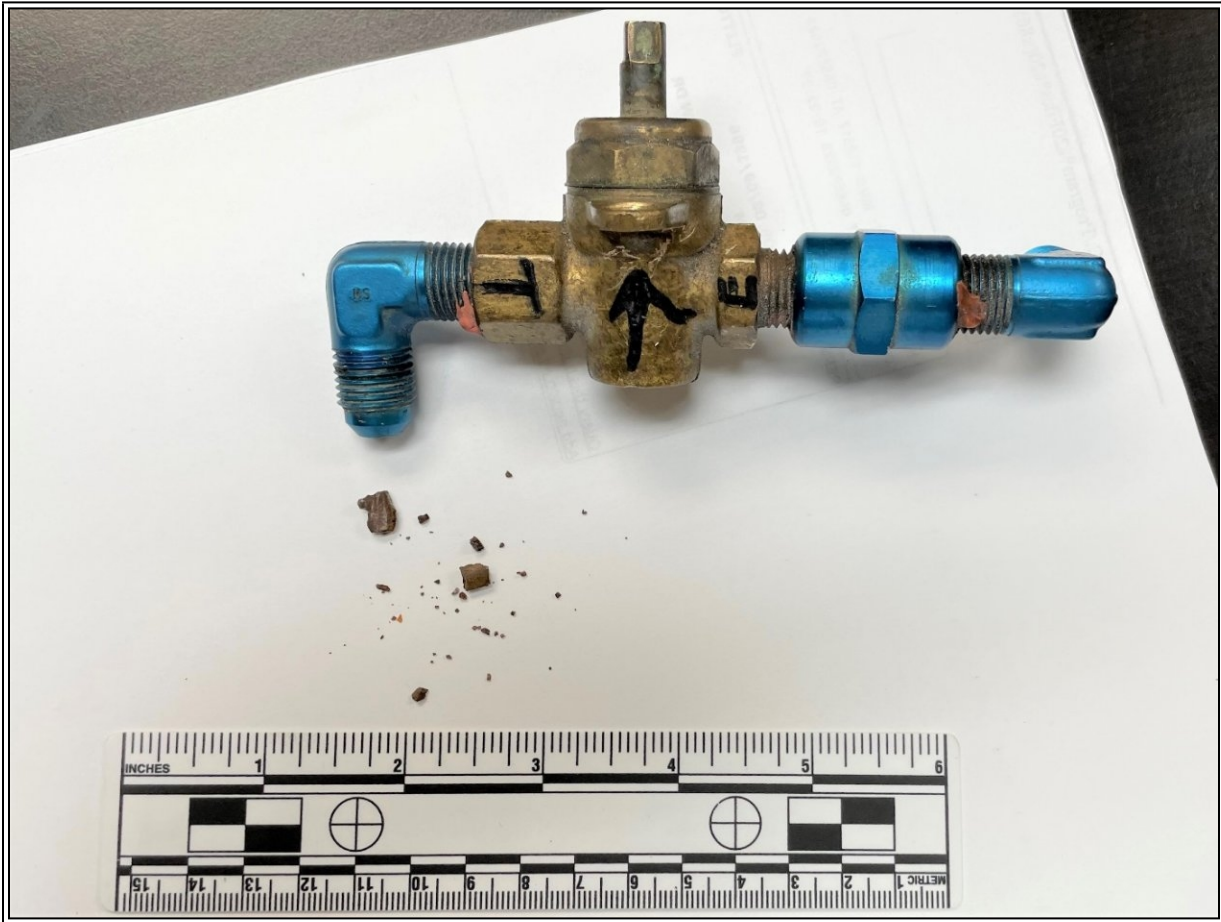
Figure 4. Fuel shutoff valve and debris recovered from inlet port

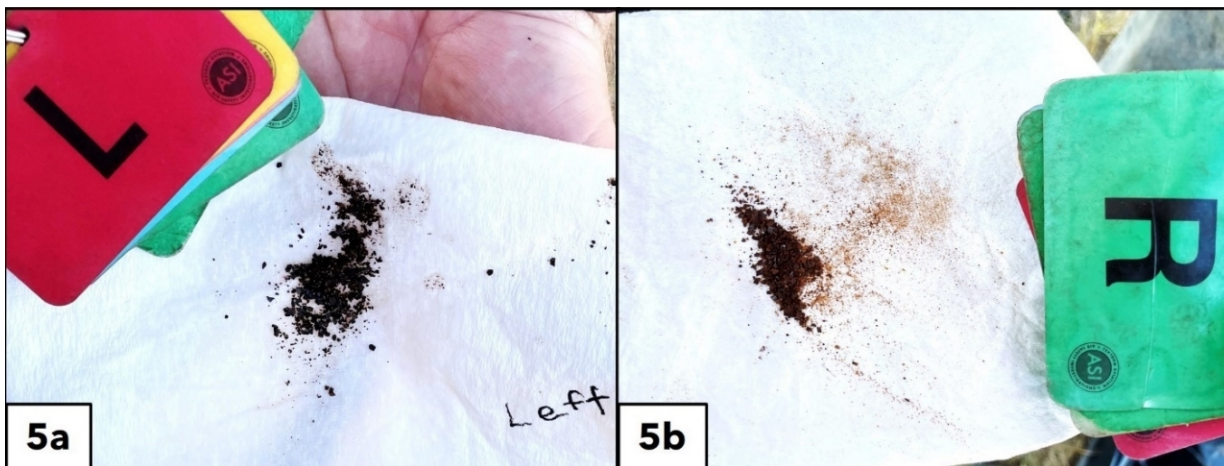
The fuel line from each wing fuel tank was disconnected and air blown through the fuel line to the disconnected line at the fuel shutoff valve. Fuel and traces of debris was extracted from the left and right fuel lines. The recovered debris was similar to the debris found in the inlet/outlet ports of the fuel shutoff valve, as shown in figures 5a and 5b. A borescope examination of the left- and right-wing fuel tanks revealed additional loose debris inside each fuel tank.

Figure 5. Debris recovered from the left fuel line (5a) and right fuel line (5b)
