# Aviation Investigation Final Report

<b>Location:</b>	Wheeling, Illinois	<b>Accident Number:</b>	CEN23LA403
<b>Date &amp; Time:</b>	August 21, 2023, 13:15 Local	<b>Registration:</b>	N39TT
<b>Aircraft:</b>	ISRAEL AIRCRAFT INDUSTRIES 1125 WESTWIND ASTRA	<b>Aircraft Damage:</b>	Substantial
<b>Defining Event:</b>	Runway excursion	<b>Injuries:</b>	2 None
<b>Flight Conducted Under:</b>	Part 91: General aviation - Positioning

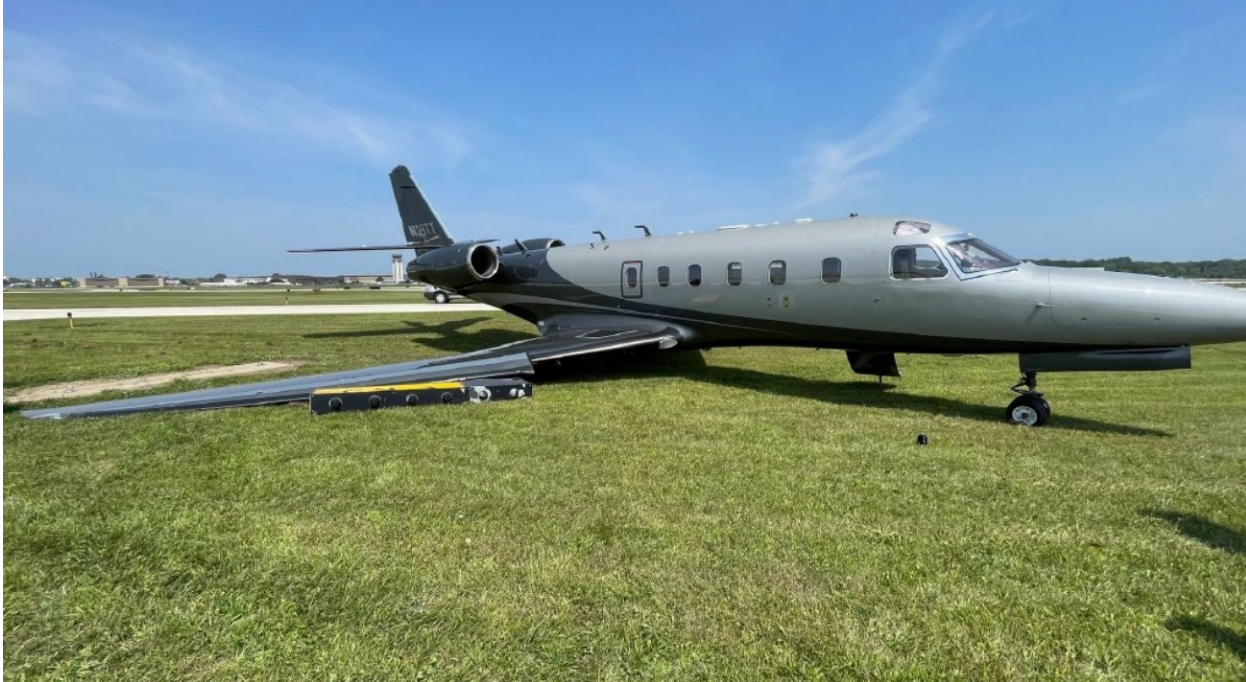
Figure

According to the flight crew, the airplane touched down within the touchdown zone. The pilot reported that he applied the brakes and deployed the thrust reversers (TRs), but the brakes “were not grabbing.” The pilot released and reapplied brake pressure with no effect and advised the co-pilot he had no brakes. The co-pilot applied his brakes with no effect. The pilot selected the emergency brake handle and applied emergency braking. The emergency braking produced some slowing, and with the airplane’s nose wheel tiller, the pilot attempted a left turn to exit the runway onto a 45° taxiway, which he thought provided additional stopping distance; however, the airplane slid off the taxiway and into the adjacent grass. The right main landing gear collapsed, and the airplane came to rest upright, resulting in substantial damage to the right wing spar.

1. Accident airplane (Source: Airport operations)

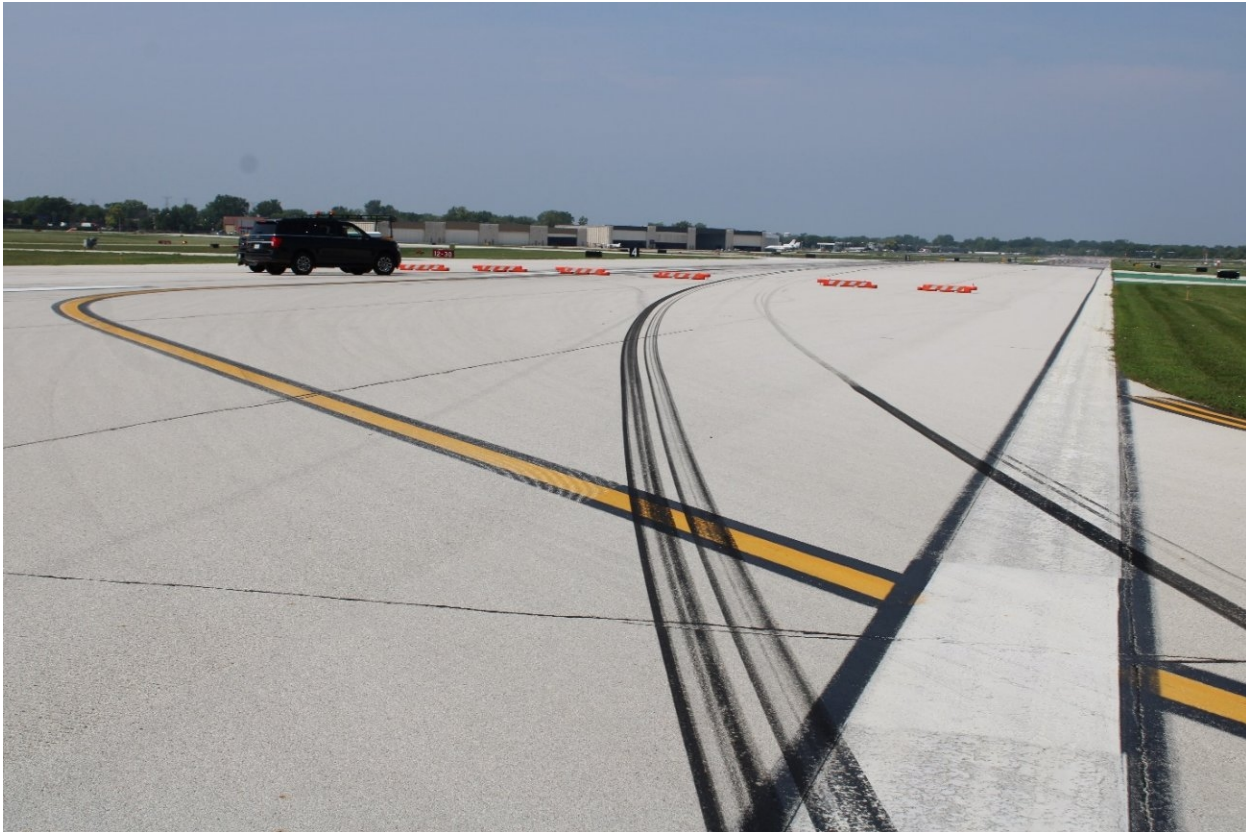
A review of airport operations photographs revealed tire skid marks beginning on the runway surface and continuing onto taxiway D (see Figure 2) until the airplane departed the runway surface. Measurements of the tire skids marks were not recorded.

Figure 2. Airplane tire skid marks (Source: Airport operations).
