Aviation Investigation Preliminary Report

Location:	Twisp, WA	Accident Number:	WPR24FA001
Date & Time:	October 1, 2023, 10:30 Local	Registration:	N56DV
Aircraft:	CUBCRAFTERS INC CCK-1865	Injuries:	1 Fatal
Flight Conducted Under:	Part 91: General aviation - Personal

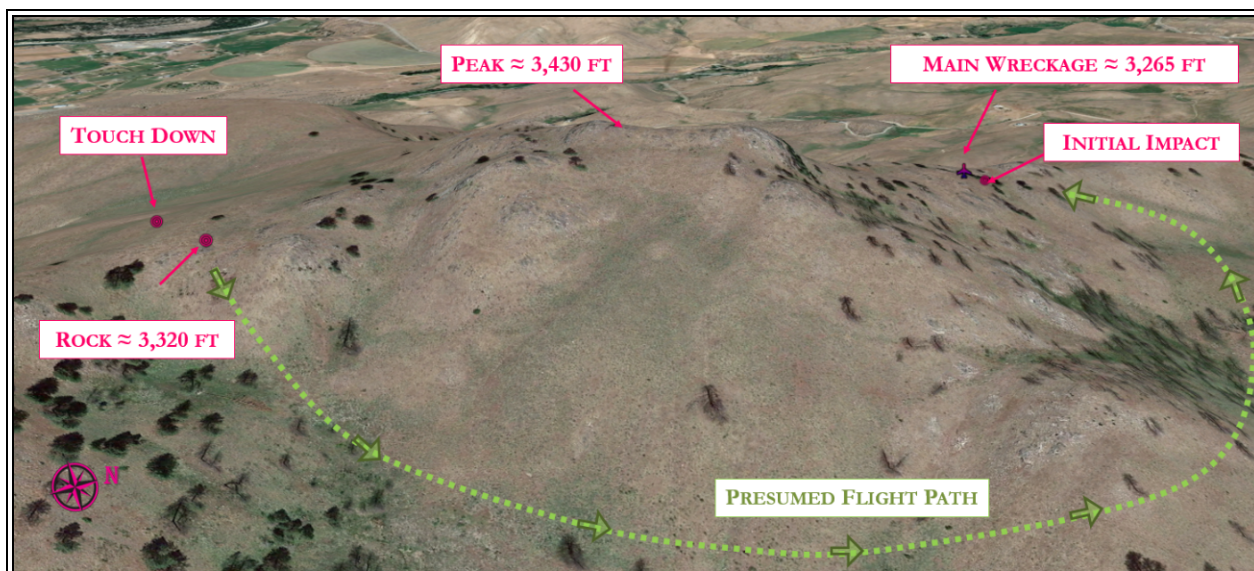
Figure 1: Initial Landing Area in Reference to the Accident Site

The friend observed the airplane continued over the ridge to the east (the presumed bail-out path) and then he lost sight. He asked the pilot if he was okay and the pilot replied "I'm flying, but I'm having problems." The airplane collided with terrain shortly thereafter. The airplane came to rest about 1,700 ft to the northeast of the rock with an approximate 3,430 peak between the locations (Figure 1).

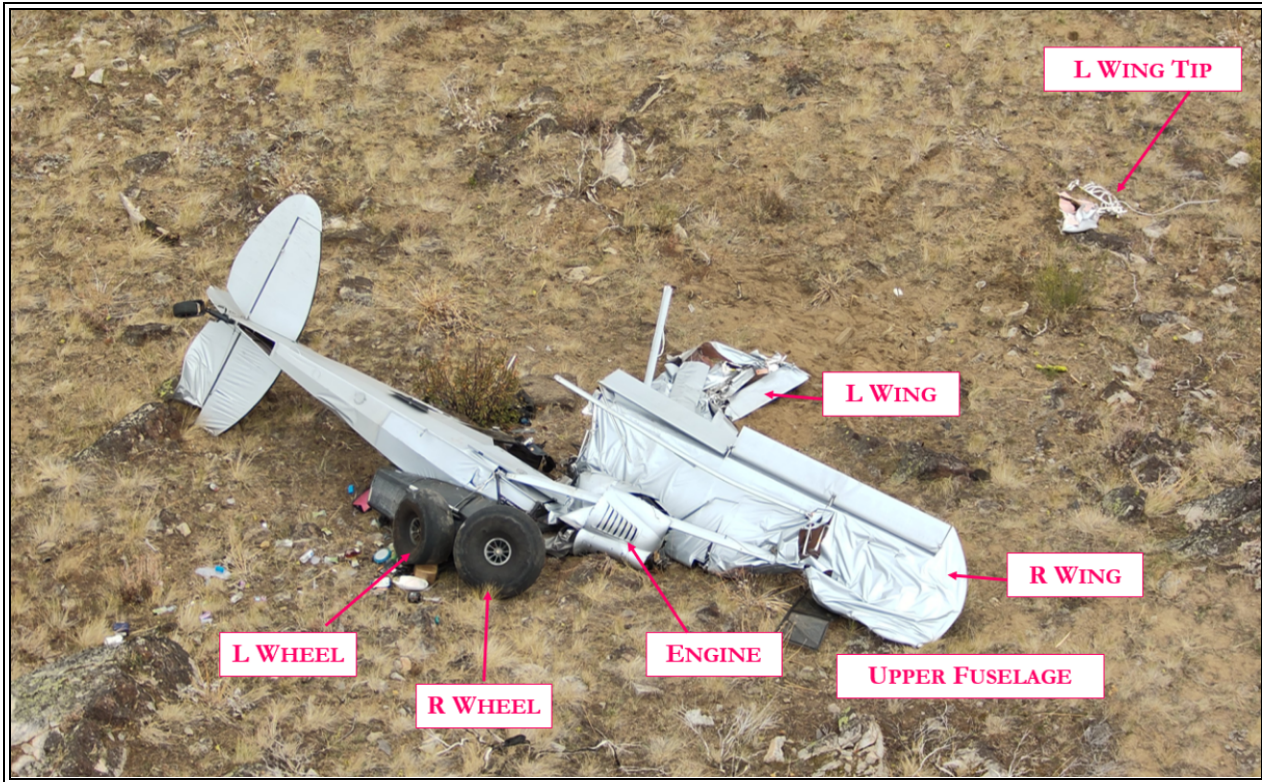
Figure 2: Wreckage

The fuselage came to rest on its left side with the right wing folded forward over the engine (see Figure 2). The left wing sustained crush deformation and came to rest inverted. The left forward and aft lift struts had separated, but remained attached to their respective fittings on the fuselage and wing. An approximate 1.5 ft piece of the left aft-lift strut remained attached to the airframe; the trailing edge of both portions of that strut contained black marks consistent with the rubber from the tire. The flaps appeared to be partially down and the fuel selector was in the off position (it could not be confirmed if this was done by first responders).

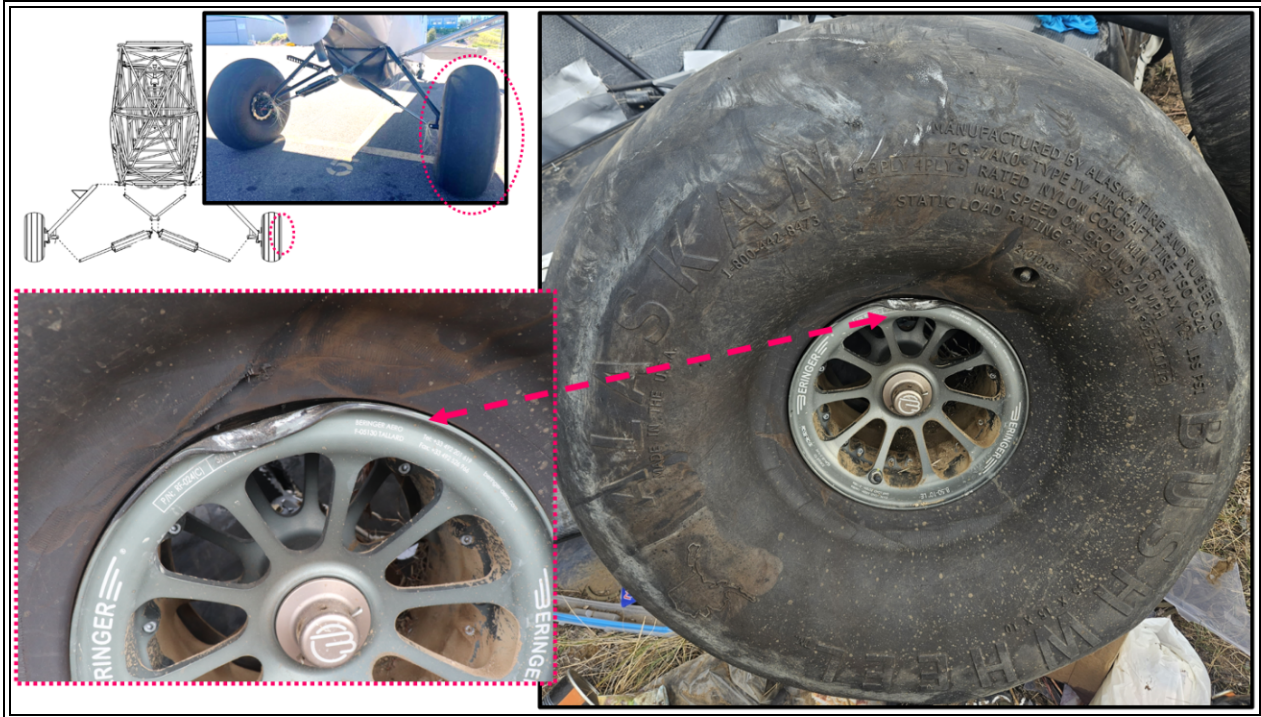
Figure 3: Left Tire

Both tires came to rest on near the belly pod. The left tire was flat and showed several gouges and scrapes on the rubber; the metal hub was bent and folded over itself in one area (see Figure 3). The landing gear struts were collapsed the bottom of the left struts were separated and appeared to have been worn from being dragged across terrain.

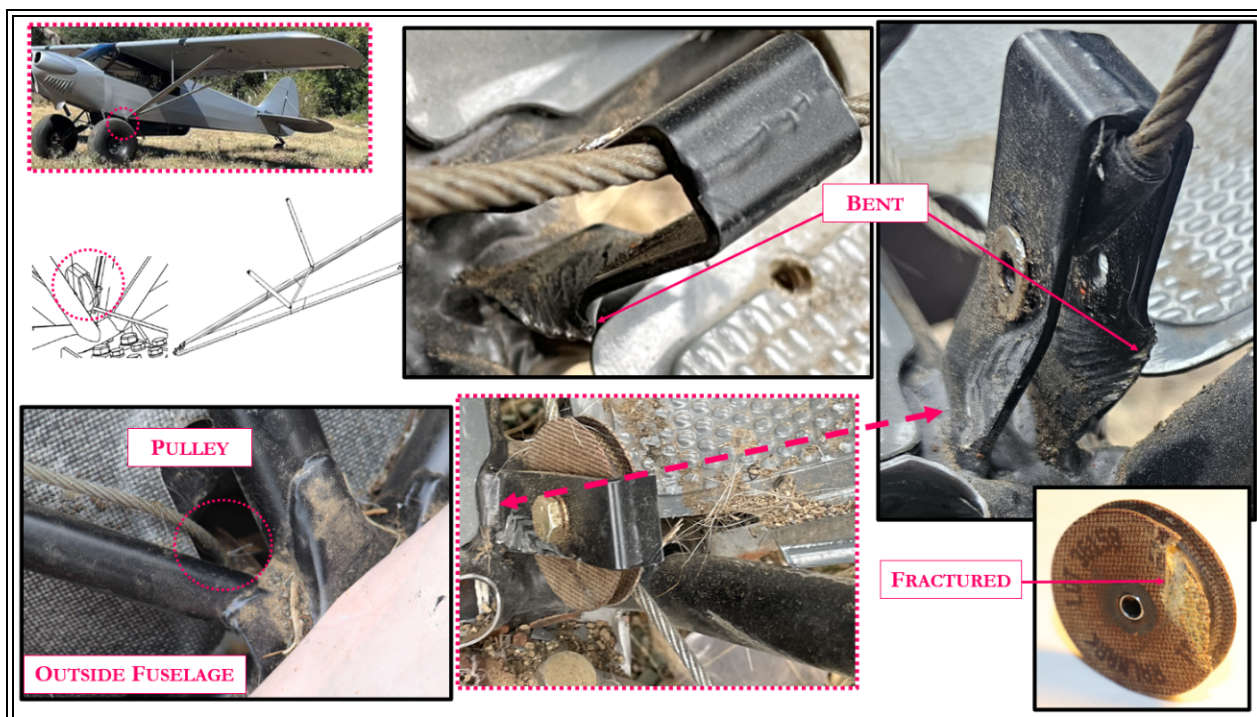
Figure 4: Left Aileron Pulley

The fuselage frame behind the left lift-strut fork and gear-strut connection fittings was deformed. The left-aileron pulley, located adjacent to the deformed frame, would not move. The aileron cable was trapped between the frame and the pulley and could not move (see Figure 4). Removal of the pulley hardware revealed that pulley bracket was bent and there was evidence of the cable rubbing against the bracket and part of the airframe. The phenolic pulley had a groove for the cable that extended around the pulley. The groove contained a peak edge on each side. One side of the peak edge was fractured, consistent with overstress. The side face of the pulley, adjacent to the fractured peak edge) contained a long, imprinted streak consistent to the location where the cable had pulled out/de-railed from the groove.

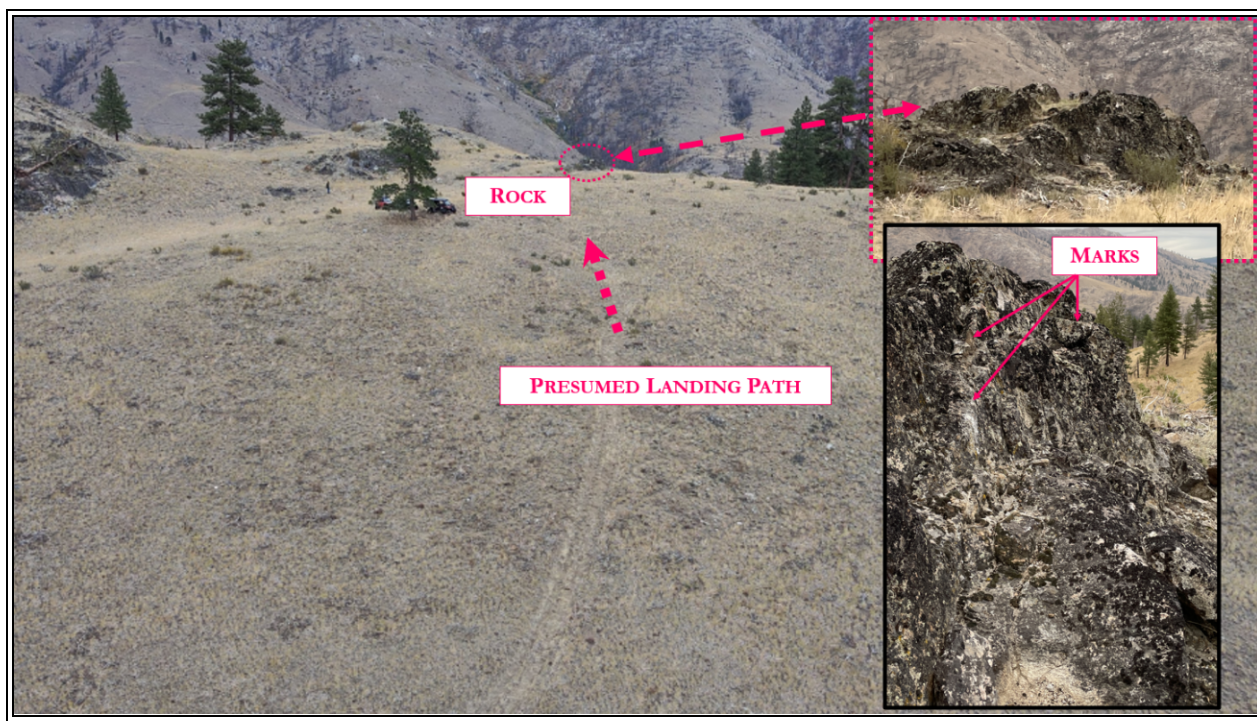
Figure 5: Accident Site Overview

The initial touchdown area could not definitely be determined, but tracks in the dry grass were found on the slope consistent with the landing direction. A large rock was located on the saddle of the hill. There were numerous marks and scrapes found on the south rock face and on the top of the rock (see Figure 5). In the surrounding area, there was several silver chips of paint and a zip-tie that would have been on the landing gear.
