# Aviation Investigation Final Report

<b>Location:</b>	Moab, Utah	<b>Accident Number:</b>	WPR24FA002
<b>Date &amp; Time:</b>	October 1, 2023, 20:24 Local	<b>Registration:</b>	N7153R
<b>Aircraft:</b>	Piper PA-28-140	<b>Aircraft Damage:</b>	Substantial
<b>Defining Event:</b>	Controlled flight into terr/obj (CFIT)	<b>Injuries:</b>	4 Fatal
<b>Flight Conducted Under:</b>	Part 91: General aviation - Personal

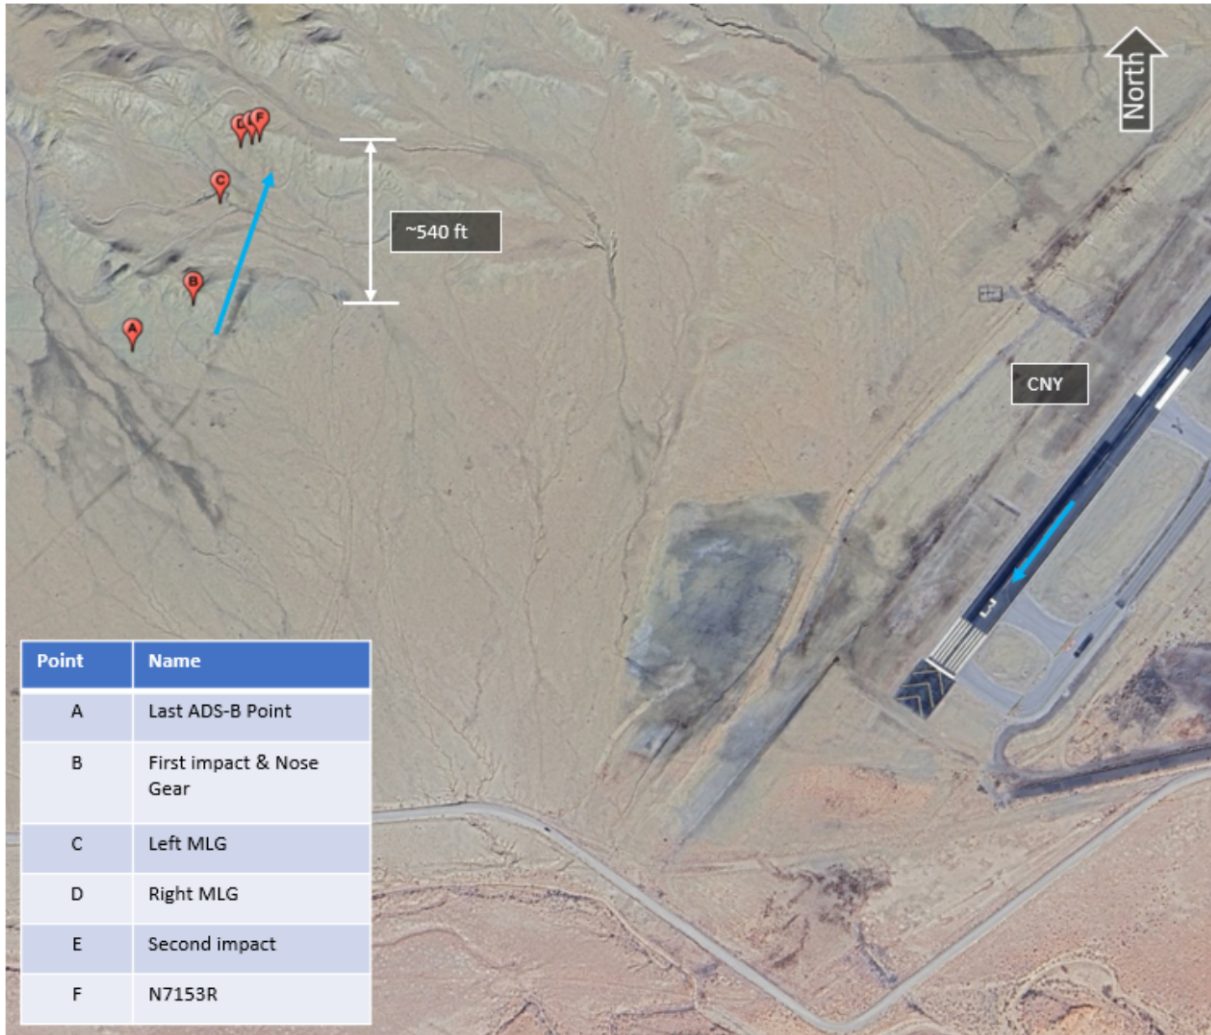
Impact marks indicated that the pilot likely began a climb or held a nose-up attitude before the airplane's landing gear struck a hill. The airplane continued beyond this first hill for about 540 ft, where it then descended in a nose-low attitude and impacted a second hill. The impacts fatally injured the occupants and substantially damaged the airplane.

The airplane came to rest on a hill at an elevation of about 4649 ft msl, on a heading of about 200° magnetic. A line of debris that included the nose and main landing gear assembly extended southwest about 540 ft and included two impact points. The first point of probable impact was a 12 ft by 24-inch gouge/indentation on a hill, at an elevation of about 4635 ft msl, and was consistent with only the nose landing gear impacting the terrain. About 50 ft northeast of this point were indications of contact by the right and then the left main landing gear. About 540 ft away was a second impact mark that was within about 40 ft of the final location of the main wreckage (Figure 1).

Figure 1. Google Earth image showing the first and second points of probable impact, and the location of the landing gear. The blue arrow points in the direction of travel.
