Aviation Investigation Final Report

Location:	Moab, Utah	Accident Number:	WPR24FA002
Date & Time:	October 1, 2023, 20:24 Local	Registration:	N7153R
Aircraft:	Piper PA-28-140	Aircraft Damage:	Substantial
Defining Event:	Controlled flight into terr/obj (CFIT)	Injuries:	4 Fatal
Flight Conducted Under:	Part 91: General aviation - Personal

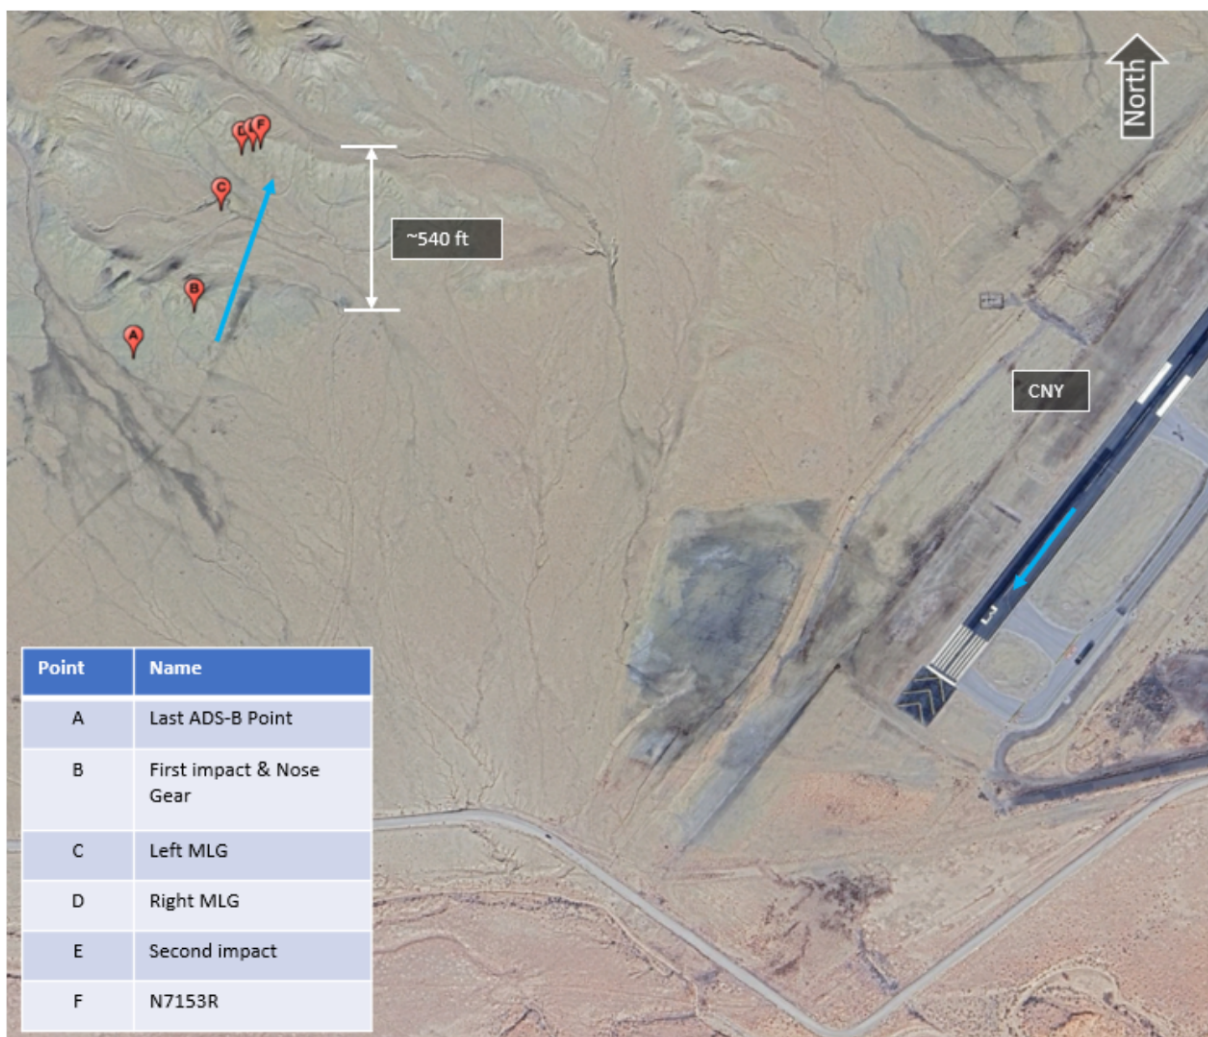
The airplane came to rest on a hill at an elevation of about 4649 ft msl, on a heading of about 200° magnetic. A line of debris that included the nose and main landing gear assembly extended southwest about 540 ft and included two impact points. The first point of probable impact was a 12 ft by 24-inch gouge/indentation on a hill, at an elevation of about 4635 ft msl, and was consistent with only the nose landing gear impacting the terrain. About 50 ft northeast of this point were indications of contact by the right and then the left main landing gear. About 540 ft away was a second impact mark that was within about 40 ft of the final location of the main wreckage (Figure 1).

Figure 1. Google Earth image showing the first and second points of probable impact, and the location of the landing gear. The blue arrow points in the direction of travel.
