# Aviation Investigation Preliminary Report

<b>Location:</b>	Newberg, OR	<b>Accident Number:</b>	WPR24FA004
<b>Date &amp; Time:</b>	October 3, 2023, 18:47 Local	<b>Registration:</b>	N8360K
<b>Aircraft:</b>	Piper PA-44-180	<b>Injuries:</b>	2 Fatal, 1 Serious
<b>Flight Conducted Under:</b>	Part 91: General aviation - Instructional

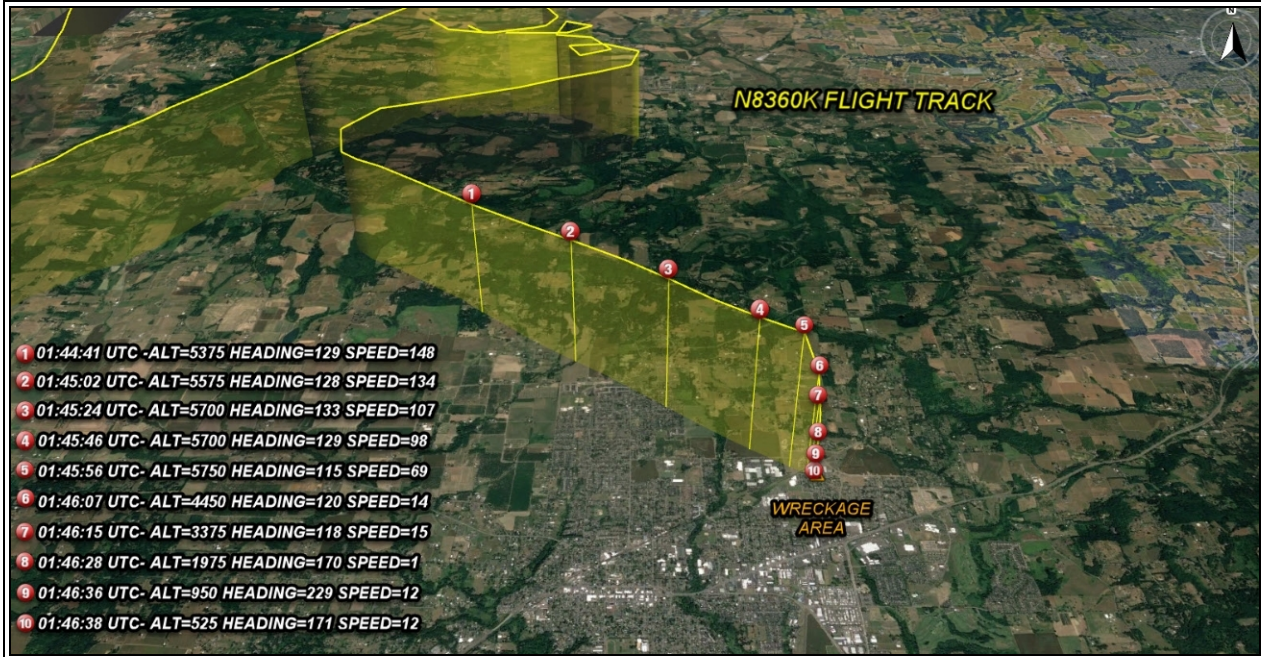
Recorded Automatic Dependent Surveillance-Broadcast (ADS-B) data provided by the Federal Aviation Administration (FAA) showed that the airplane departed Portland-Hillsboro Airport (HIO) at 0118:21 and ascended to 1,200 ft mean sea level (msl) before a left turn was initiated. The airplane continued on a western heading and ascended to an altitude of about 3,400 ft msl. At 0125:35 the airplane made a left turn to the south and ascended to an altitude of 5,300 ft msl. At 0130:46 the airplane made a left 180° turn to the north, then made a right turn to the northeast. The data showed the airplane continued on a northeast heading for about 3 minutes, before a series of 360° turns to the left and right were performed. At the completion of the turns, the airplane turned to the southwest. The data showed that at 0143:48, the airplane made a left turn to the southeast. While on a southeasterly heading, the airplane's ground speed began to decrease from 133 kts. At 0145:56 the data showed the airplanes ground speed had decreased to 69 kts, at an altitude of 5750 ft msl, and began to descend on a southeasterly heading. The last recorded ADS-B target, at 0146:38, was located about 50 ft northwest of the accident site at an altitude of 525 ft, as seen in figure 1.

Figure 1: View of accident airplane flight track.
