Aviation Investigation Final Report

Location:	Newberg, Oregon	Accident Number:	WPR24FA004
Date & Time:	October 3, 2023, 18:47 Local	Registration:	N8360K
Aircraft:	Piper PA-44-180	Aircraft Damage:	Substantial
Defining Event:	Loss of control in flight	Injuries:	2 Fatal, 1 Serious
Flight Conducted Under:	Part 91: General aviation - Instructional

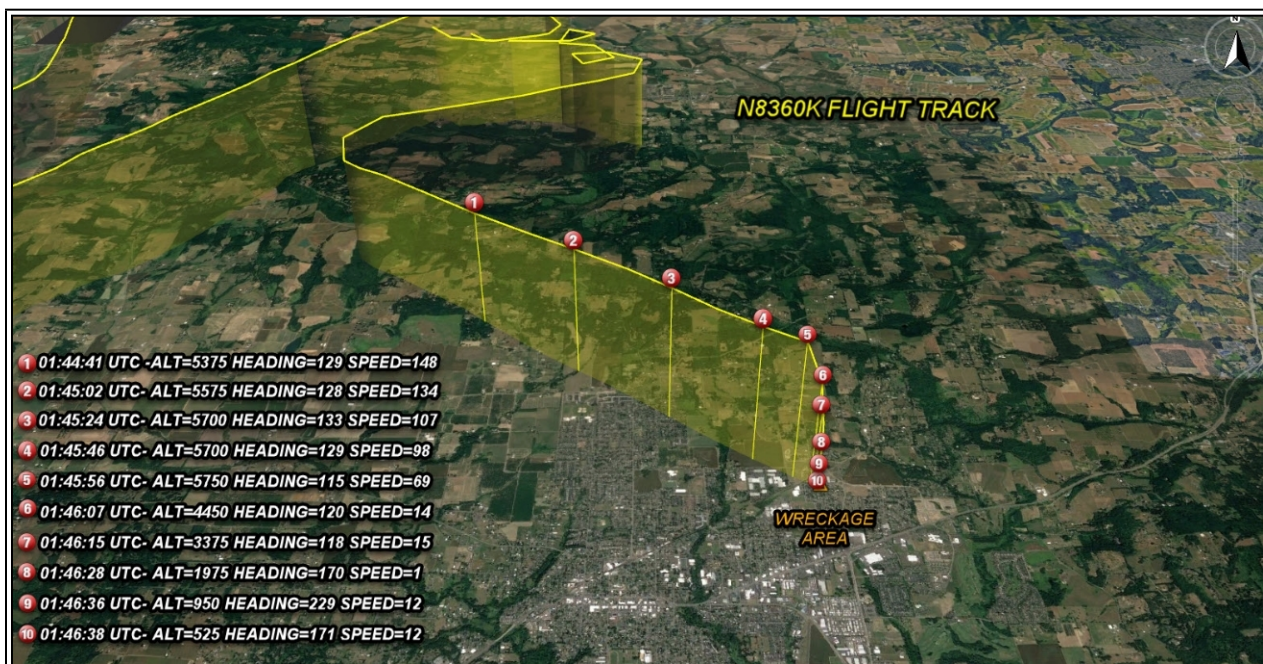
heading and ascended to an altitude of about 3,400 ft msl. At 0125:35 the airplane made a left turn to the south and ascended to an altitude of 5,300 ft msl. At 0130:46 the airplane made a left 180° turn to the north, then made a right turn to the northeast. The data showed the airplane continued on a northeast heading for about 3 minutes before a series of 360° turns to the left and right were performed. At the completion of the turns, the airplane turned to the southwest. The data showed that at 0143:48, the airplane made a left turn to the southeast. While on a southeasterly heading, the airplane's ground speed began to decrease from 133 kts. At 0145:56 the data showed the airplane's ground speed had decreased to 69 kts, at an altitude of 5,750 ft msl, and began to descend on a southeasterly heading. The last recorded ADS-B target, at 0146:38, was located about 50 ft northwest of the accident site at an altitude of 525 ft, as seen in Figure 1.

Figure 1: View of accident airplane flight track.
