Aviation Investigation Preliminary Report

Location:	Chattanooga, TN	Accident Number:	DCA24FA002
Date & Time:	October 4, 2023, 23:47 Local	Registration:	N977FD
Aircraft:	Boeing 757-236	Injuries:	3 None
Flight Conducted Under:	Part 121: Air carrier - Non-scheduled

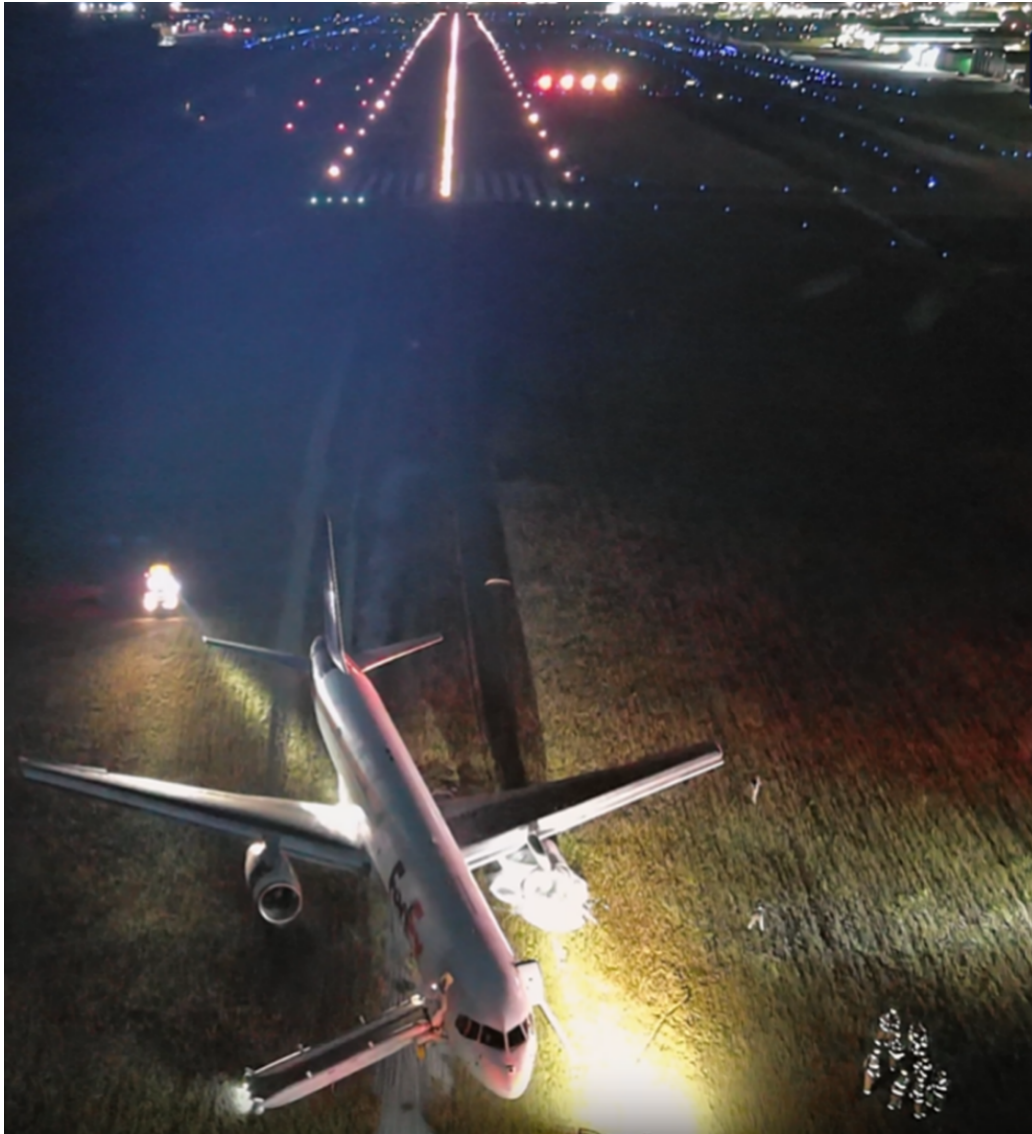
The flight crewmembers reported that during the initial touchdown, the airplane bounced slightly but they were able to maintain directional control and the runway's centerline. The flight crew was unable to stop the airplane and it slid off the departure end of runway 20 and impacted localizer antennas before coming to rest about 830 ft beyond the end of the runway, (see figure 1).

Figure 1. Airplane in its final resting position. (Source: Chattanooga Fire Department).

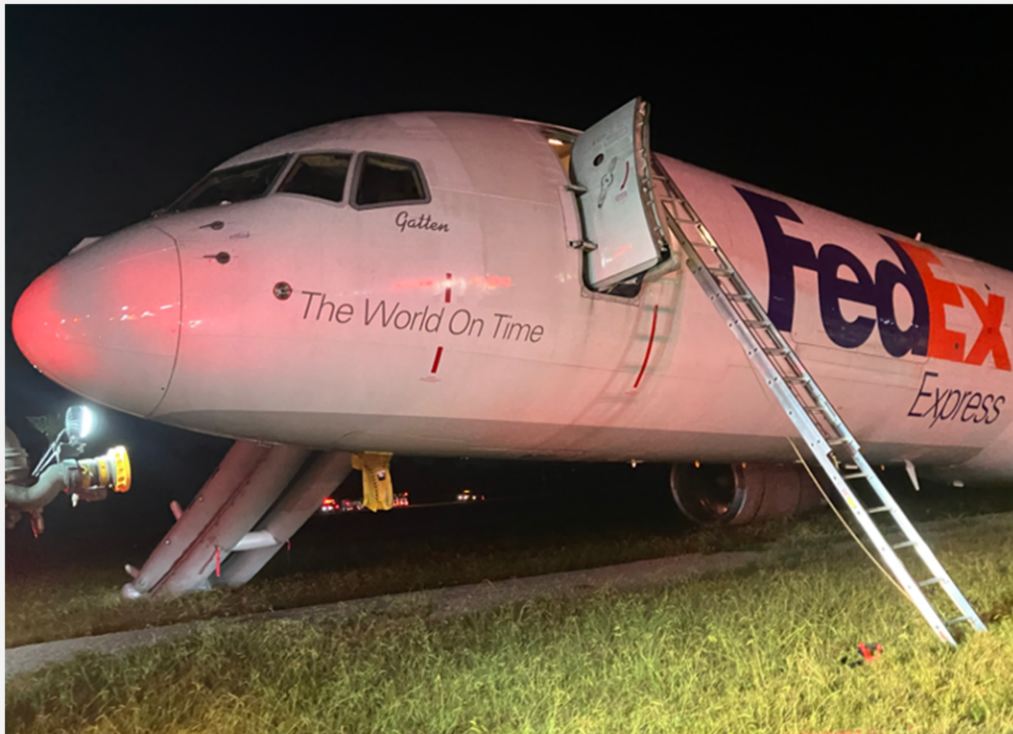
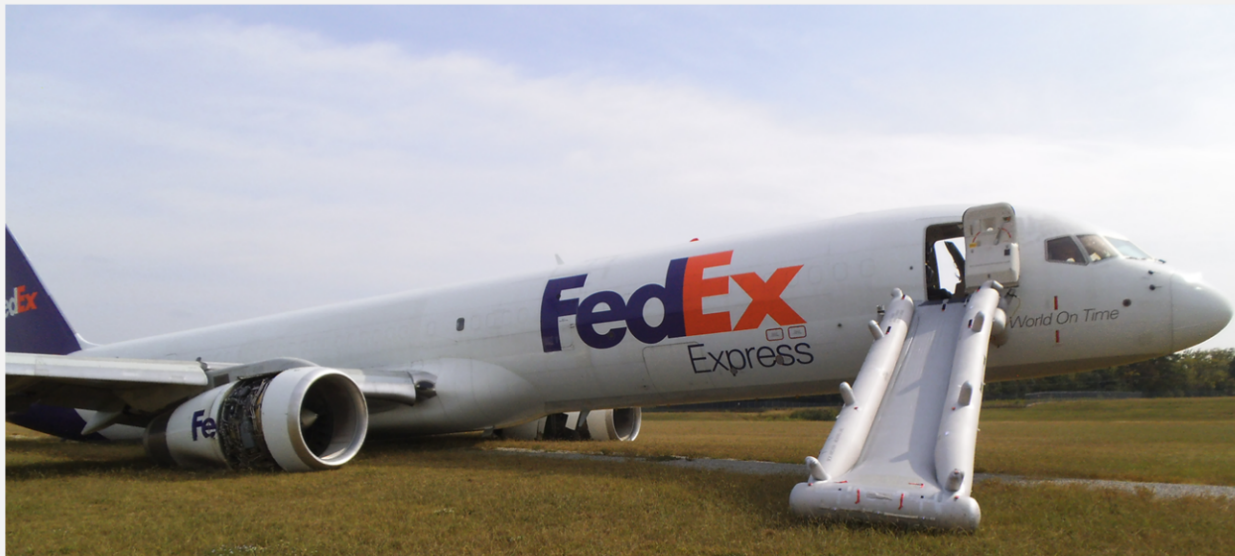
After the airplane came to a complete stop, the flight crew performed the “EVACUATION” checklist, and the jump seat occupant attempted to open the left-hand door (L1). The door rotated halfway open and then became bound, and the slide did not deploy (figure 2, upper photo). The jump seat occupant then attempted to open the right-hand door (R1), but it became lodged on the packing of the raft/slide. The jump seat occupant subsequently forced the door open, and the slide deployed. The flight crew and the jump seat occupant then egressed the airplane via the R1 door/slide (figure 2, lower photo).

Figure 2. Photos of the airplane in its final resting position. (Source for upper photo: Chattanooga Fire Department; source for lower photo Federal Aviation Administration.)

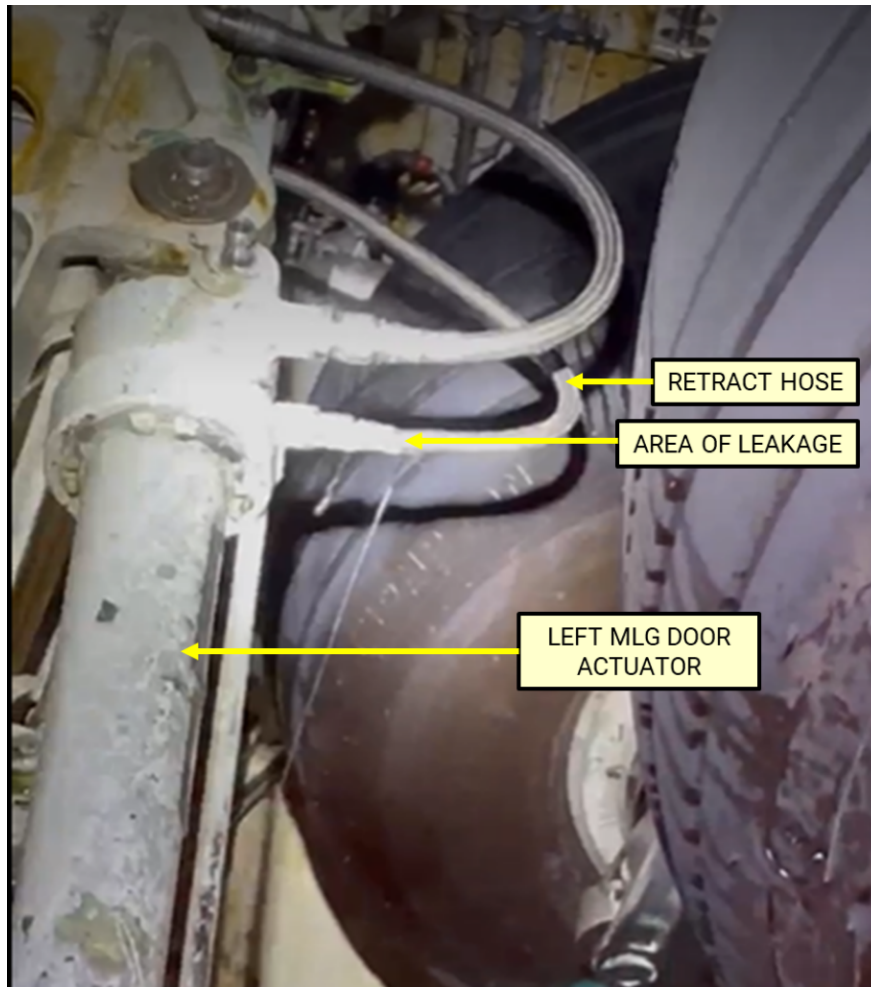
Postaccident examination of the airplane revealed that the left main landing gear door actuator retract port hose was leaking hydraulic fluid (see figure 3). The hose was removed and retained by the NTSB for further investigation. The examination also found a discontinuity in the wiring of the landing gear alternate extension system. The section of that wire was retained for further examination.

Figure 3. Left MLG door actuator showing the area of leakage.
