# Aviation Investigation Final Report

<b>Location:</b>	Croydon, New Hampshire	<b>Accident Number:</b>	ERA24FA003
<b>Date &amp; Time:</b>	October 8, 2023, 19:32 Local	<b>Registration:</b>	N802JR
<b>Aircraft:</b>	BELL HELICOPTER TEXTRON CANADA 407	<b>Aircraft Damage:</b>	Substantial
<b>Defining Event:</b>	Loss of control in flight	<b>Injuries:</b>	1 Fatal
<b>Flight Conducted Under:</b>	Part 91: General aviation - Positioning

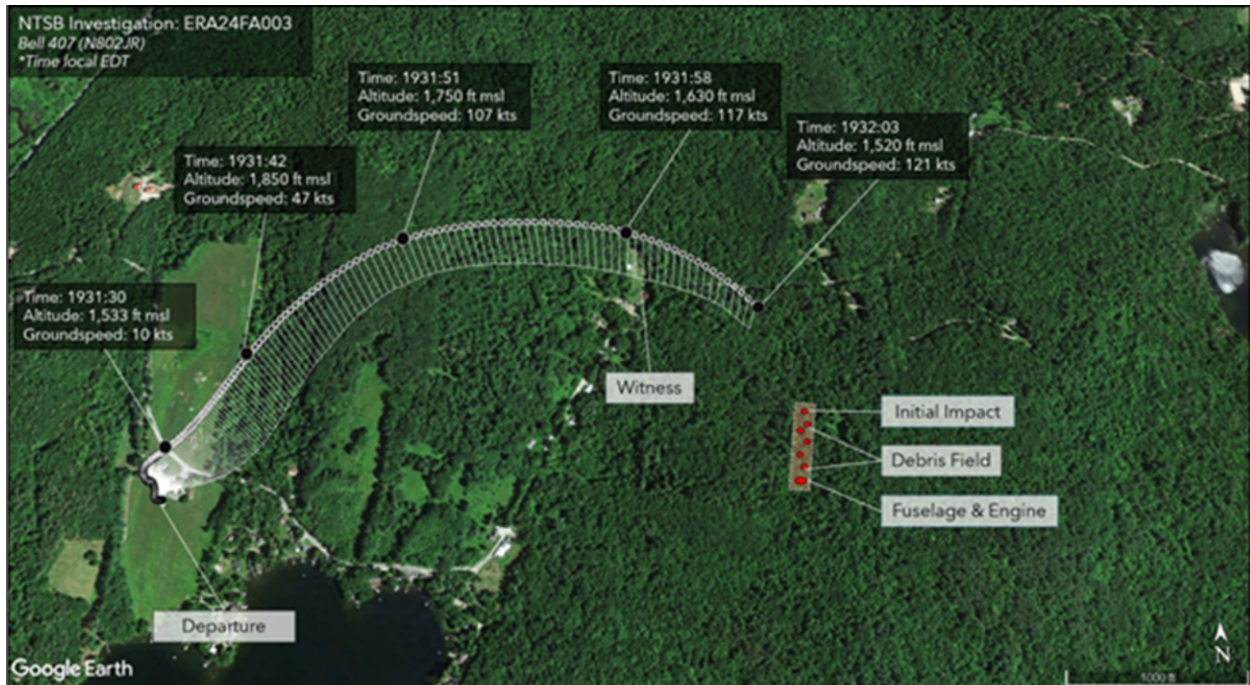
Figure 1 - Overview of the flight information and wreckage location.

Data recovered from an Appareo Vision 1000 Airborne Image Recording System showed that the helicopter took off about 1931, climbed vertically to about 500 ft above ground level (agl), and began flying northeast. About 30 seconds of flight data was recorded, which showed that the helicopter climbed northeast about 600-700 ft agl. The helicopter then turned east and eventually southeast, and as the helicopter turned, it began descending while its ground speed gradually increased. The helicopter subsequently impacted trees and terrain about 600 ft southeast of the helicopter's last recorded position (see Figure 1).

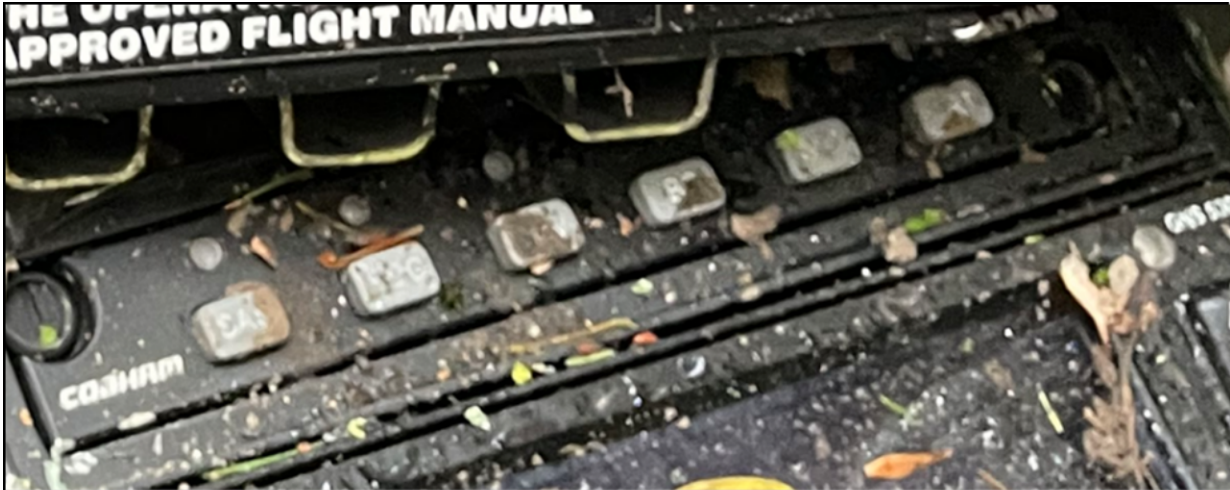
Figure 3: View of the accident helicopter HCP.

The figures below provide an exemplar view and accident helicopter view of the HeliSAS Control Panel (HCP) that is incorporated with the autopilot. The exemplar HCP panel below reflects a SAS “green” status indicating SAS is engaged. A white light above the SAS selection button indicates that the mode is not engaged and is in a standby mode ready to be engaged. In the exemplar photo, the HCP also has an engaged altitude (ALT) mode on.

Review of the onboard image recorder found that during the takeoff and initial climb, the SAS system was not activated and remained in a white standby mode throughout the flight.
