Aviation Investigation Preliminary Report

Location:	Houston, TX	Accident Number:	DCA24FA017
Date & Time:	October 24, 2023, 15:20 Local	Registration:	N510HM (A1); N269AA (A2)
Aircraft:	TEXTRON AVIATION INC 510 (A1); RAYTHEON AIRCRAFT COMPANY HAWKER 850XP (A2)	Injuries:	4 None (A1); 3 None (A2)
Flight Conducted Under:	Part 91: General aviation - Personal (A1); Part 135: Air taxi & commuter - Non-scheduled (A2)

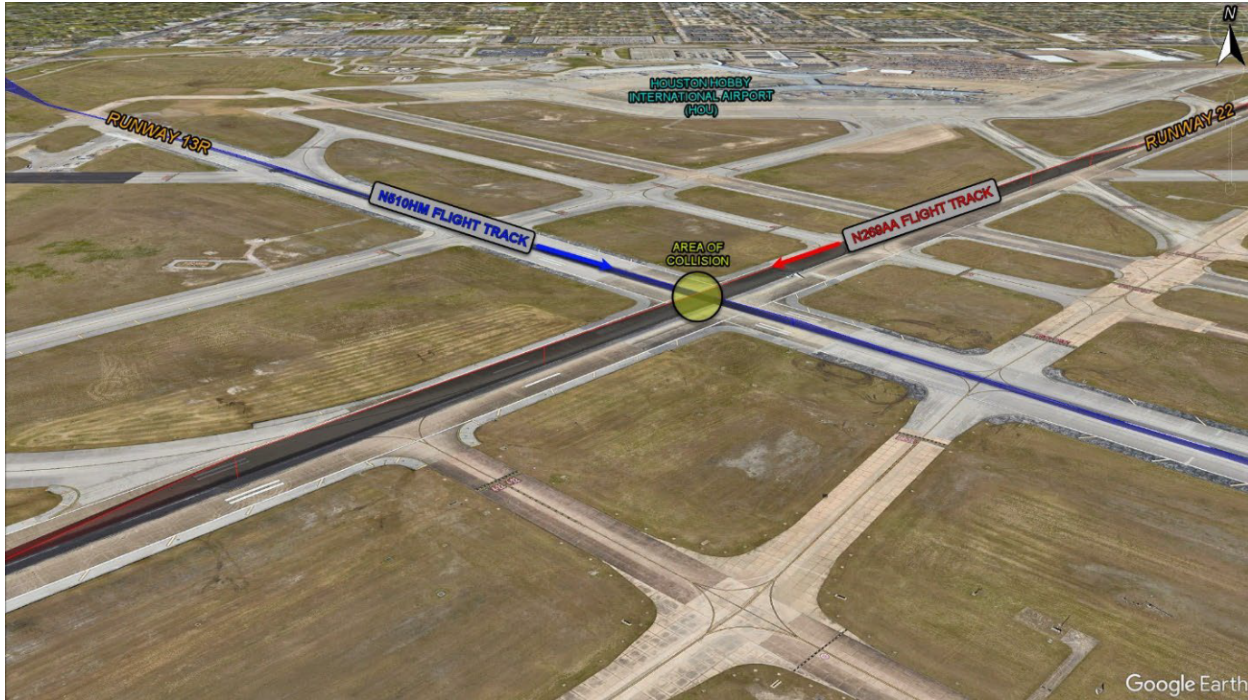
HOU has intersecting runways, and the local controller had instructed the crew of N269AA to line up and wait (LUAW) on runway 22. The crew of N269AA said in a post-accident interview that they believed they heard that they were cleared for takeoff when they took off. The collision between the two airplanes occurred at the intersection of the two runways, see figure 1.

Figure 1. View of both airplanes flight tracks with the area the ground collision occurred highlighted in yellow. The blue line represents N510HM, and the red line represents N269AA.

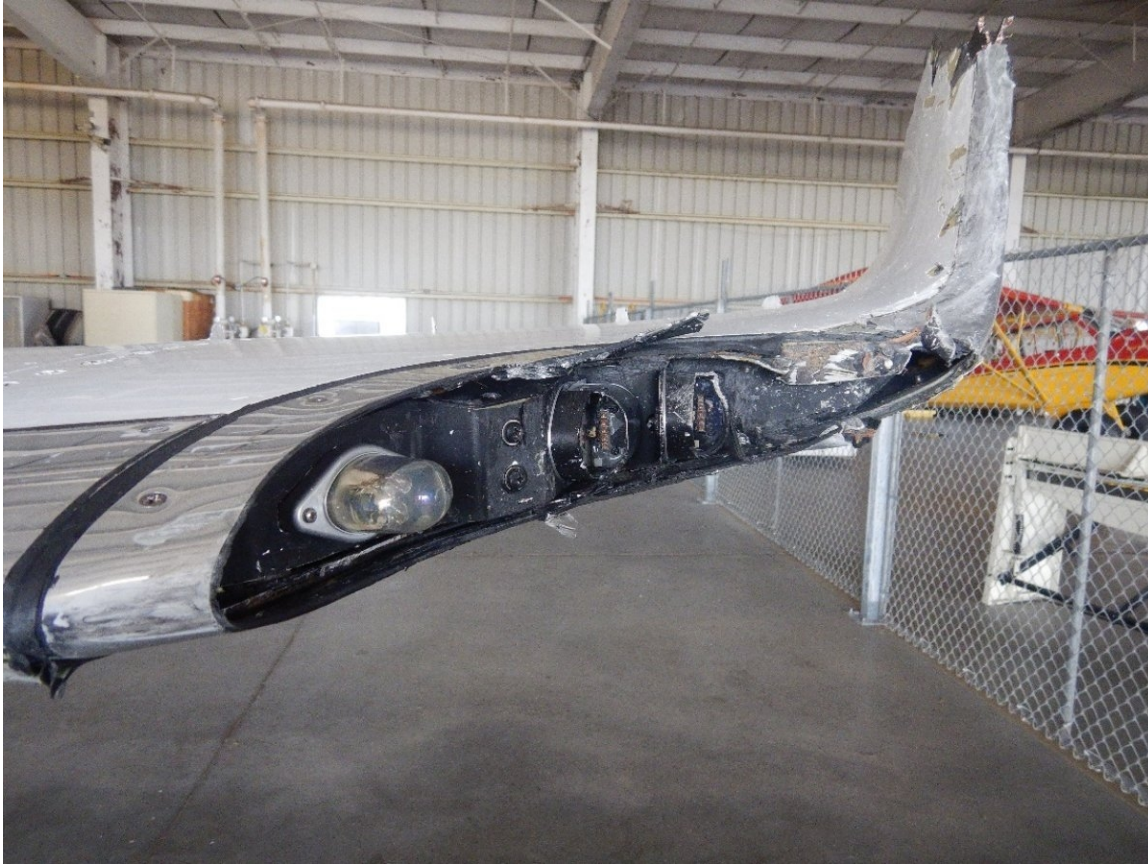
N269AA’s left-wing winglet remained attached to the left wing. The winglet leading edge exhibited white paint transfer marks and the navigation light lens was impact separated and pieces of the glass were found in the Cessna Mustang’s tail cone/stinger. About ten inches of

the top section of N269AA's winglet had separated due to the impact with N510HM, see figure 3.

Figure 3. Close up view of N269AA's left winglet/navigation light assembly damage.

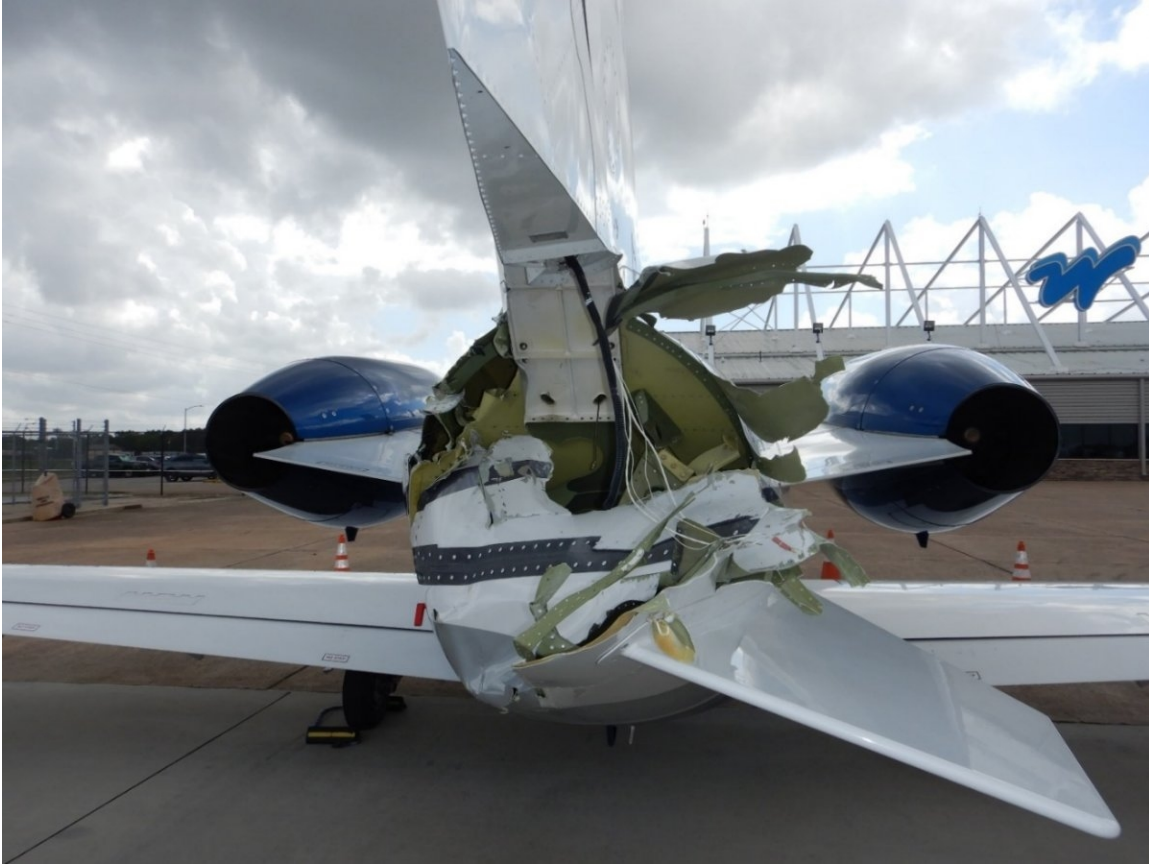
Post-crash examination of N510HM revealed that the left side of its tail section had been impacted by the left wing of N269AA. The torn skin on the tail section was consistent with N269AA's wing penetrating the left side of N510HM's tail stinger and exiting the right side, severing a portion of the stinger. The impact damage was isolated to the area of the empennage, see figures 4, 5 and 6.

Figure 5. Aft view of N510HM's damage to its empennage.
