Aviation Investigation Preliminary Report

Location:	Micanopy, FL	Accident Number:	ERA24FA036
Date & Time:	November 14, 2023, 14:09 Local	Registration:	N7806W
Aircraft:	Piper PA-28-180	Injuries:	1 Fatal
Flight Conducted Under:	Part 91: General aviation - Personal

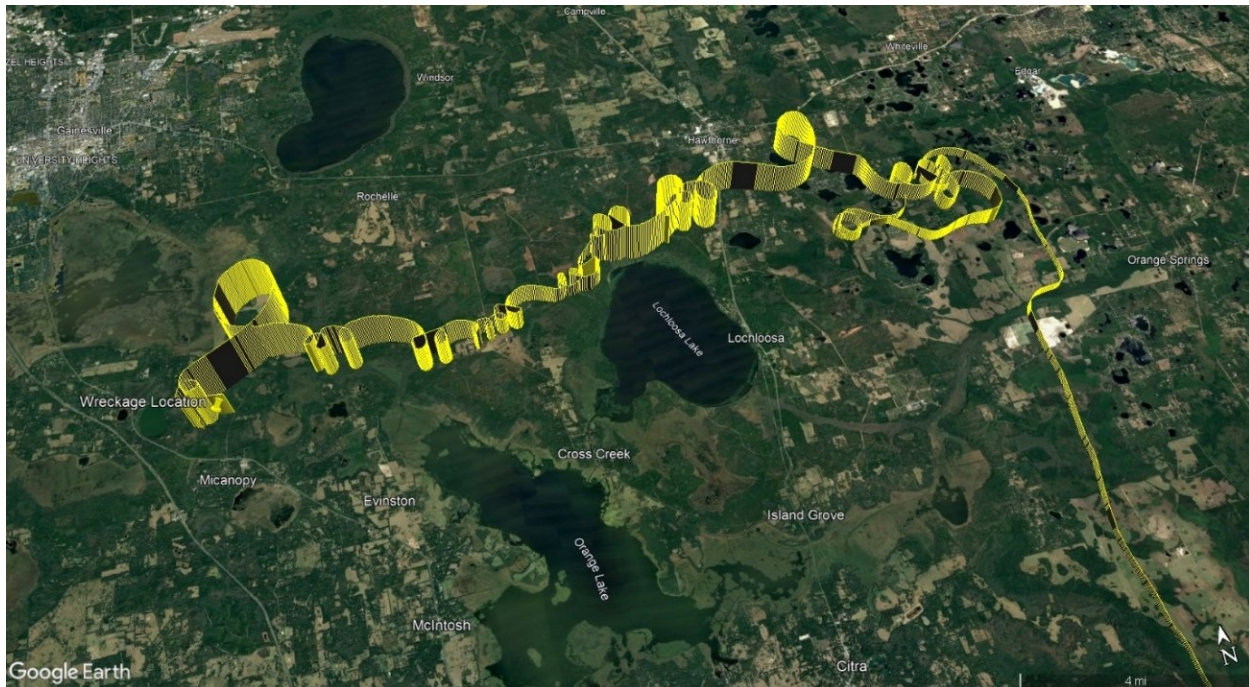
ADS-B flight track data indicated that after departure, the airplane flew on a northerly track until about 1333, when a brief turn towards the east was observed, which was followed by a left turn back to a northerly heading. Subsequently, the airplane performed several erratic 360° turns, as well as numerous climbs and descents to a maximum altitude of 6,900 ft mean sea level (msl) and a minimum altitude of 500 ft msl, between 1335 and 1409 prior to losing radar contact. The rate of descent was in excess of 5,000 ft per minute for the final data point. The main wreckage was located about 650 ft northeast of the final ADS-B data point (see Figure 1).

Preliminary review of air traffic control communications revealed that during the erratic maneuvering, the pilot called "mayday" and stated he "was lost in weather." During this period, the pilot reported multiple times that he was having issues with his instruments, he "mistakenly flew into weather," "it's completely white," and he could not see anything outside.

Figure 1. View of final flight track data. Yellow line indicates the airplane flight track for the final approximate 40 minutes of flight.
