Aviation Investigation Final Report

Location:	Ludington, Michigan	Accident Number:	CEN24FA046
Date & Time:	November 26, 2023, 10:00 Local	Registration:	N850JH
Aircraft:	Socata TBM 700	Aircraft Damage:	Destroyed
Defining Event:	Structural icing	Injuries:	2 Fatal
Flight Conducted Under:	Part 91: General aviation - Personal

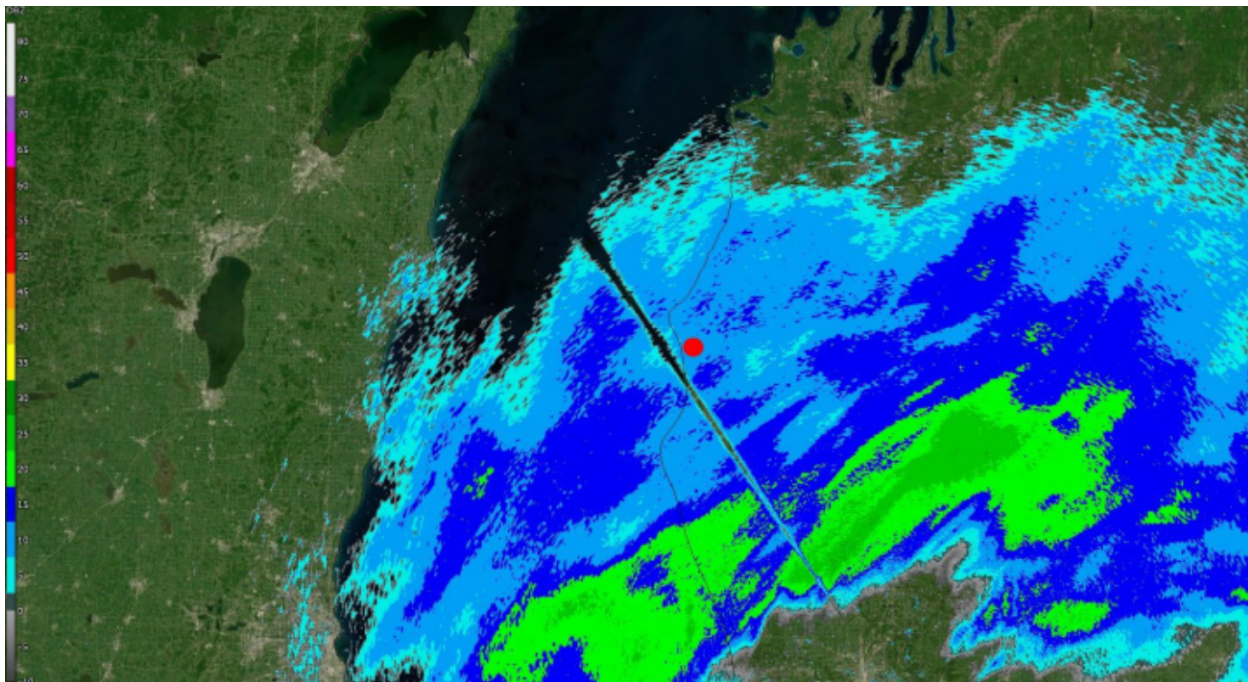
WSR-88D Level-II base reflectivity weather radar imagery from the Grand Rapids, Michigan, site (KGRR) is presented the figure below. KGRR was located about 75 miles south-southeast of the accident location with an antenna elevation of 875 feet. The reflectivity images depict light reflectivity across the accident region.

Figure – KGRR 0.483° Level-II base reflectivity product from a sweep initiated at 1000:40. The accident location is identified by the red circle.
