Aviation Investigation Final Report

Location:	Mertzon, Texas	Accident Number:	WPR24FA040
Date & Time:	November 25, 2023, 18:36 Local	Registration:	N7763W
Aircraft:	Piper PA-28-180	Aircraft Damage:	Destroyed
Defining Event:	VFR encounter with IMC	Injuries:	3 Fatal
Flight Conducted Under:	Part 91: General aviation - Personal

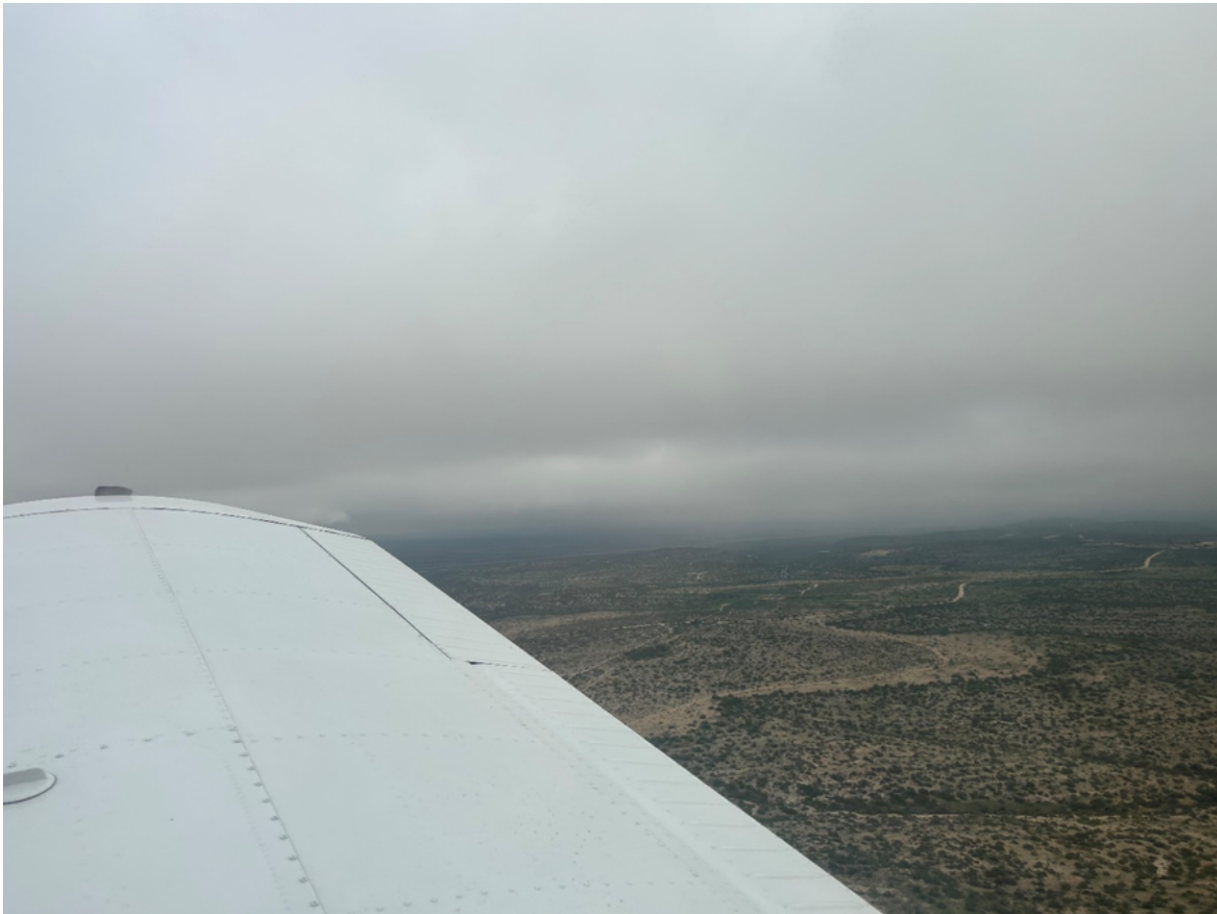
Stockton, Texas. About 1340, before the airplane's arrival at FST, the pilot's wife texted his mother to report that they had turned around to go to Fort Stockton because the weather was not good. The wife also texted a photo that showed the airplane operating in an area with a low cloud layer and visible moisture, as shown in Figure 1. The airplane arrived at FST and landed about 1358, as shown in Figure 2.

Figure 1. Photo sent by the passenger, about 1340 CST to a family member.

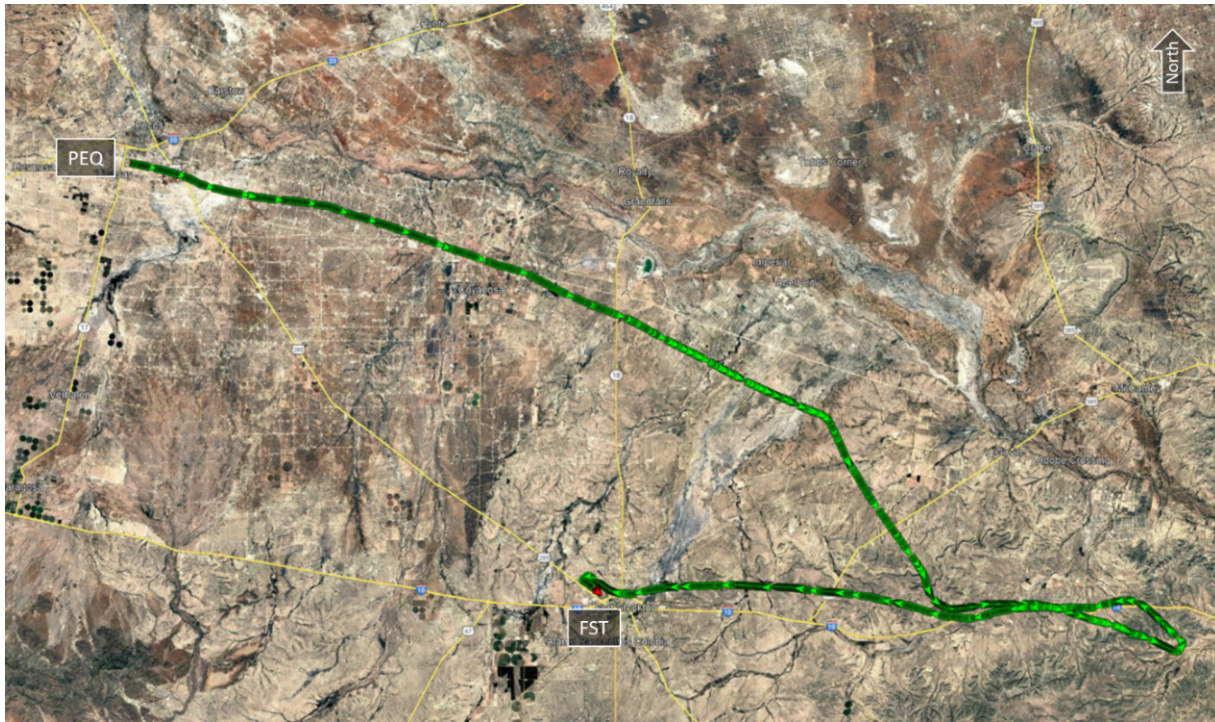
Figure 2. ADS-B flight route from PEQ to FST.

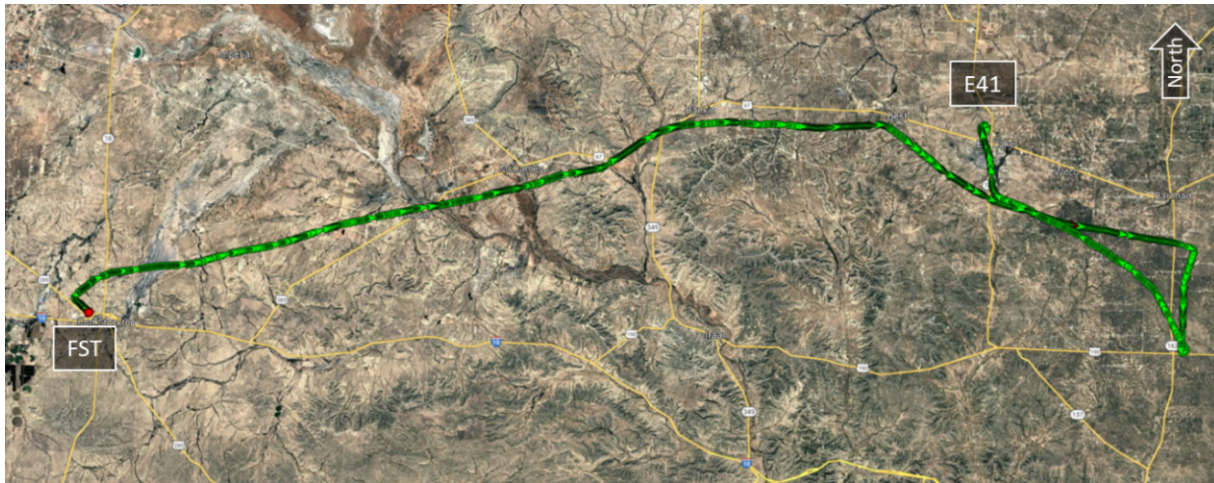
airplane turned right and proceeded directly to the Reagan County Airport (E41) Big Lake, Texas, landing at 1540, as shown in Figure 3.

Figure 3. ADS-B flight route from FST to E41.

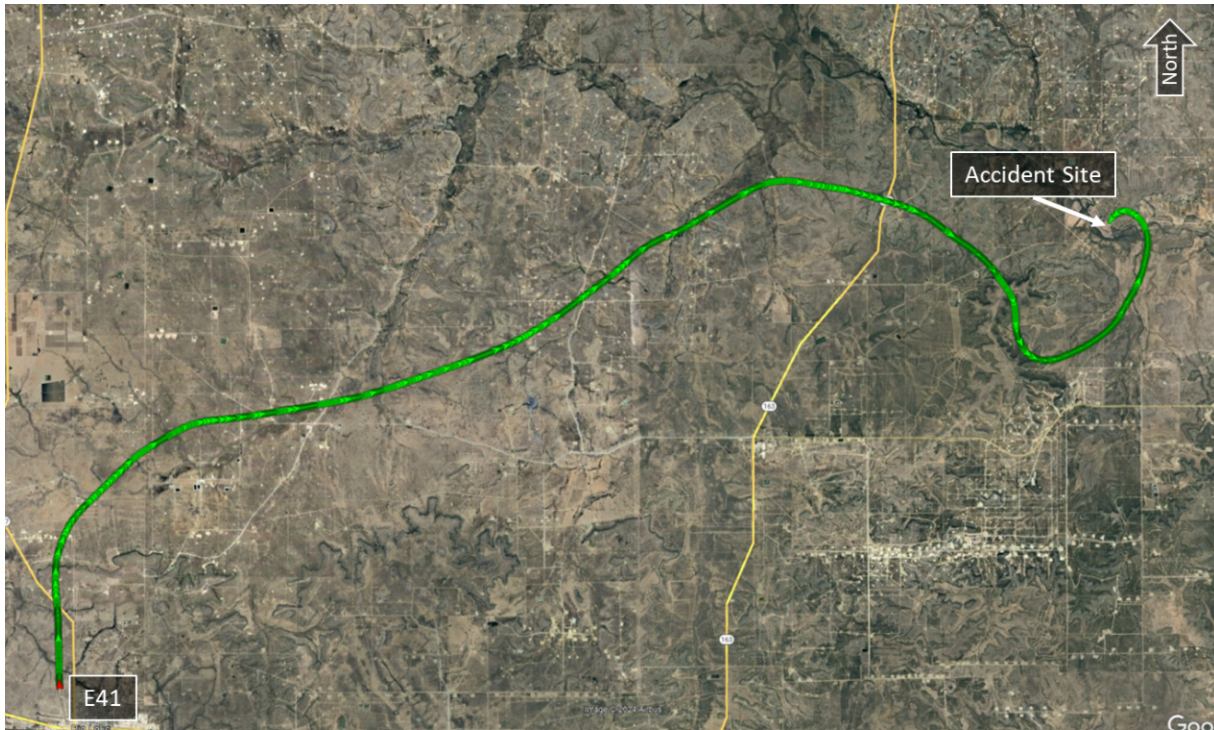
While at E41, the pilot purchased 24.39 gallons of 100 low-lead fuel and then delayed the departure for about 2 hours and 38 minutes for unknown reasons. ADS-B data showed the airplane departed E41 about 1818 during nighttime conditions. According to the US Naval Observatory Astronomical Applications Department, official sunset for the Mertzon, Texas, area was 1741. The airplane departed to the north then turned right and climbed to 3,900 ft momentarily then descended and flew between 3,700 and 3,500 ft. Around 1829, the airplane turned right to the southeast for about 7 miles while flying between 3,500 and 3,000 ft. The airplane then turned left and began a shallow left turn while descending and accelerating until the last 4 seconds of flight, when the left turn rate increased. The last ADS-B data point recorded the airplane, about 2,200 ft msl , about 281 ft northeast of the accident site, as shown

Figure 4. Google Earth image with the accident flight route depicted.

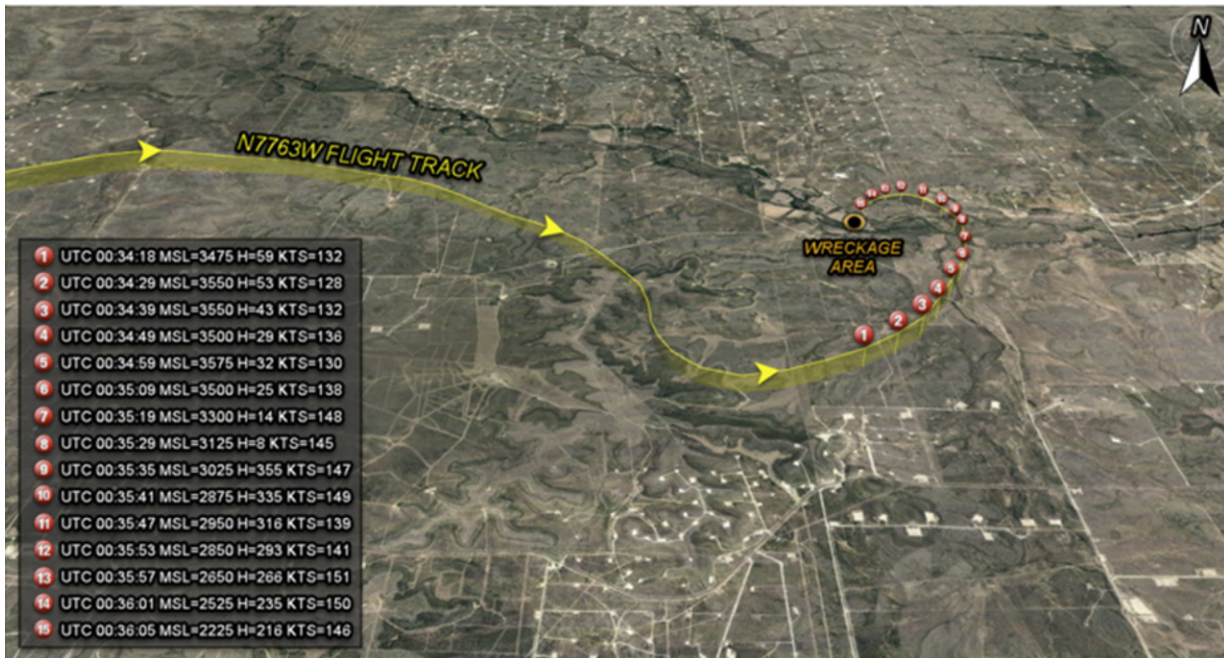
Figure 5. Image showing the last 15 ADS-B data points with groundspeed.

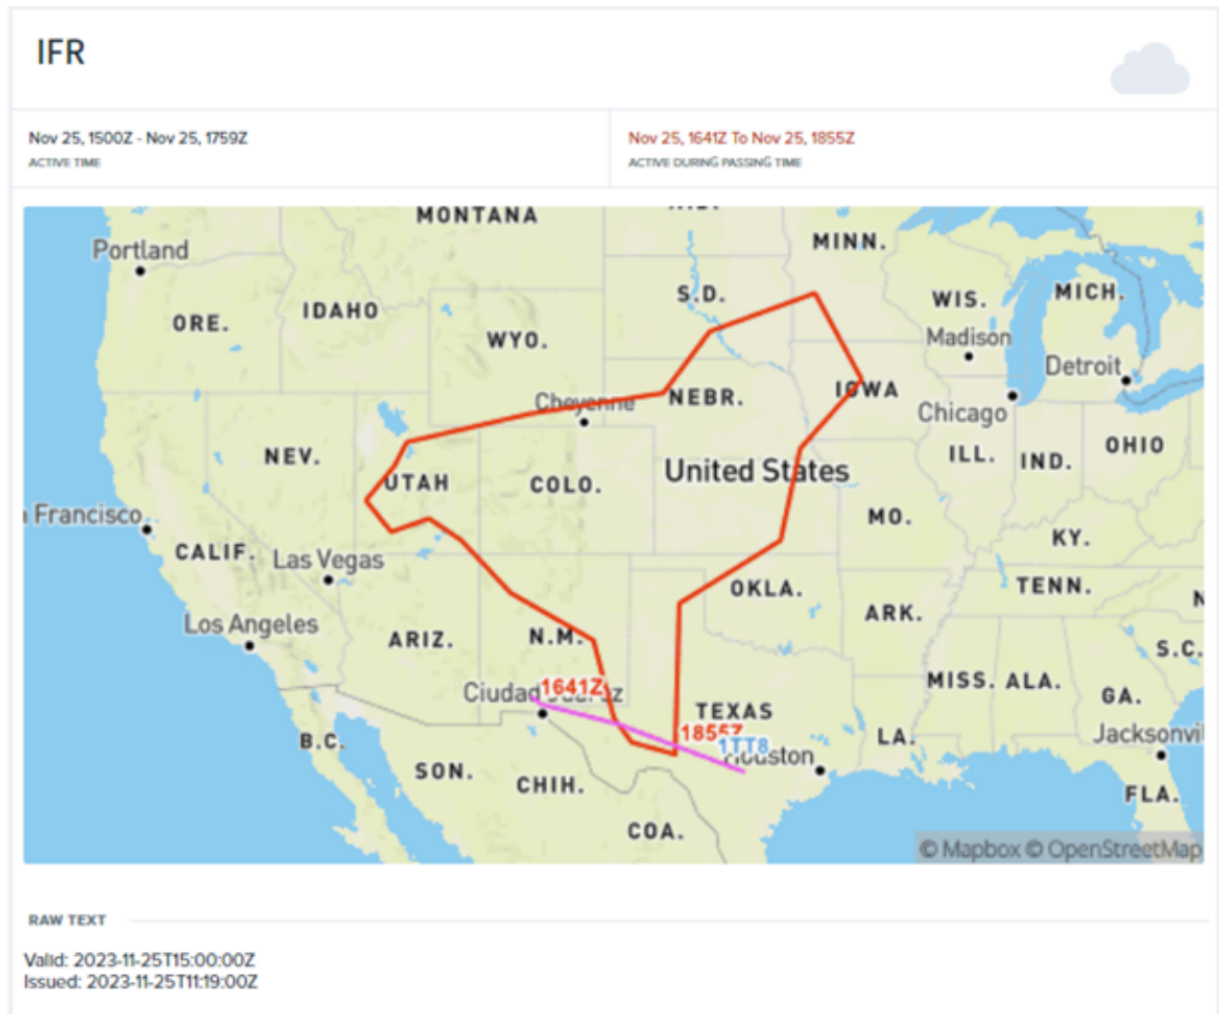
most of the flight route, including overcast cloud conditions less than 3,000 ft above ground level (agl). Multiple AIRMETs were included in the brief that forecasted IFR conditions along a portion of the route of flight. The AIRMETs were active when the airplane flew through Mertzon, Texas.

Figure 6. Image from the weather briefing showing IFR conditions outlined in red that would be active during the airplane's passing time. The planned route of flight is identified with the magenta line.

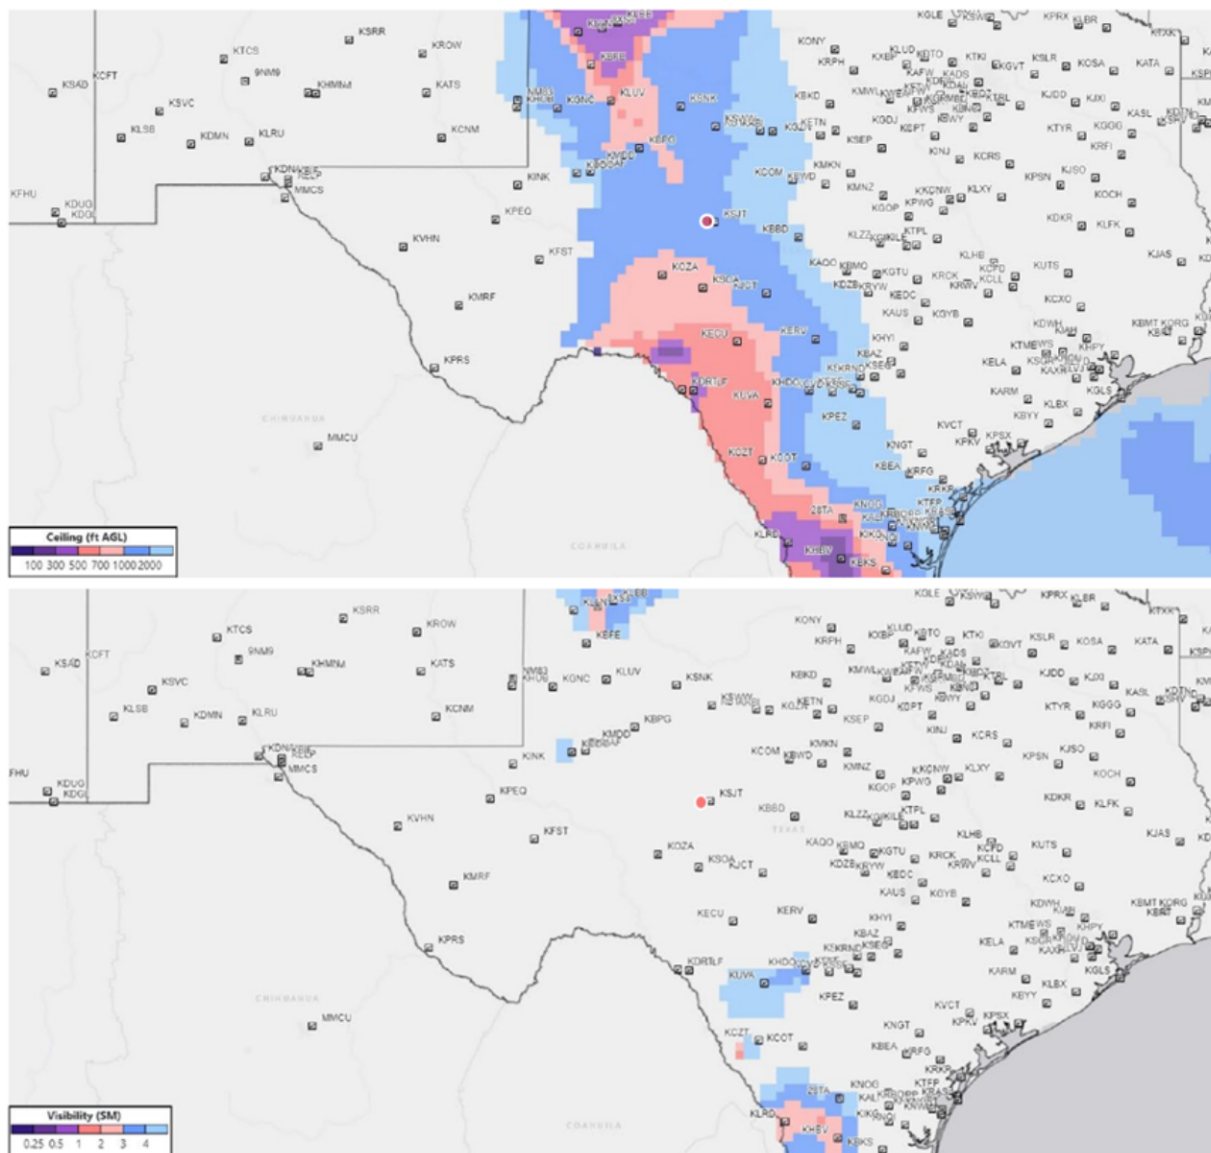
Aviation Weather Center (AWC) ceiling and visibility analysis charts reported, about the time of the accident, ceilings around the accident site around 1,000 ft agl and visibility greater than 4 miles.

Figure 7. Ceiling (top) and visibility (bottom) charts valid about the time of the accident.
