Aviation Investigation Preliminary Report

Location:	Taylor, AZ	Accident Number:	WPR24FA052
Date & Time:	December 6, 2023, 07:44 Local	Registration:	N449RA
Aircraft:	REMOS AIRCRAFT GmbH Remos GX	Injuries:	1 Serious
Flight Conducted Under:	Part 91: General aviation - Personal

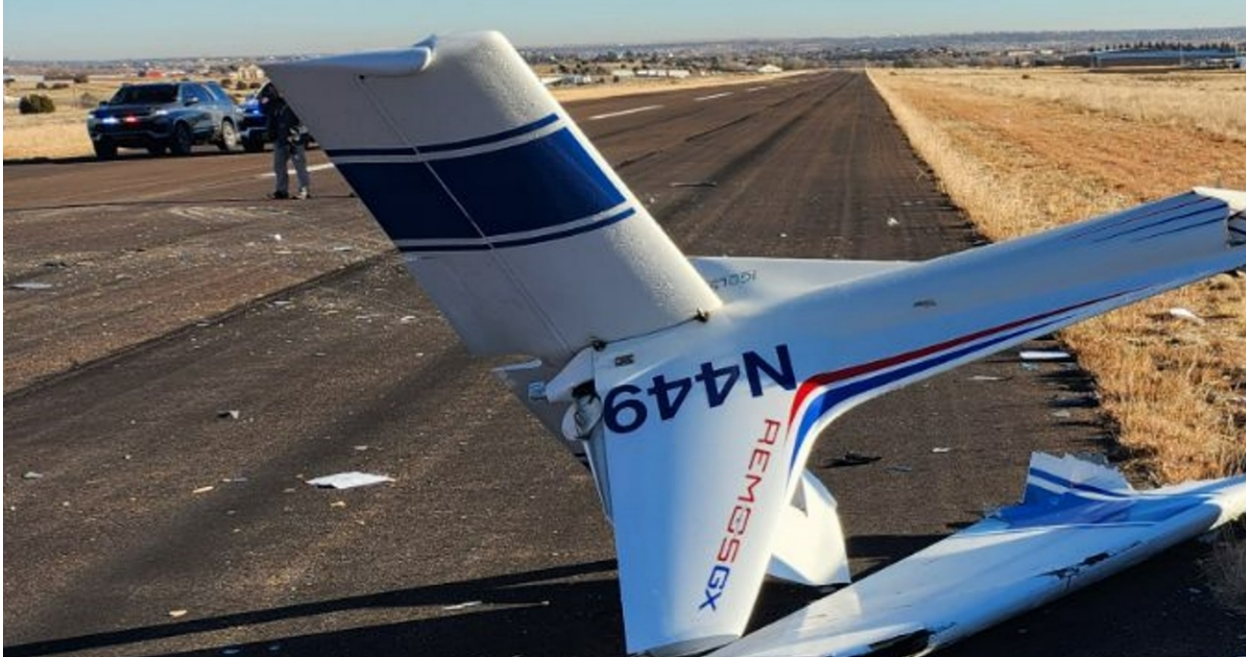
The postaccident examination of the accident site revealed that the airplane impacted near the centerline of the runway about midfield in an inverted, nose down attitude, then came to rest inverted on the left side of the runway. A photo of the accident site minutes after the accident revealed that the upper surfaces of the horizontal stabilizers was covered in frost.

Figure 1-Accident site, aircraft empennage and frost covering the upper surfaces of the horizontal stabilizer. (Courtesy of the Airport Manager)
