Aviation Investigation Preliminary Report

Location:	Christoval, TX	Accident Number:	CEN24FA064
Date & Time:	December 14, 2023, 12:18 Local	Registration:	N188PC
Aircraft:	Pilatus PC-12/45	Injuries:	2 Fatal
Flight Conducted Under:	Part 91: General aviation - Personal

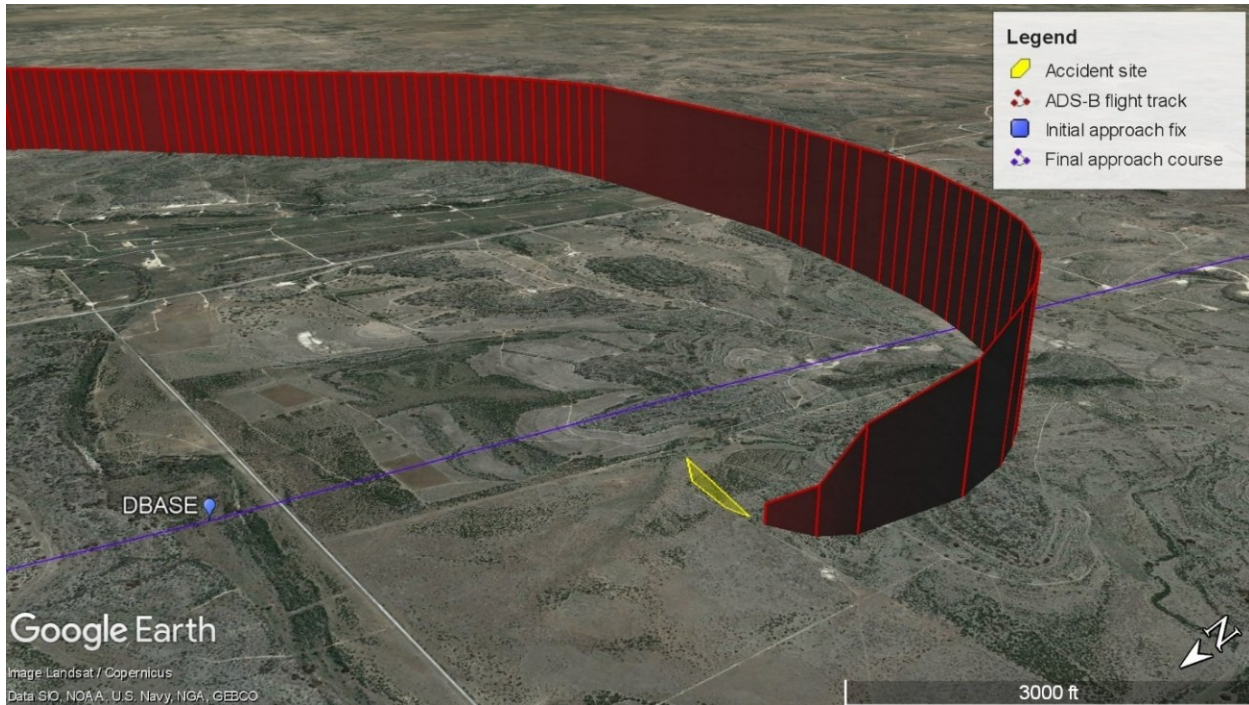
At 12:17:32, the flight track passed through the final approach course and continued a shallow right turn

At 12:17:40, the flight track began a right descending turn about 1,000 fpm

At 12:17:44, the descent rate was about 5,000 fpm and the right turn steepened

At 12:17:49, the flight track continued in a steep right turn with a descent rate about 15,000 fpm

Figure 1. Google Earth view of the accident area with the ADS-B flight track, the RNAV (GPS) runway 36 initial approach fix “DBASE”, and the 002° final approach course.

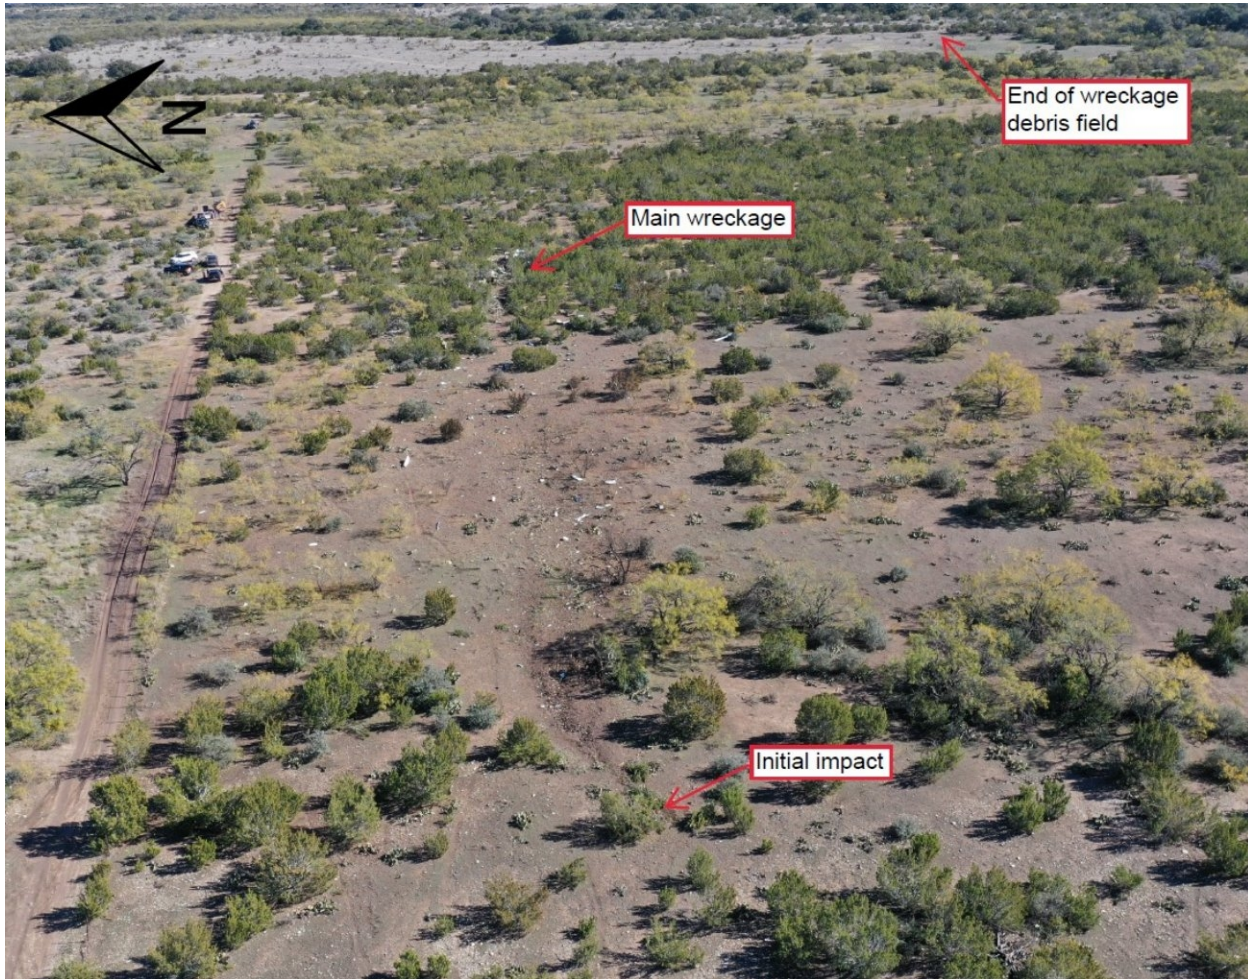
The airplane impacted trees and terrain about 15 miles south of SJT and the wreckage debris was aligned on a 100° magnetic heading. The initial impact point was defined by a small tree that was cut at a 24° angle slanted down toward south and surrounded by small wreckage debris, which included pieces of the right wing tip and a green navigation light. The initial ground impact crater was immediately adjacent to the tree, measured about 1 ft deep by 20 ft long, and contained a lot of small wreckage debris and one propeller blade. The main wreckage was located about 500 ft to the east of the initial impact area. A large section of the left wing remained mostly intact and was found on the right side of the debris field near the main wreckage. The area between the initial impact and the main wreckage contained a significant amount of airplane parts and wreckage debris. The main portion of the engine was located about 870 ft from the initial impact area. The farthest piece of wreckage was a main landing gear tire that was located about 1,320 ft from the initial impact. Several portions of the wreckage sustained thermal damage and contained black soot.

Figure 2. Aerial image of the accident site facing east. The initial impact area, main wreckage, and end of the wreckage debris field are labeled in red.
