# Aviation Investigation Preliminary Report

<b>Location:</b>	Portland, OR	<b>Accident Number:</b>	DCA24MA063
<b>Date &amp; Time:</b>	January 5, 2024, 17:14 Local	<b>Registration:</b>	N704AL
<b>Aircraft:</b>	Boeing 737-9	<b>Injuries:</b>	177 None
<b>Flight Conducted Under:</b>	Part 121: Air carrier - Scheduled

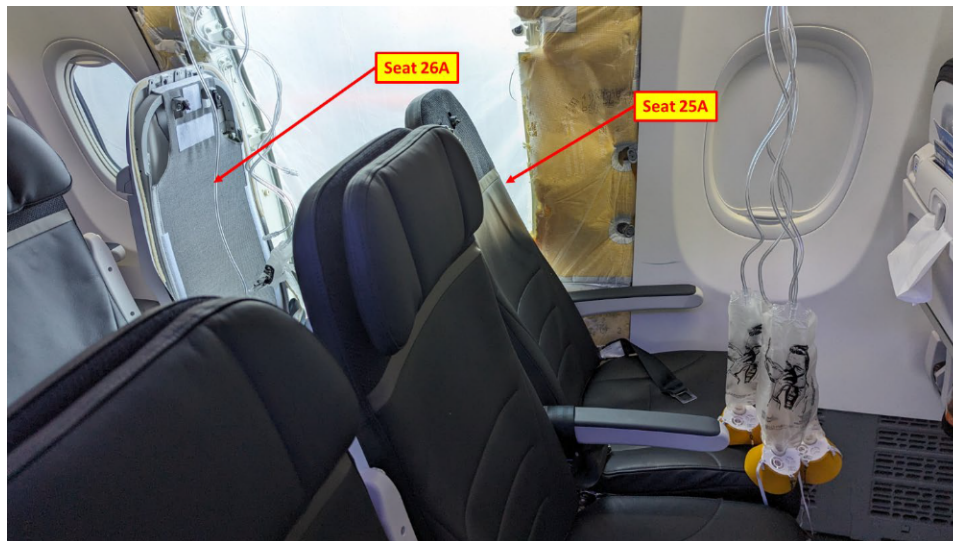
Damage to the passenger cabin included: damage in seat rows 25ABC and 26ABC as described below, deformation of the doorframe of the forward lavatory, and buckling and displacement of the sidewall panels and trim throughout the airplane. There were no indications of any other failures or malfunction of the airplane or any of its systems.

As seen in figure 7, Seat 25A was rotated out and aft approximately 10°–20° toward the opening. The seatback of Seat 26A was rotated forward and outboard.

**Figure 7.** Photo of seat rows 25ABC and 26ABC.

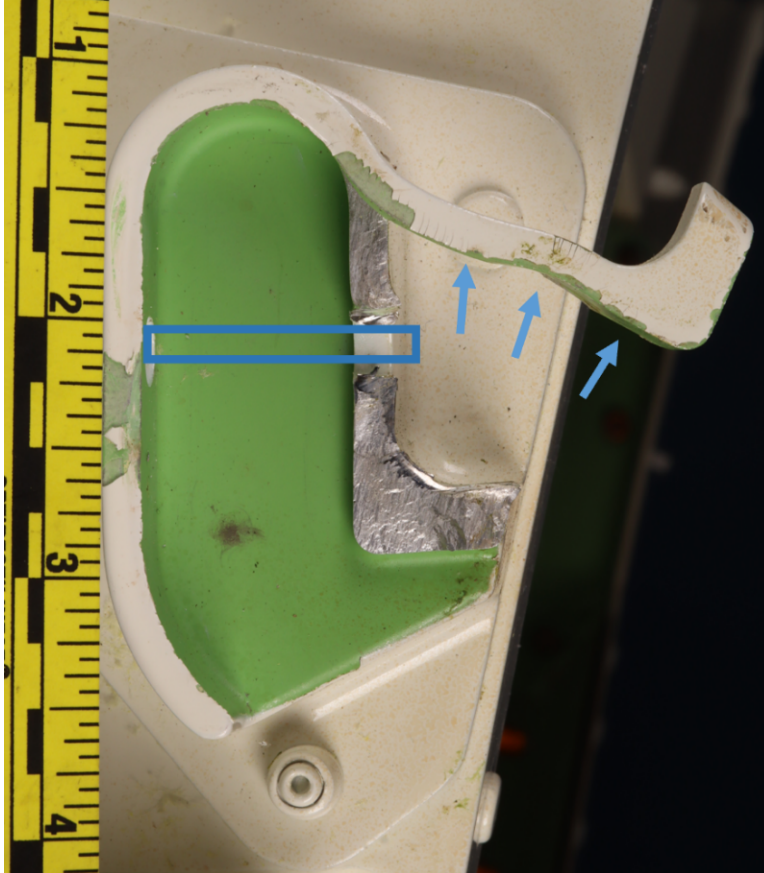
Both upper guide fittings installed on the forward and aft sides of the MED plug, respectively, were fractured vertically through the inboard wall of the track. Examination revealed features consistent with overstress fracture and no evidence of pre-existing cracks or damage. The outboard upper guide track bolt holes were intact and exhibited no deformation. Figure 10 shows the aft upper guide fitting; the forward upper guide fitting was similar.

**Figure 10.** Fractured aft upper guide fitting. Arrows point to the fractured and deformed piece of the guide fitting's inboard wall. The rectangle indicates where the upper guide track bolt would be installed.

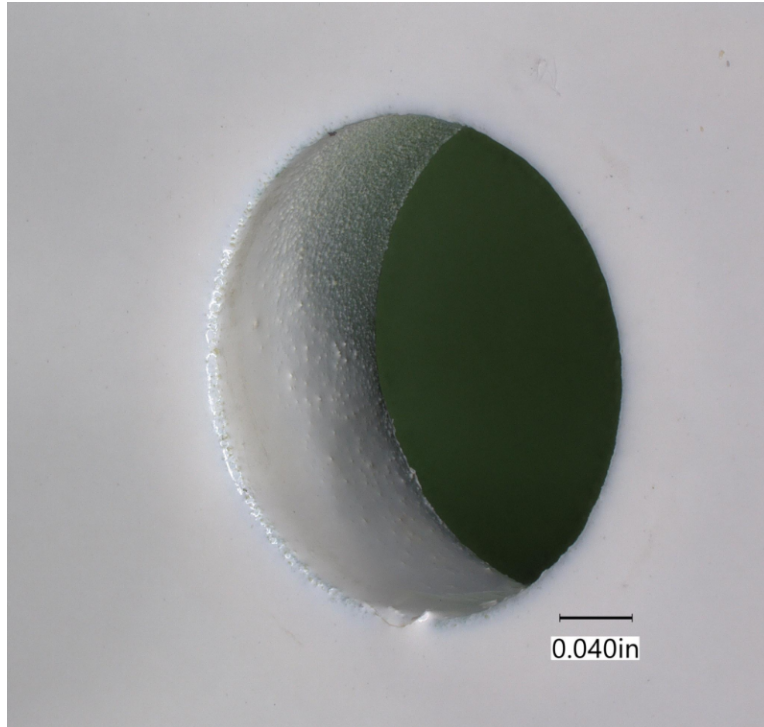
The paint in the upper guide track bolt hole bores was intact and showed no evidence of heavy contact damage. Figure 11 shows a representative hole bore. There were some light circular witness marks around the hole bores consistent with the presence of a washer at some time.

**Figure 11.** Aft upper guide track fitting showing the outboard track bolt hole bore.

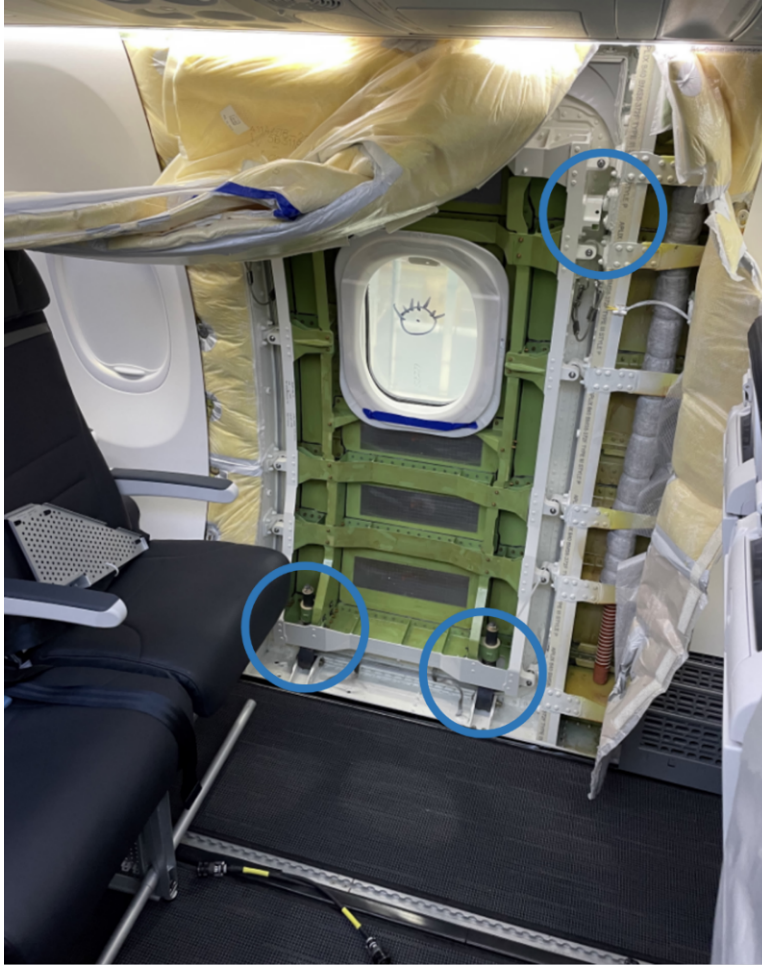
Records show the rivets were replaced per engineering requirements on Non-Conformance (NC) Order 145-8987-RSHK-1296-002NC completed on September 19, 2023, by Spirit AeroSystems personnel. Photo documentation obtained from Boeing shows evidence of the left-hand MED plug closed with no retention hardware (bolts) in the three visible locations (the aft upper guide track is covered with insulation and cannot be seen in the photo). See figure 16. This image was attached to a text message between Boeing team members on September 19, 2023, around 1839 local. These Boeing personnel were discussing interior restoration after the rivet rework was completed during second shift operations that day.

**Figure 16.** Photo showing the left MED plug immediately before interior restoration and the circles show the three locations without the retaining bolts, two vertical movement arrestor bolts and the forward upper guide track bolt. The aft upper guide track is covered with insulation and cannot be seen in the photo. (Source: Boeing. Image Copyright © Boeing. Reproduced with permission.)
