Aviation Investigation Preliminary Report

Location:	Portland, OR	Accident Number:	DCA24MA063
Date & Time:	January 5, 2024, 17:14 Local	Registration:	N704AL
Aircraft:	Boeing 737-9	Injuries:	177 None
Flight Conducted Under:	Part 121: Air carrier - Scheduled

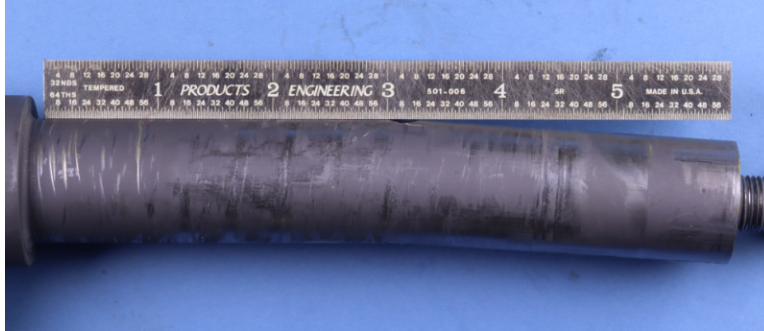
The aft hinge fitting was bent inboard about 3.7° with corresponding contact damage noted to the MED plug lower beam. Contact damage was noted on the inboard side of the hinge fitting shaft intersecting the vertical movement arrestor bolt hole consistent with contact with the MED plug, but the hole bore was otherwise undamaged. The outboard side of the vertical movement arrestor bolt hole was slightly elongated and exhibited small tensile cracks at the apex of the bend consistent with plastic deformation of the hinge fitting shaft (figure 12). The hole bore was otherwise undamaged.

Figure 12. Aft hinge fitting after disassembly showing the bent shaft.
