Aviation Investigation Final Report

Location:	Miami, Florida	Incident Number:	DCA24LA079
Date & Time:	January 18, 2024, 22:34 Local	Registration:	N859GT
Aircraft:	Boeing 747-87UF	Aircraft Damage:	Minor
Defining Event:	Fire/smoke (non-impact)	Injuries:	5 None
Flight Conducted Under:	Part 121: Air carrier - Non-scheduled

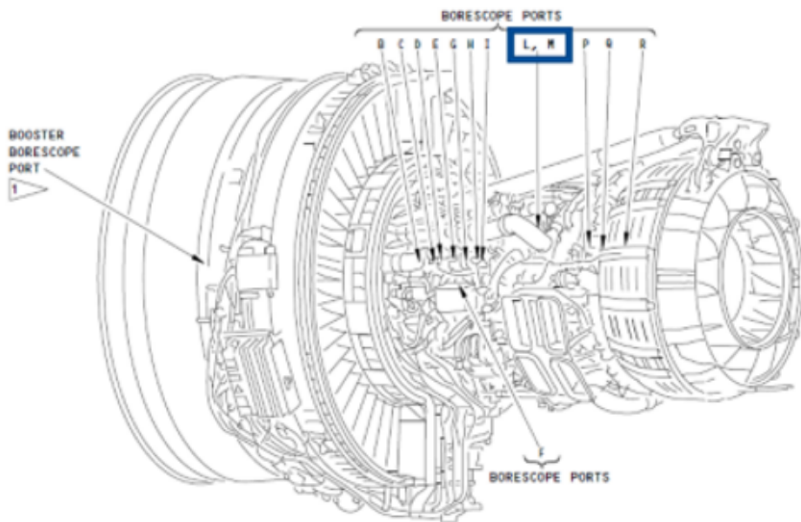
engine. The inspection, performed by a third-party vendor, required the removal of the port M borescope plug; see figure 1 for the location of port M.

Figure 1. Engine diagram with port M depicted in the combustor diffuser nozzle (Source: General Electric).

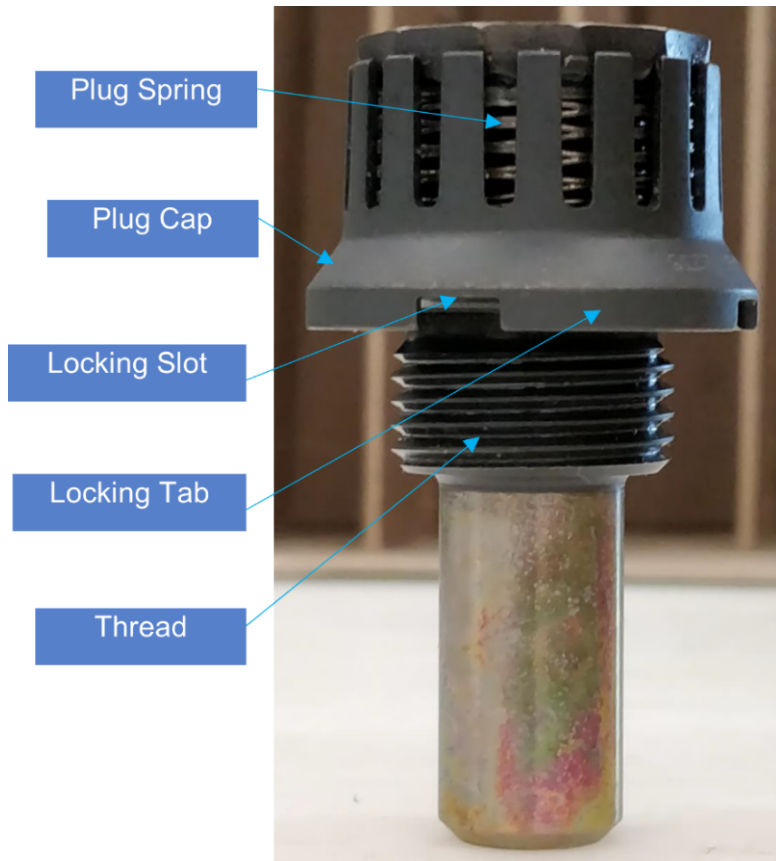
The maintenance work card provided instructions on how to properly reinstall the borescope plug to ensure that the locking feature was engaged. The locking design on the borescope plug incorporated a plug cap that utilizes fingers, detents, an internal spring, and a locking slot, as shown in figure 2. When properly installed with the locking slot engaged on the engine, case friction is generated by the fingers and detents, and the plug would be prevented from backing out. The work card was initialed by the technician who performed the work and an inspector

Figure 2. Exemplar borescope plug (Source: General Electric).

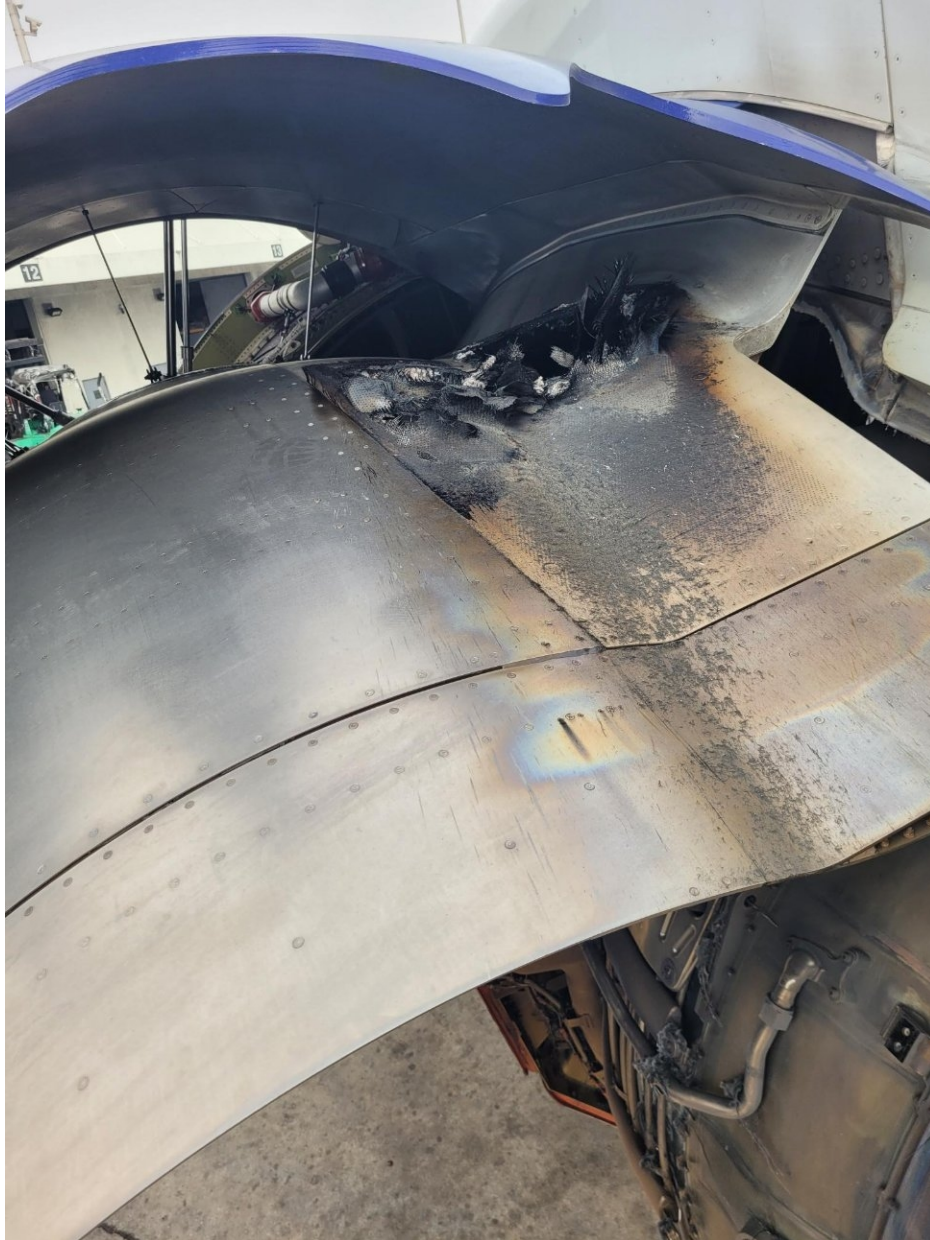
A postincident inspection of the No. 2 engine revealed that the engine cases were intact with no evidence of an uncontained engine failure. The inspection also revealed burn through of the thrust reverser fan duct fixed inner wall located directly over the combustor diffuser nozzle (CDN) port M borescope plug. The CDN case port M borescope plug was not secured in the engine case and was found loose in the engine cowling. The open CDN port allowed hot gases to escape from the engine, which caused thermal damage to the thrust reverser.

A postincident inspection of the No. 2 engine revealed burn-through of the thrust reverser fan duct fixed inner wall (see figure 3). The engine cases were intact with no evidence of an uncontained engine failure. The combustor diffuser nozzle (CDN) case port M borescope plug was not secured in the case and was found loose in the engine cowling. The burn-through observed on the thrust reverser wall was directly above the open CDN port M. The engine low-pressure spool (N1) and high-pressure spool (N2) rotated smoothly with manual rotation. A borescope inspection through CDN port M was performed, and no combustor damage was visible. A review of quick access recorder, flight data recorder, and continuous engine operating data showed no evidence of engine failure or surge/stall.

Figure 3. Burned area above borescope port M (Source: Atlas Air).

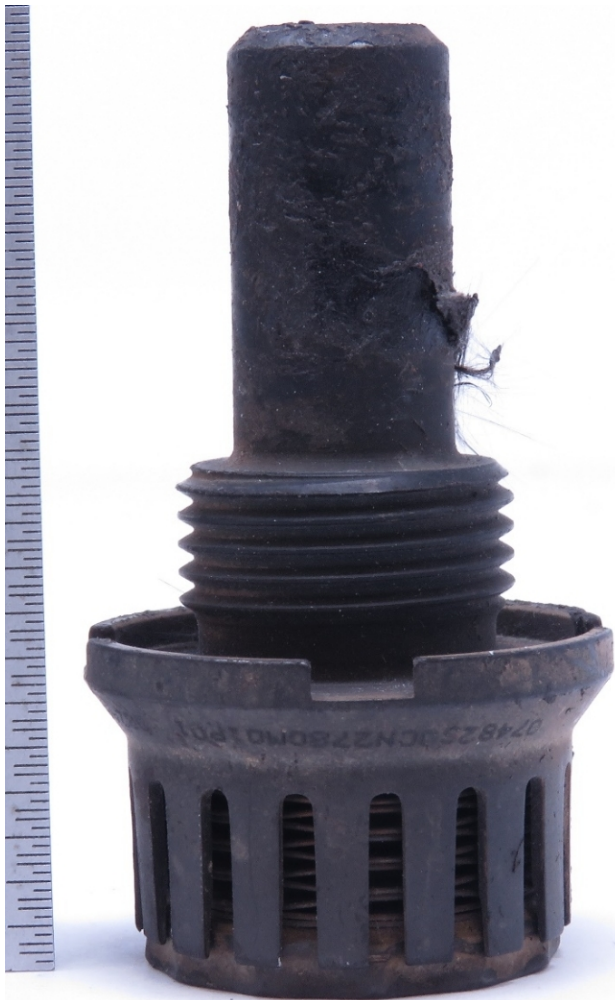
A postincident inspection of the port M borescope plug revealed no anomalies to the plug’s material composition, dimensions, threads or locking components. The plug was threaded into an exemplar engine without binding or stiffness and locked as designed. Although the work card had been initialed by a technician and an inspector, it is likely that the port M borescope

plug was not properly secured and inspected according to maintenance manual procedures and that the improperly secured plug resulted in the engine fire.

Maintenance personnel's improper installation and inspection of the port M borescope plug, which resulted in an engine fire.

A postincident inspection of the port M borescope plug (see figure 4) revealed general debris and oxidation. The plug's geometry/features conformed to the drawing requirements with no anomalies noted to the plug's threads and its locking components. The plug's materials and coatings were consistent with the design requirements. The plug was threaded into an exemplar engine without binding or stiffness, and the locking feature engaged as designed.

Figure 4. Borescope plug recovered from the incident airplane (Source: General Electric).
