Aviation Investigation Final Report

Location:	Miami, Florida	Incident Number:	DCA24LA079
Date & Time:	January 18, 2024, 22:34 Local	Registration:	N859GT
Aircraft:	Boeing 747-87UF	Aircraft Damage:	Minor
Defining Event:	Fire/smoke (non-impact)	Injuries:	5 None
Flight Conducted Under:	Part 121: Air carrier - Non-scheduled

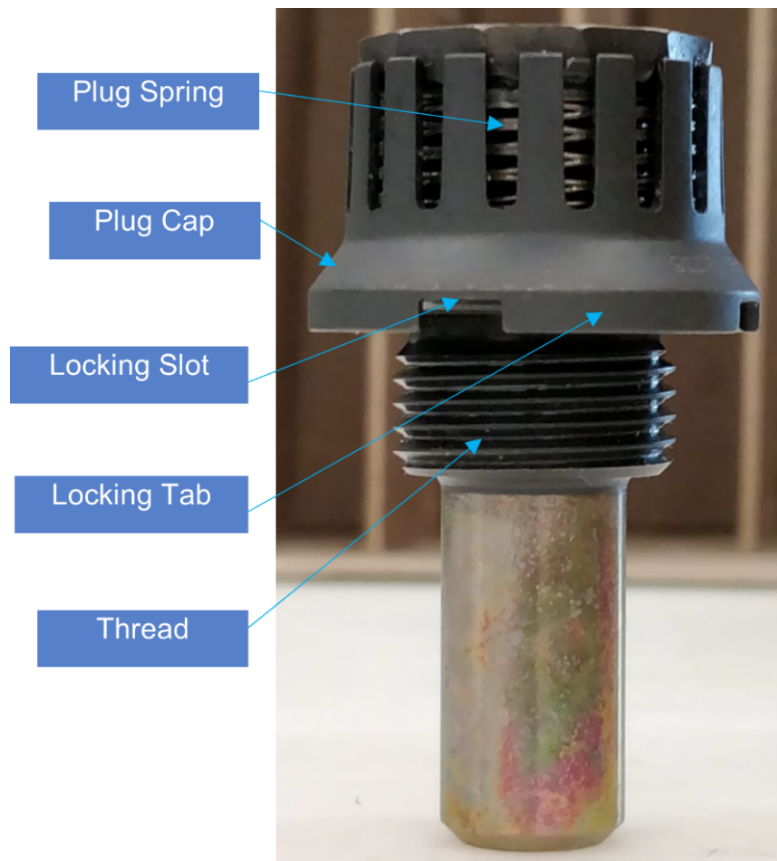
The maintenance work card provided instructions on how to properly reinstall the borescope plug to ensure that the locking feature was engaged. The locking design on the borescope plug incorporated a plug cap that utilizes fingers, detents, an internal spring, and a locking slot, as shown in figure 2. When properly installed with the locking slot engaged on the engine, case friction is generated by the fingers and detents, and the plug would be prevented from backing out. The work card was initialed by the technician who performed the work and an inspector

Figure 2. Exemplar borescope plug (Source: General Electric).

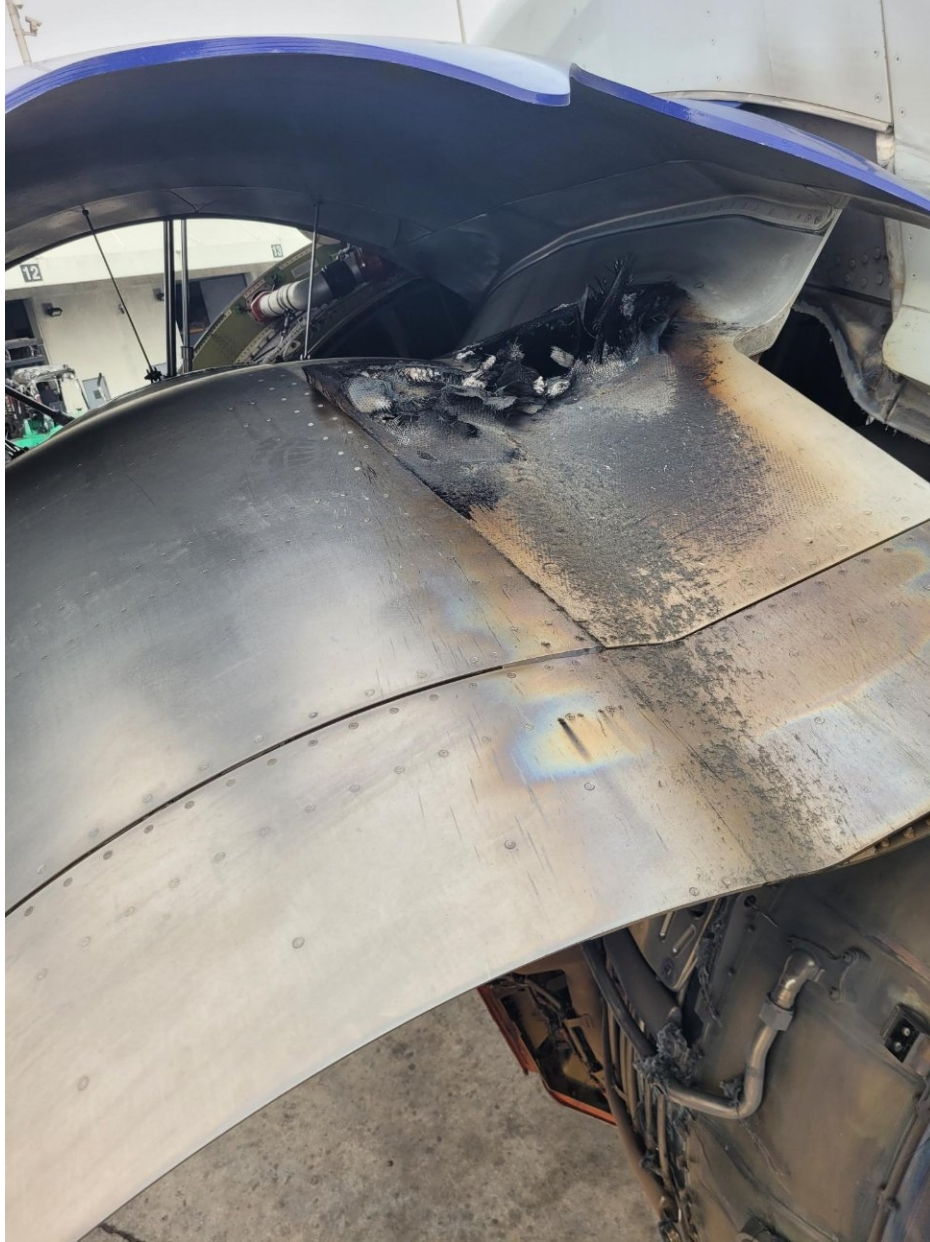
A postincident inspection of the No. 2 engine revealed that the engine cases were intact with no evidence of an uncontained engine failure. The inspection also revealed burn through of the thrust reverser fan duct fixed inner wall located directly over the combustor diffuser nozzle (CDN) port M borescope plug. The CDN case port M borescope plug was not secured in the engine case and was found loose in the engine cowling. The open CDN port allowed hot gases to escape from the engine, which caused thermal damage to the thrust reverser.

A postincident inspection of the No. 2 engine revealed burn-through of the thrust reverser fan duct fixed inner wall (see figure 3). The engine cases were intact with no evidence of an uncontained engine failure. The combustor diffuser nozzle (CDN) case port M borescope plug was not secured in the case and was found loose in the engine cowling. The burn-through observed on the thrust reverser wall was directly above the open CDN port M. The engine low-pressure spool (N1) and high-pressure spool (N2) rotated smoothly with manual rotation. A borescope inspection through CDN port M was performed, and no combustor damage was visible. A review of quick access recorder, flight data recorder, and continuous engine operating data showed no evidence of engine failure or surge/stall.

Figure 3. Burned area above borescope port M (Source: Atlas Air).

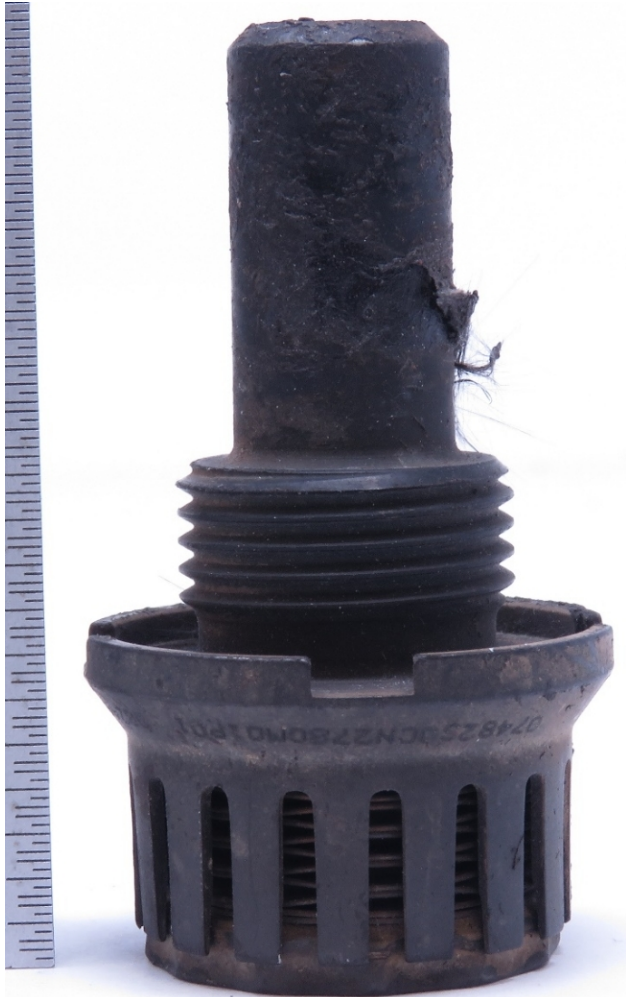
A postincident inspection of the port M borescope plug revealed no anomalies to the plug's material composition, dimensions, threads or locking components. The plug was threaded into an exemplar engine without binding or stiffness and locked as designed. Although the work card had been initialed by a technician and an inspector, it is likely that the port M borescope

plug was not properly secured and inspected according to maintenance manual procedures and that the improperly secured plug resulted in the engine fire.

Maintenance personnel's improper installation and inspection of the port M borescope plug, which resulted in an engine fire.

A postincident inspection of the port M borescope plug (see figure 4) revealed general debris and oxidation. The plug's geometry/features conformed to the drawing requirements with no anomalies noted to the plug's threads and its locking components. The plug's materials and coatings were consistent with the design requirements. The plug was threaded into an exemplar engine without binding or stiffness, and the locking feature engaged as designed.

Figure 4. Borescope plug recovered from the incident airplane (Source: General Electric).
