Aviation Investigation Final Report

Location:	Miami, Florida	Incident Number:	DCA24LA079
Date & Time:	January 18, 2024, 22:34 Local	Registration:	N859GT
Aircraft:	Boeing 747-87UF	Aircraft Damage:	Minor
Defining Event:	Fire/smoke (non-impact)	Injuries:	5 None
Flight Conducted Under:	Part 121: Air carrier - Non-scheduled

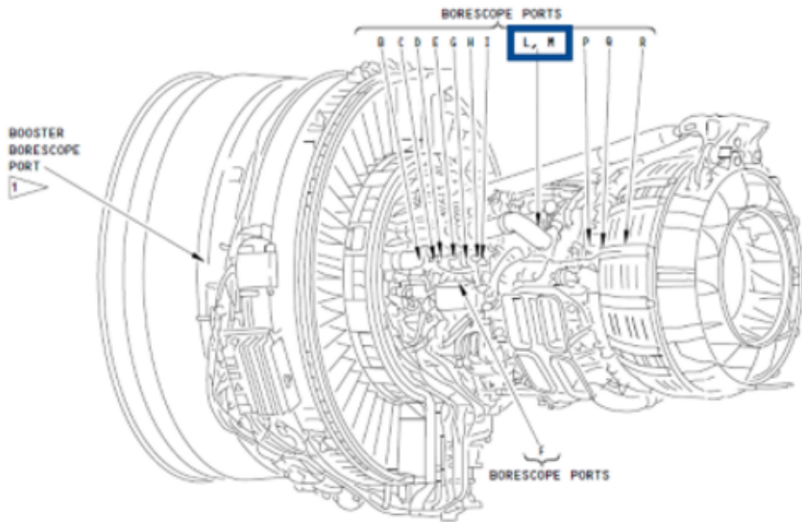
engine. The inspection, performed by a third-party vendor, required the removal of the port M borescope plug; see figure 1 for the location of port M.

Figure 1. Engine diagram with port M depicted in the combustor diffuser nozzle (Source: General Electric).

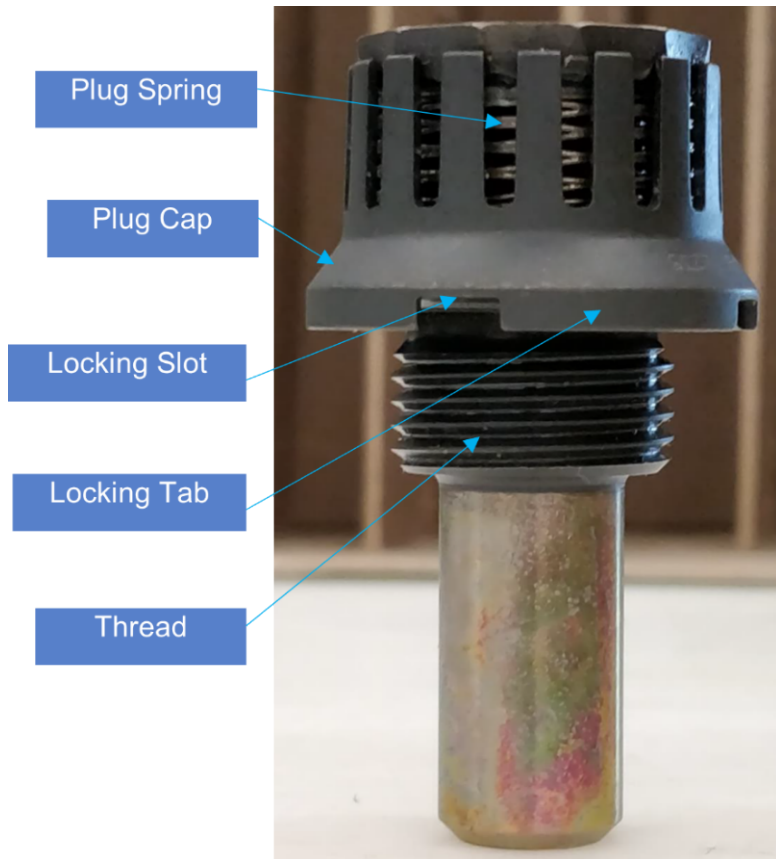
The maintenance work card provided instructions on how to properly reinstall the borescope plug to ensure that the locking feature was engaged. The locking design on the borescope plug incorporated a plug cap that utilizes fingers, detents, an internal spring, and a locking slot, as shown in figure 2. When properly installed with the locking slot engaged on the engine, case friction is generated by the fingers and detents, and the plug would be prevented from backing out. The work card was initialed by the technician who performed the work and an inspector

Figure 2. Exemplar borescope plug (Source: General Electric).
