Aviation Investigation Preliminary Report

Location:	Hydro, OK	Accident Number:	CEN24FA094
Date & Time:	January 20, 2024, 23:23 Local	Registration:	N295AE
Aircraft:	Bell 206	Injuries:	3 Fatal
Flight Conducted Under:	Part 135: Air taxi & commuter - Non-scheduled - Air Medical (Discretionary)

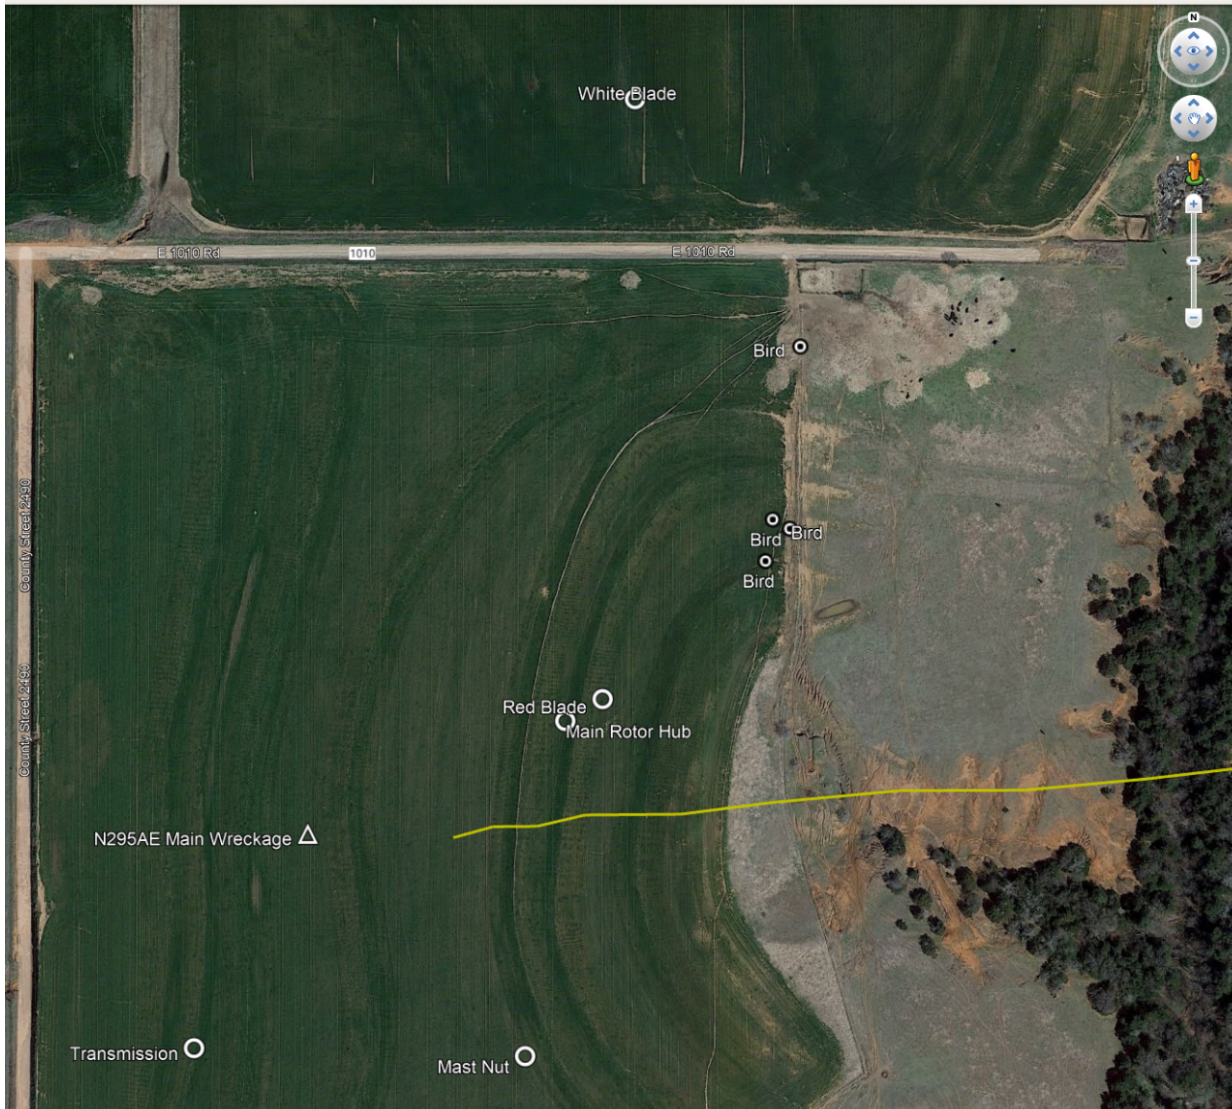
Figure 1. ADS-B Flight Track with Wreckage and Bird Locations

A preliminary review of Automatic Dependent Surveillance–Broadcast (ADS-B) data captured the accident flight as it departed OL16 and flew west towards Weatherford between 500 ft and 600 ft above ground level and about 110 knots groundspeed. The last ADS-B point was at 2323:39 about 210 ft east of the main wreckage location.

The carcasses of several geese were located in the debris field as well as one embedded in a flight control servo. Samples of the geese feathers were recovered for more detailed identification.

All major components of the helicopter were located at the accident site. The main wreckage consisted of the fuselage, engine, and tail rotor. The transmission had separated from the fuselage and was located at the site. The white main rotor blade was fractured found in an adjacent field. The red main rotor blade was also fractured and found near the main rotor hub. The mast nut had separated and was located in the debris field.
