Aviation Investigation Final Report

Location:	Eden, Oregon	Accident Number:	WPR24LA082
Date & Time:	January 26, 2024, 13:29 Local	Registration:	N7473D
Aircraft:	Piper PA-18A 150	Aircraft Damage:	Substantial
Defining Event:	Unknown or undetermined	Injuries:	1 Serious, 1 Minor
Flight Conducted Under:	Part 91: General aviation - Personal

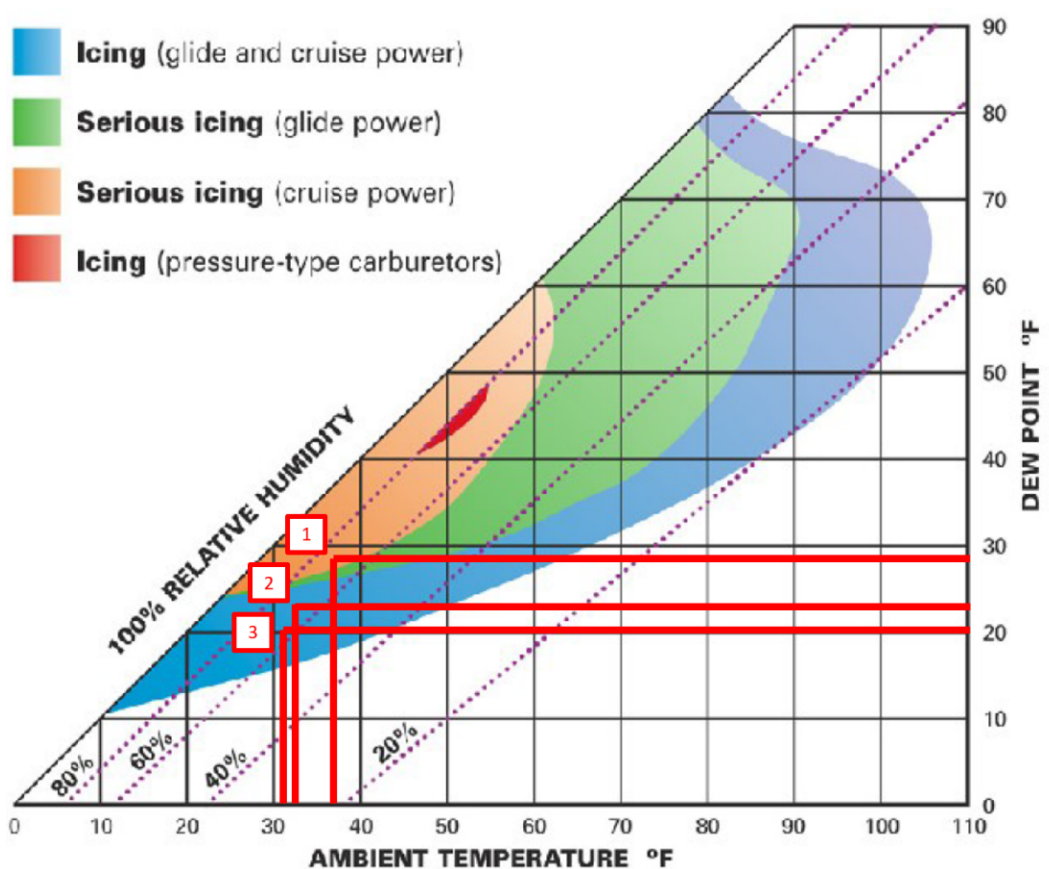
Figure 1: Carburetor icing probability chart from Federal Aviation Administration Special Airworthiness Information Bulletin CE-09-35

Further evidence suggests that the airplane was also operating in conditions conducive to potentially serious carburetor ice at cruise power; however, it is unknown if the pilot used carburetor heat during the flight.

The airplane impacted mountainous terrain at a field elevation of about 2,900 ft mean sea level (msl) and was about 30 nm from the nearest airport with an onsite weather reporting station. A High-Resolution Rapid Refresh (HRRR) model sounding was created for the accident time and location. As the pilot and passenger were unable to recall their altitude before the airplane crashed, the model sounding was created from various altitudes. At an elevation of 3,900 ft msl, the HRRR sounding indicated the temperature was about 38° F and the dewpoint was about 29° F (“1” in Figure 1); the wind was from 207° at 3 kts.

At an elevation of 4,900 ft msl, the HRRR sounding indicated the temperature was about 32° F and the dewpoint was about 23° F (“2” in Figure 1); the wind was from 204° at 9 kts.

At an elevation of 5,900 ft msl, the HRRR sounding indicated the temperature was about 31° F and the dewpoint was about 20° F (“3” in Figure 1); the wind was from 201° at 11.5 kts.

According to the model sounding, the airplane was operating in conditions conducive to serious icing at cruise power at 3,900 ft msl (1,000 ft above ground level). At higher altitudes, the conditions were conducive to icing at both glide and cruise power.
