Aviation Investigation Preliminary Report

Location:	Westwater, UT	Accident Number:	WPR24FA083
Date & Time:	February 7, 2024, 10:48 Local	Registration:	N900VA
Aircraft:	HAWKER BEECHCRAFT CORP HAWKER 900XP	Injuries:	2 Fatal
Flight Conducted Under:	Part 91: General aviation - Positioning

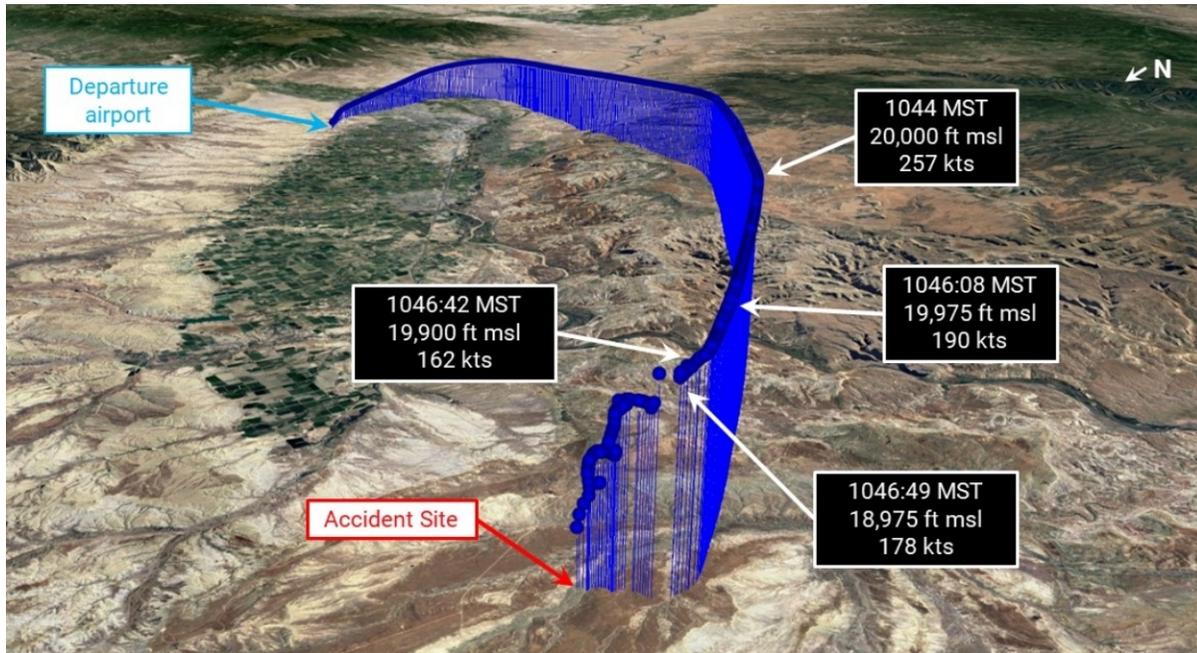
Figure 1: Accident airplane flight track

leveled off at 1043:49, near the top of the altitude block. At 1046:47 the flight track data showed the airplane begin a rapid descent in circular pattern that resembled the shape of a corkscrew. The airplane made multiple rotations before the track ceased at 1047:44.

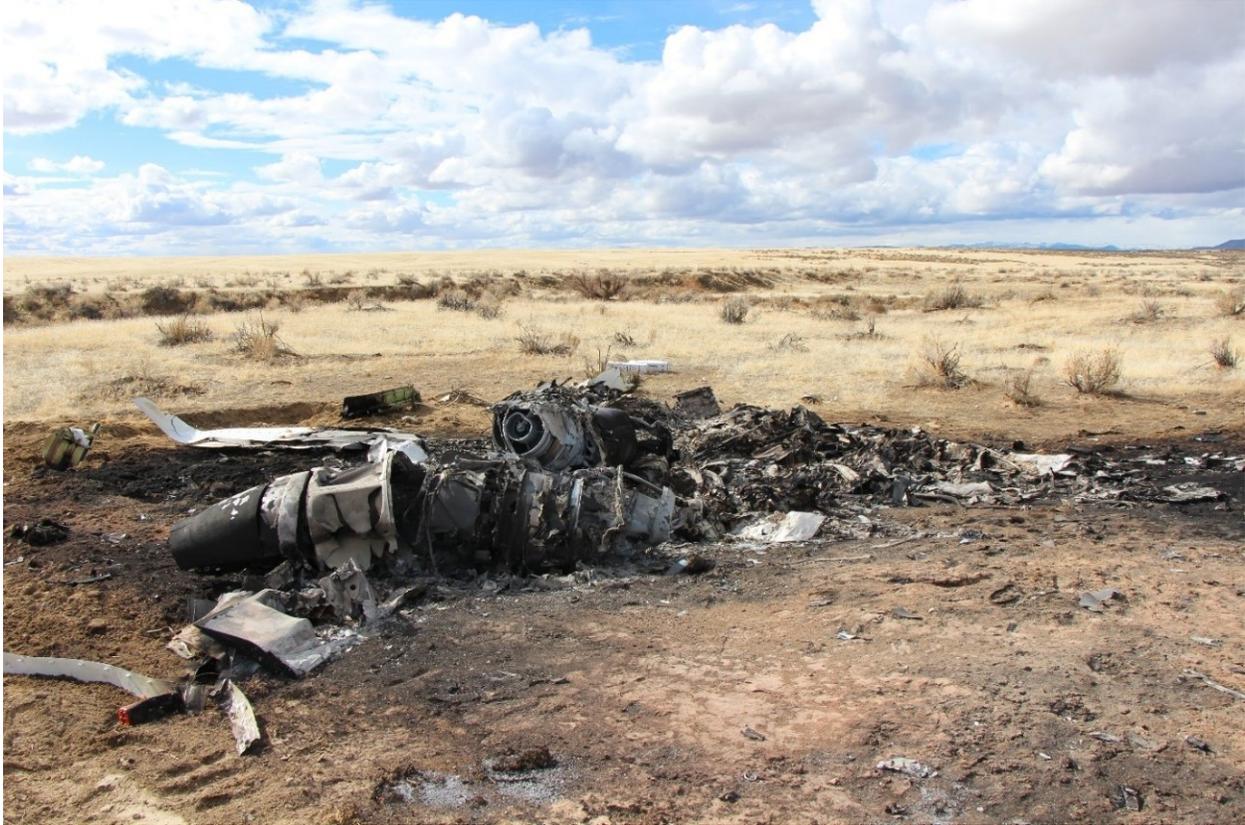
Figure 2: Accident site main wreckage

The airplane came to rest in flat open terrain about 25 nm northwest of GJT at an elevation of about 4,800 ft mean sea level and oriented on a west heading. The airplane's major structures were all accounted for at the accident site. A debris path was traced from the main wreckage to the end of a burn area that was about 200 ft long and 175 ft wide at the widest point, oriented on a magnetic heading of 345°. A silhouette of the left wing, fuselage and both engines was located about 10 ft south of the main wreckage.
