# Aviation Investigation Preliminary Report

<b>Location:</b>	Westwater, UT	<b>Accident Number:</b>	WPR24FA083
<b>Date &amp; Time:</b>	February 7, 2024, 10:48 Local	<b>Registration:</b>	N900VA
<b>Aircraft:</b>	HAWKER BEECHCRAFT CORP HAWKER 900XP	<b>Injuries:</b>	2 Fatal
<b>Flight Conducted Under:</b>	Part 91: General aviation - Positioning

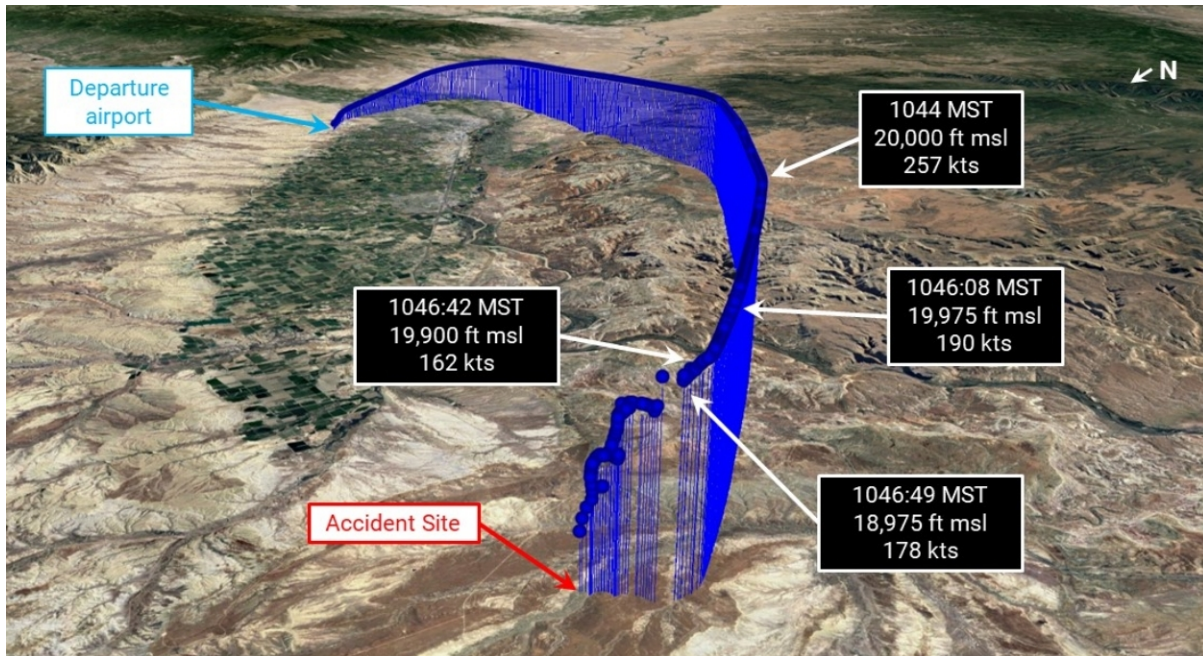
According to preliminary automatic dependent system broadcast (ADS-B) data, the airplane departed GJT at 1037 and entered a climb on a southeast heading. The flight crew asked air traffic control (ATC) for a block of altitude from FL180 to FL200 and ATC approved the request. The airplane circled to the northwest as it continued to climb and subsequently

leveled off at 1043:49, near the top of the altitude block. At 1046:47 the flight track data showed the airplane begin a rapid descent in circular pattern that resembled the shape of a corkscrew. The airplane made multiple rotations before the track ceased at 1047:44.

**Figure 1: Accident airplane flight track**

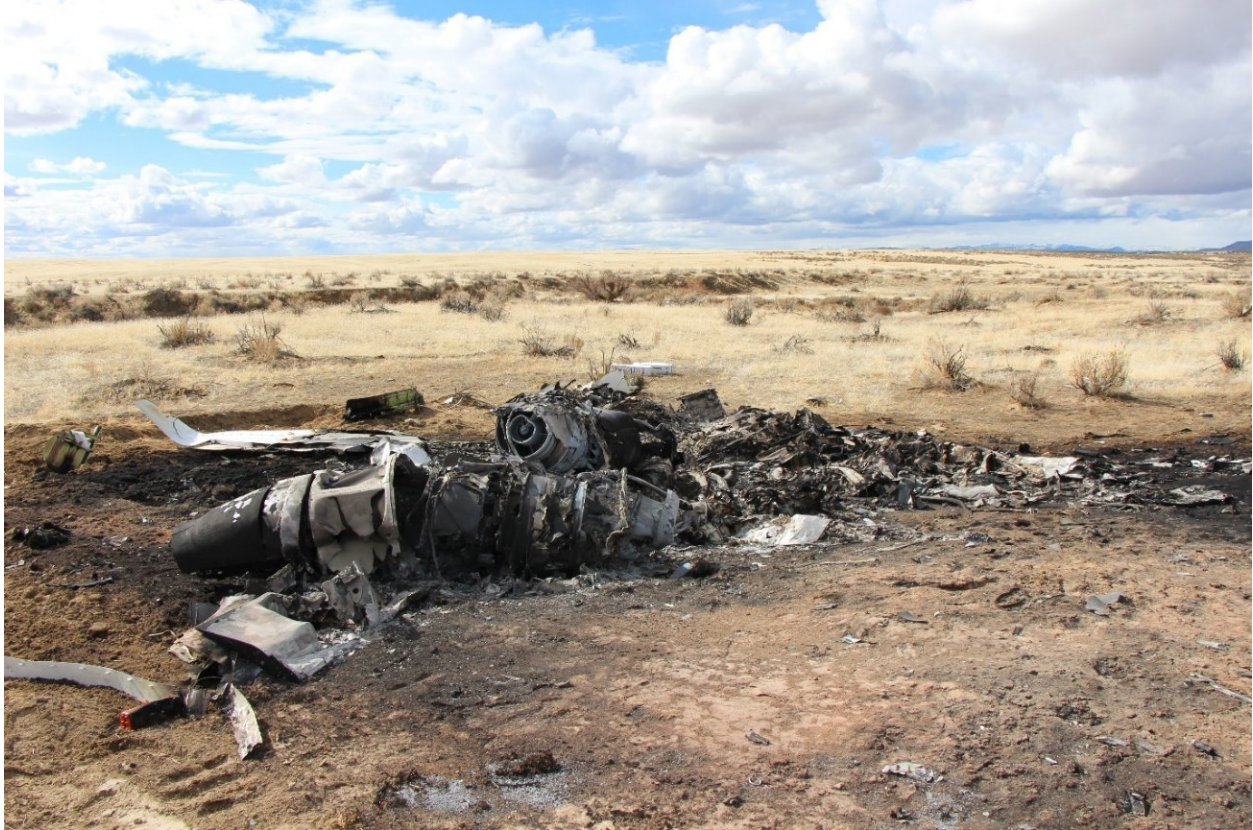
The airplane came to rest in flat open terrain about 25 nm northwest of GJT at an elevation of about 4,800 ft mean sea level and oriented on a west heading. The airplane's major structures were all accounted for at the accident site. A debris path was traced from the main wreckage to the end of a burn area that was about 200 ft long and 175 ft wide at the widest point, oriented on a magnetic heading of 345°. A silhouette of the left wing, fuselage and both engines was located about 10 ft south of the main wreckage.

**Figure 2: Accident site main wreckage**
