Aviation Investigation Preliminary Report

Location:	Westwater, UT	Accident Number:	WPR24FA083
Date & Time:	February 7, 2024, 10:48 Local	Registration:	N900VA
Aircraft:	HAWKER BEECHCRAFT CORP HAWKER 900XP	Injuries:	2 Fatal
Flight Conducted Under:	Part 91: General aviation - Positioning

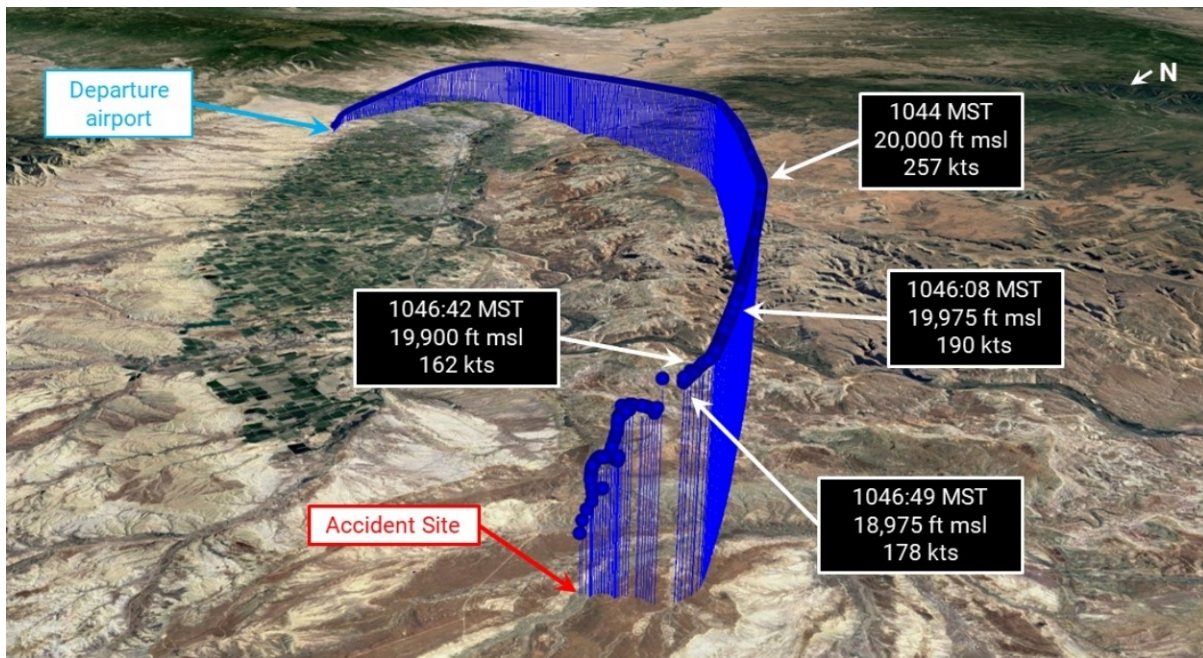
leveled off at 1043:49, near the top of the altitude block. At 1046:47 the flight track data showed the airplane begin a rapid descent in circular pattern that resembled the shape of a corkscrew. The airplane made multiple rotations before the track ceased at 1047:44.

Figure 1: Accident airplane flight track
