Aviation Investigation Final Report

Location:	Boston, Massachusetts	Accident Number:	DCA24LA092
Date & Time:	February 8, 2024, 11:37 UTC	Registration:	N956JT (A1); N2157J (A2)
Aircraft:	Airbus A321-231 (A1); Airbus A321 (A2)	Aircraft Damage:	Substantial (A1); Minor (A2)
Defining Event:	Ground collision	Injuries:	210 None (A1); 154 None (A2)
Flight Conducted Under:	Part 121: Air carrier - Scheduled (A1); Part 121: Air carrier - Scheduled (A2)

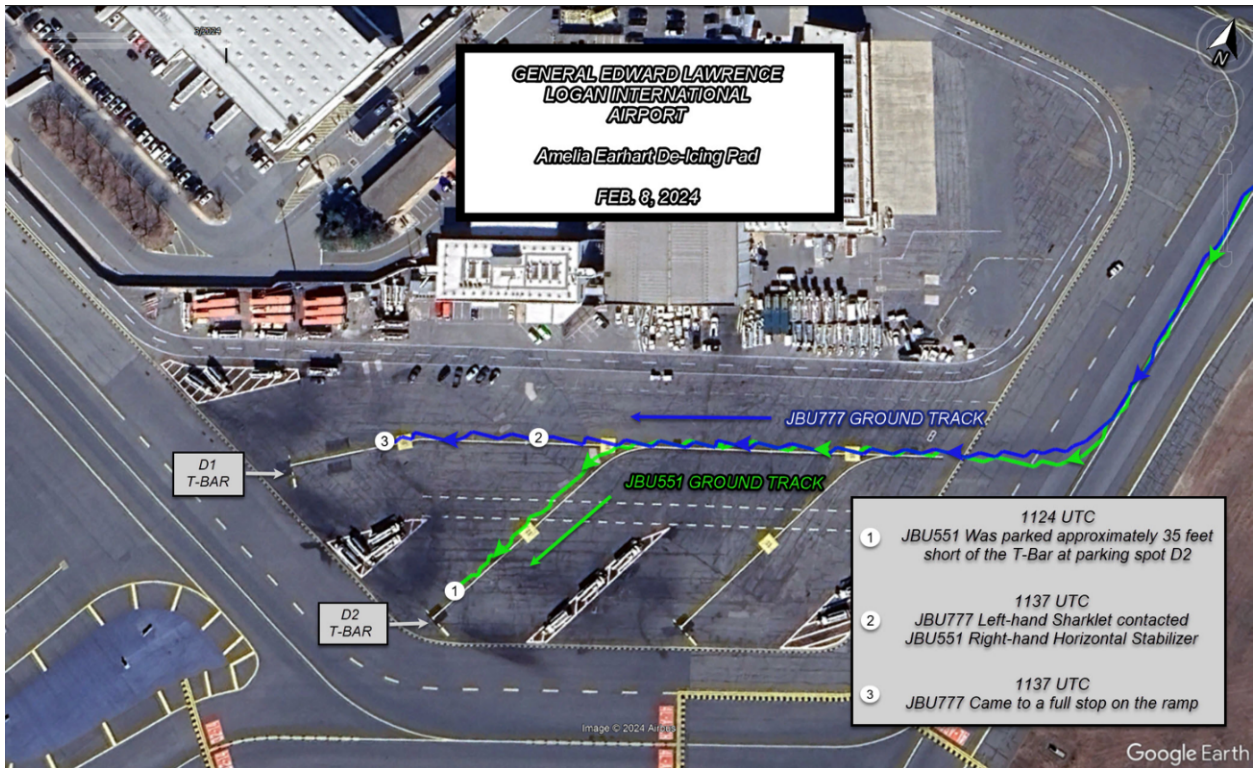
The flight crew of flight 551 stated that, following a normal preflight and uneventful taxi from the gate to the de-icing pad, they were guided by a “follow me” vehicle operated by JetBlue contractor, Aeromag (see figure 1). The flight crew proceeded to follow the vehicle to the D2 parking spot. A yellow painted “T” inside a black square marked the proper stopping point location for the airplane’s nose tires when parked. Nearing the stopping point, the “follow me” vehicle turned to the right and stopped with its headlights facing toward the back of the airplane. The driver of the “follow me” vehicle communicated with the flight crew via radio and began a “countdown” for when the captain should stop the airplane.

Figure 1. Google Earth image showing the ground position tracks of both airplanes.

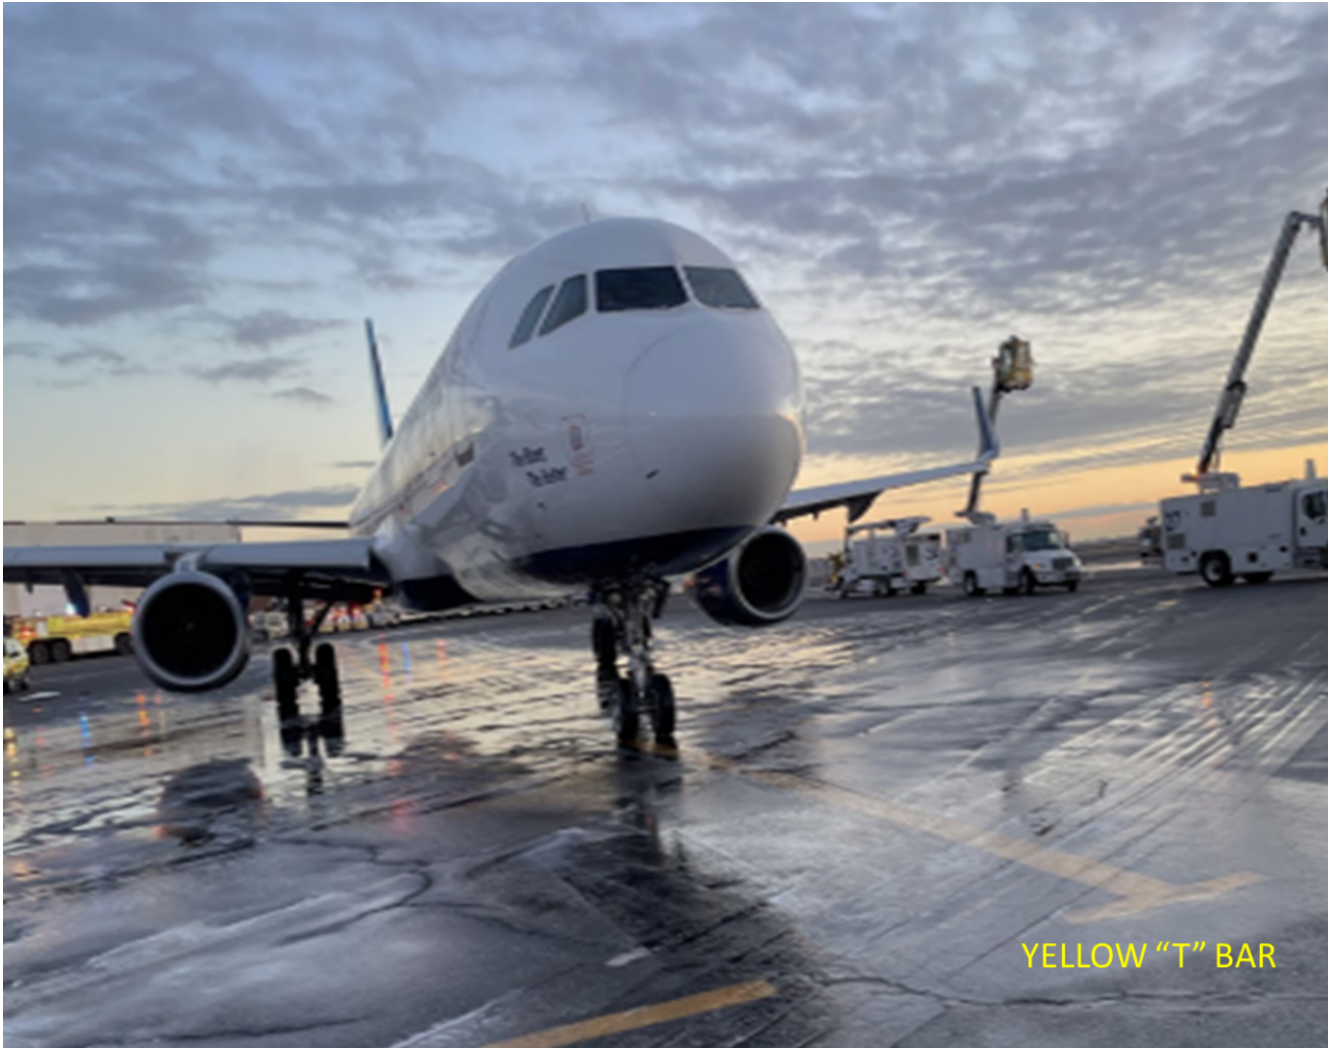
In a post-accident statement, the driver of the “follow me” vehicle indicated that he stopped the airplane (flight 551) at what he thought was the normal stopping point. He had difficulty seeing the yellow “T” -bar due to the dark night conditions and the de-icing fluid that was present on the ground (figure 2). A post-accident inspection found that the airplane was about 35 ft short of the normal stopping point.

Figure 2. Photograph showing N956JT (JetBlue flight 551) about 35 feet from the yellow “T” bar. (Source: JetBlue)

The “follow me” driver stopping the airplane (flight 551) about 35 feet from the normal stopping point due to a difficulty in seeing the yellow “T”-bar because of the dark night conditions and the presence of de-icing fluid on the ground.

As a result of this event, Aeromag investigated and produced a February 12, 2024, memo to their BOS-JBU [JetBlue] operations staff discussing an amendment to the Coordinator of Traffic and Movement (CTM) phraseology and aircraft stopping procedures. The memo outlined the updated procedures and phraseology as:

- o "Follow me" truck is now required to verbally confirm with the flight crew that the aircraft is correctly stopped on the deicing "T"-Bar.
- o JetBlue will add to the Airport Briefing Guide (ABG) that the pilot will not configure the aircraft until confirmation that the aircraft is correctly stopped on the deicing "T"-Bar.
- o The "follow me" truck is required to check the rear of the aircraft to ensure that it is within the bay and clear of the zipper line before confirming brake set.
- o Safety Lead will perform a secondary check, reconfirming with the CTM that the aircraft has stopped on the deicing "T"-Bar. Safety Lead will also verify that the rear of the aircraft is clear of the zipper line and within the bay.
- o Truck positioning and aircraft deicing will commence after these checks have been completed.

- o Repainting and reviewing the color format of the delineated markings using high-visibility paint and/or reflective inset markers.
- o Investigating the feasibility of adding high mast lighting for the Earhart facility.
- o Operational audits to focus on the correct positioning of aircraft while maintaining the safety buffer zones.
- o Explore opportunities to locate Aeromag tower personnel in elevated positions.
