Aviation Investigation Preliminary Report

Location:	Newark, NJ	Incident Number:	DCA24LA094
Date & Time:	February 6, 2024, 15:55 Local	Registration:	N47280
Aircraft:	Boeing 737-8	Injuries:	161 None
Flight Conducted Under:	Part 121: Air carrier - Scheduled

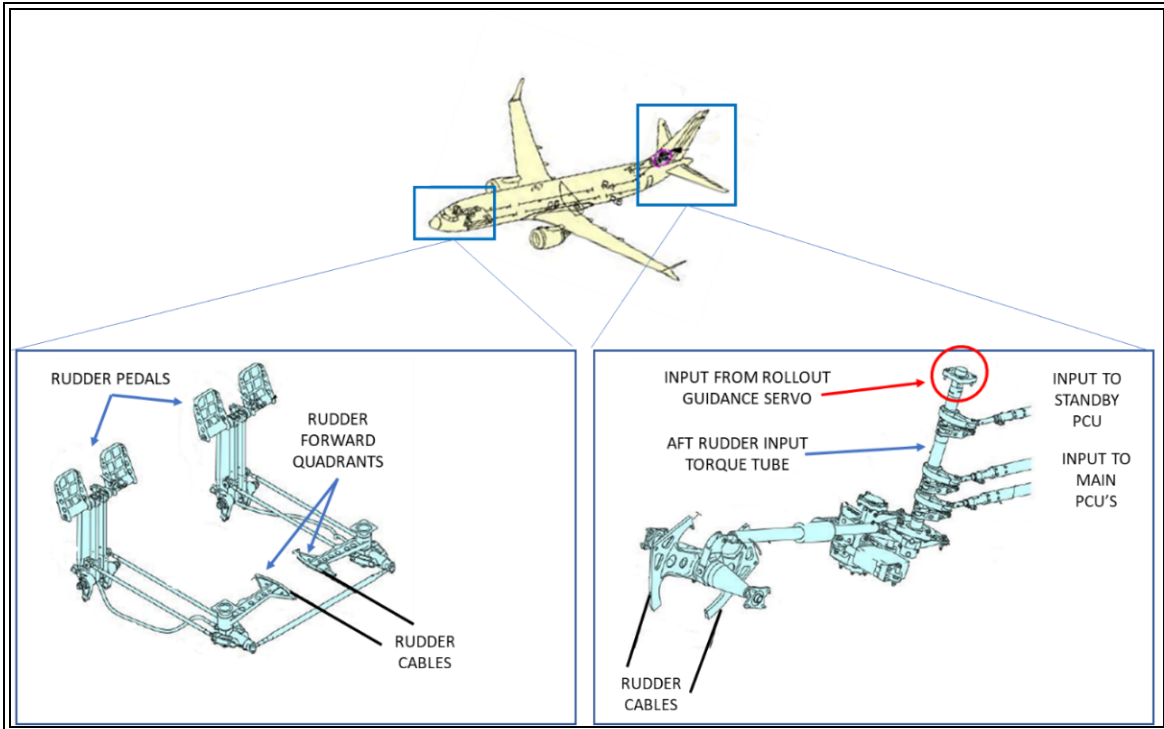
Pilot control of the 737-8 rudder is transmitted in a closed-loop system from the pilots' rudder pedals in the cockpit through a single cable system, aft rudder quadrant, pedal force transducer to the aft rudder input torque tube in the vertical fin. Rotation of the torque tube provides the command inputs to the two main and standby rudder power control units (PCU's) to move the rudder surface. UAL received the incident airplane from Boeing on February 20, 2023, configured with a rudder SVO-730 rollout guidance servo that was disabled per UAL's delivery requirements to reconfigure the autoflight system from CAT IIIB to CAT IIIA capability. Although the servo was disabled, it remained mechanically connected to the upper portion of the aft rudder input torque tube by the servo's output crank arm and pushrod (see figures 1 and 2).

Figure 1. Diagram of rudder control system. (Source: Boeing. Image Copyright © Boeing. Reproduced with permission.)

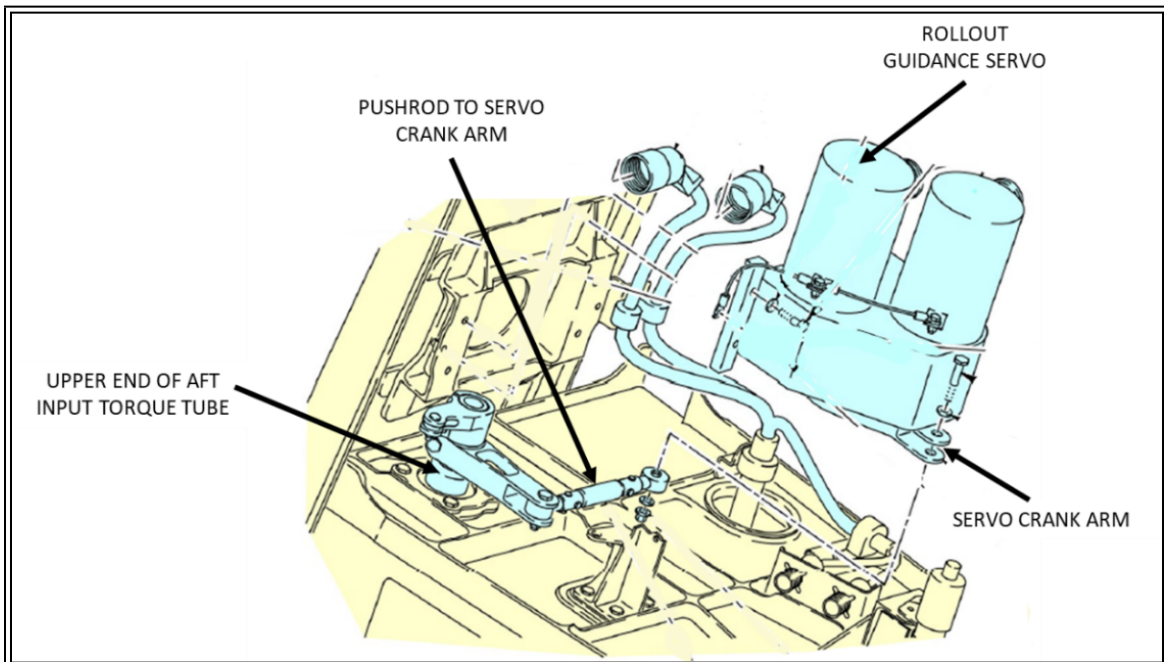
Figure 2. Diagram showing the location of the rollout guidance servo. (Source: Boeing. Image Copyright © Boeing. Reproduced with permission.)

On February 28, 2024, the Systems group met at the Collins Aerospace facility in Cedar Rapids, Iowa to examine and test the SVO-730 rollout guidance servo removed from the incident airplane. The testing was conducted to evaluate the effects that temperature “cold soaking” of the servo might have on the torque required to move the servo’s output crank arm. Testing at room temperature found that the torque to rotate the servo’s output crank arm was within design specifications. The unit was then “cold soaked” for 1 hour and the test was repeated. That testing found that the torque to move the servo’s output crank arm was significantly beyond the specified design limits. Because the servo output crank arm is mechanically connected to the rudder input torque tube, the restricted movement of the servo’s output crank arm would prevent the rudder pedals from moving as observed during flight 1539 and the test flight. Further examination of the SVO-730 rollout guidance servo will be conducted as the investigation continues.
