# Aviation Investigation Preliminary Report

<b>Location:</b>	Newark, NJ	<b>Incident Number:</b>	DCA24LA094
<b>Date &amp; Time:</b>	February 6, 2024, 15:55 Local	<b>Registration:</b>	N47280
<b>Aircraft:</b>	Boeing 737-8	<b>Injuries:</b>	161 None
<b>Flight Conducted Under:</b>	Part 121: Air carrier - Scheduled

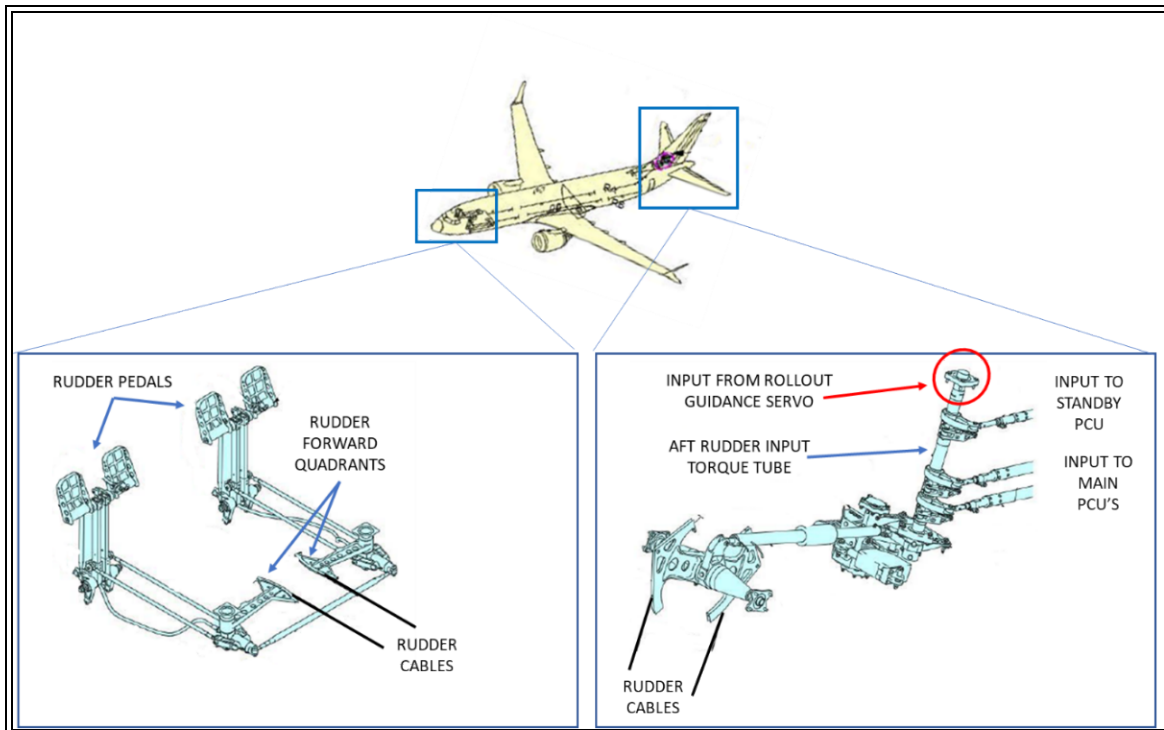
Pilot control of the 737-8 rudder is transmitted in a closed-loop system from the pilots' rudder pedals in the cockpit through a single cable system, aft rudder quadrant, pedal force transducer to the aft rudder input torque tube in the vertical fin. Rotation of the torque tube provides the command inputs to the two main and standby rudder power control units (PCU's) to move the rudder surface. UAL received the incident airplane from Boeing on February 20, 2023, configured with a rudder SVO-730 rollout guidance servo that was disabled per UAL's delivery requirements to reconfigure the autoflight system from CAT IIIB to CAT IIIA capability. Although the servo was disabled, it remained mechanically connected to the upper portion of the aft rudder input torque tube by the servo's output crank arm and pushrod (see figures 1 and 2).

Figure 1. Diagram of rudder control system. (Source: Boeing. Image Copyright © Boeing. Reproduced with permission.)

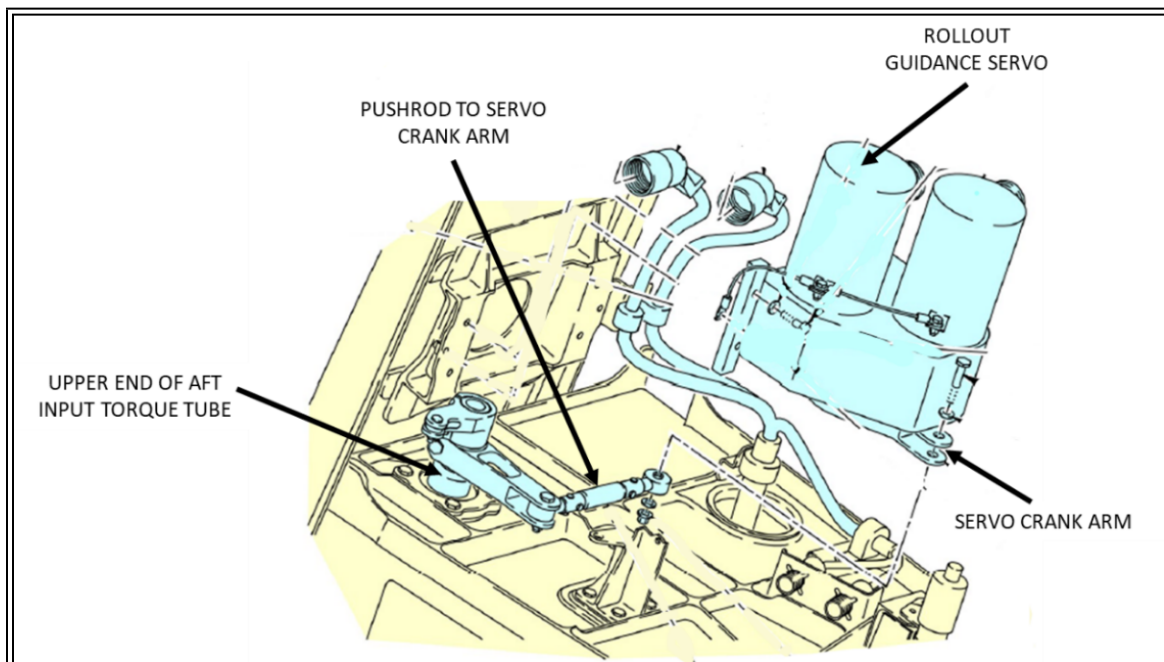
Figure 2. Diagram showing the location of the rollout guidance servo. (Source: Boeing. Image Copyright © Boeing. Reproduced with permission.)

On February 28, 2024, the Systems group met at the Collins Aerospace facility in Cedar Rapids, Iowa to examine and test the SVO-730 rollout guidance servo removed from the incident airplane. The testing was conducted to evaluate the effects that temperature “cold soaking” of the servo might have on the torque required to move the servo’s output crank arm. Testing at room temperature found that the torque to rotate the servo’s output crank arm was within design specifications. The unit was then “cold soaked” for 1 hour and the test was repeated. That testing found that the torque to move the servo’s output crank arm was significantly beyond the specified design limits. Because the servo output crank arm is mechanically connected to the rudder input torque tube, the restricted movement of the servo’s output crank arm would prevent the rudder pedals from moving as observed during flight 1539 and the test flight. Further examination of the SVO-730 rollout guidance servo will be conducted as the investigation continues.
