Aviation Investigation Preliminary Report

Location:	Naples, FL	Accident Number:	ERA24FA110
Date & Time:	February 9, 2024, 15:17 Local	Registration:	N823KD
Aircraft:	BOMBARDIER INC CL-600-2B16	Injuries:	2 Fatal, 4 Minor
Flight Conducted Under:	Part 135: Air taxi & commuter - Non-scheduled

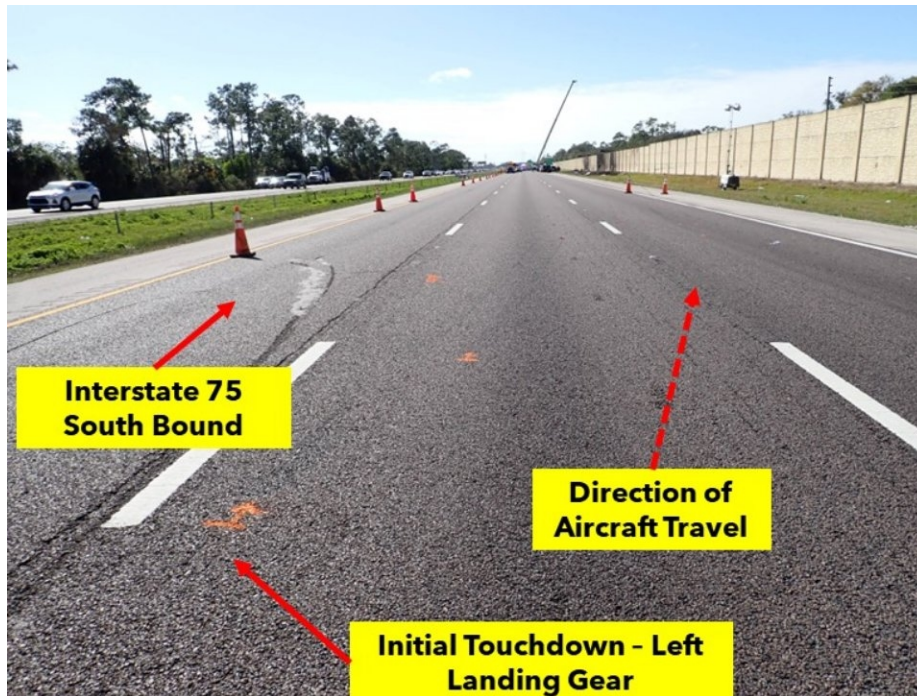
Examination of the accident site revealed tire marks on the southbound lane of Interstate 75 consistent with the left main landing gear (see figure 2). The airplane came to rest about 1,000 ft past the initial touchdown point, upright in the grass area between the break-down lane and the sound barrier wall facing north, opposite the direction of travel.

Figure 2 Annotated photograph of the airplane's initial touchdown point on Interstate 75.

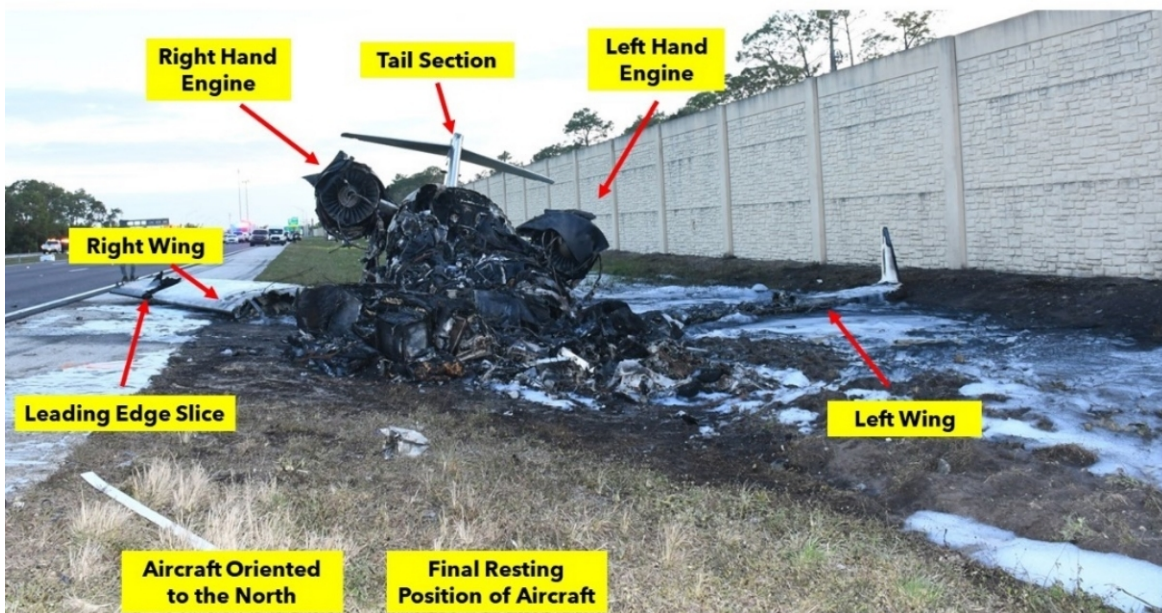
The forward portion of the fuselage was consumed by the post-impact fire (see figure 3). All major components of the airplane were accounted for at the scene, and the ground surrounding the wreckage was fuel-soaked having an odor consistent with Jet-A fuel. The cockpit center console was found separated from the main wreckage. Both engine throttle levers were found near the IDLE stop position. The flap selector handle was found in a position consistent with 45° flap extension.

Figure 3 – Annotated photograph of main wreckage as found.
