Aviation Investigation Preliminary Report

Location:	Naples, FL	Accident Number:	ERA24FA110
Date & Time:	February 9, 2024, 15:17 Local	Registration:	N823KD
Aircraft:	BOMBARDIER INC CL-600-2B16	Injuries:	2 Fatal, 4 Minor
Flight Conducted Under:	Part 135: Air taxi & commuter - Non-scheduled

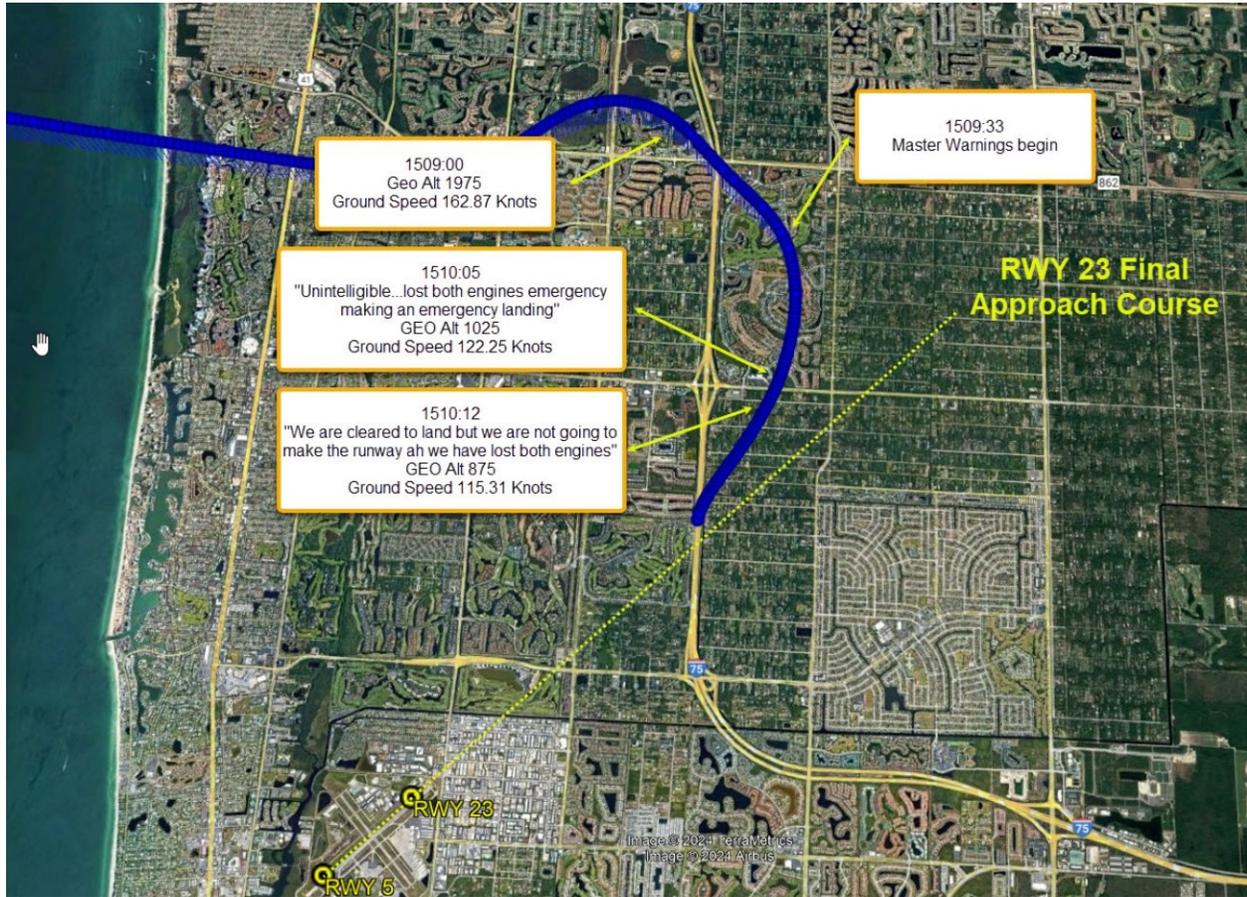
Twenty seconds later, at 1510:05, about 1,000 ft msl and 122 kts, on a shallow intercept angle for the final approach course, the crew announced, "...lost both engines... emergency... making an emergency landing" (see figure 1). The tower controller acknowledged the call and cleared the airplane to land. At 1510:12, about 900 ft and 115 knots, the crew replied, "We are cleared to land but we are not going to make the runway... ah... we have lost both engines."

Figure 1 – Plot of the airplane’s ADS-B ground track (blue dots) with annotations of specific events during the approach that include time as well as the airplane’s geometric altitude and groundspeed (source: Federal Aviation Administration).

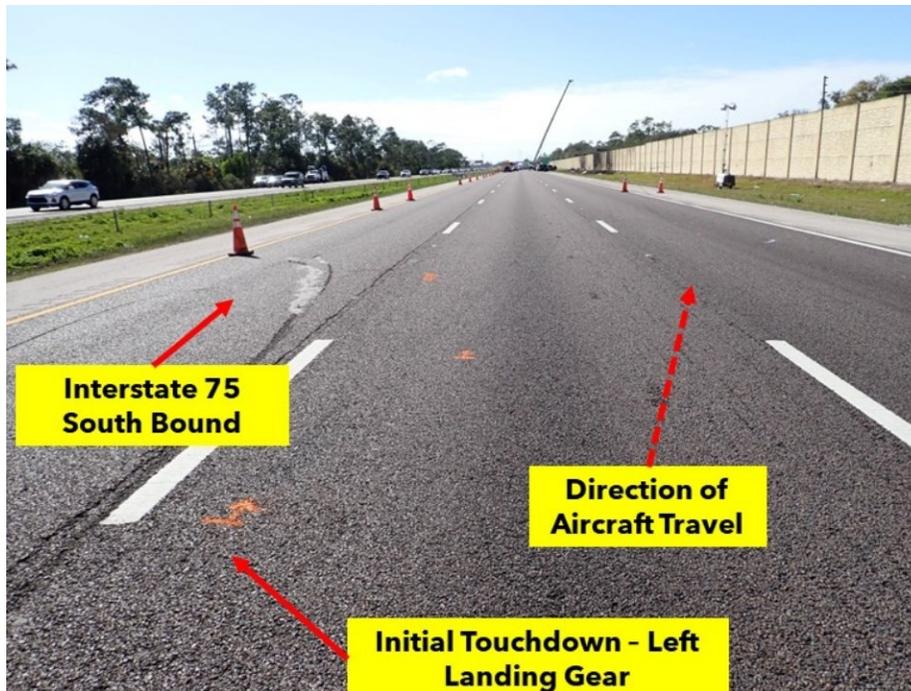
Examination of the accident site revealed tire marks on the southbound lane of Interstate 75 consistent with the left main landing gear (see figure 2). The airplane came to rest about 1,000 ft past the initial touchdown point, upright in the grass area between the break-down lane and the sound barrier wall facing north, opposite the direction of travel.

Figure 2 Annotated photograph of the airplane's initial touchdown point on Interstate 75.

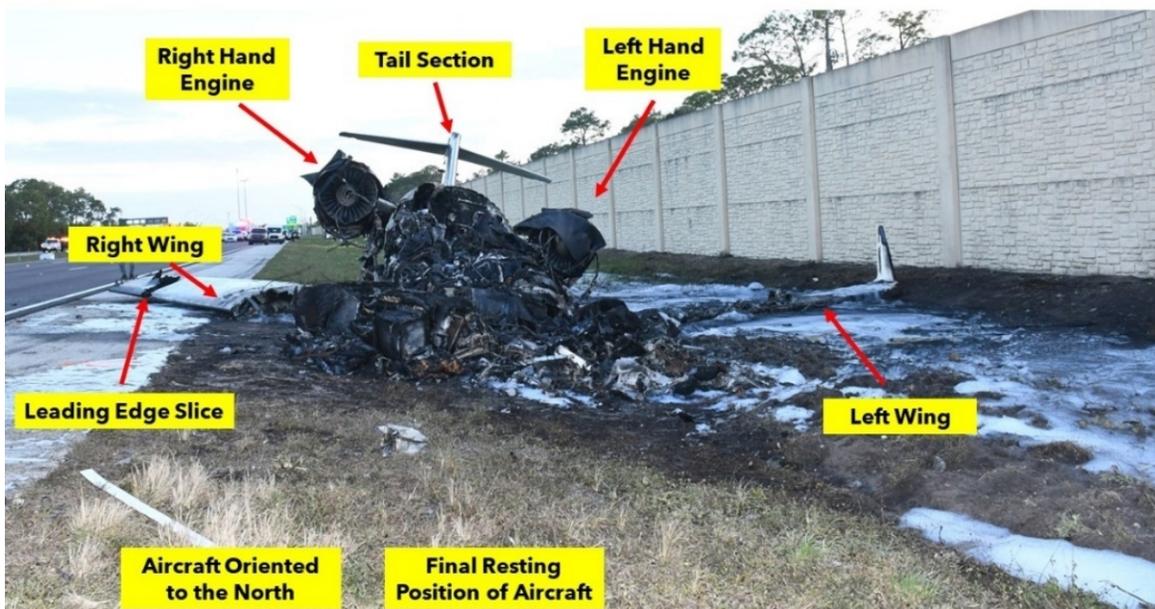
The forward portion of the fuselage was consumed by the post-impact fire (see figure 3). All major components of the airplane were accounted for at the scene, and the ground surrounding the wreckage was fuel-soaked having an odor consistent with Jet-A fuel. The cockpit center console was found separated from the main wreckage. Both engine throttle levers were found near the IDLE stop position. The flap selector handle was found in a position consistent with 45° flap extension.

Figure 3 – Annotated photograph of main wreckage as found.
