Aviation Investigation Final Report

Location:	Halloran Springs, California	Accident Number:	CEN24MA111
Date & Time:	February 9, 2024, 22:08 Local	Registration:	N130CZ
Aircraft:	Airbus Helicopters EC 130	Aircraft Damage:	Destroyed
Defining Event:	VFR encounter with IMC	Injuries:	6 Fatal
Flight Conducted Under:	Part 135: Air taxi & commuter - Non-scheduled

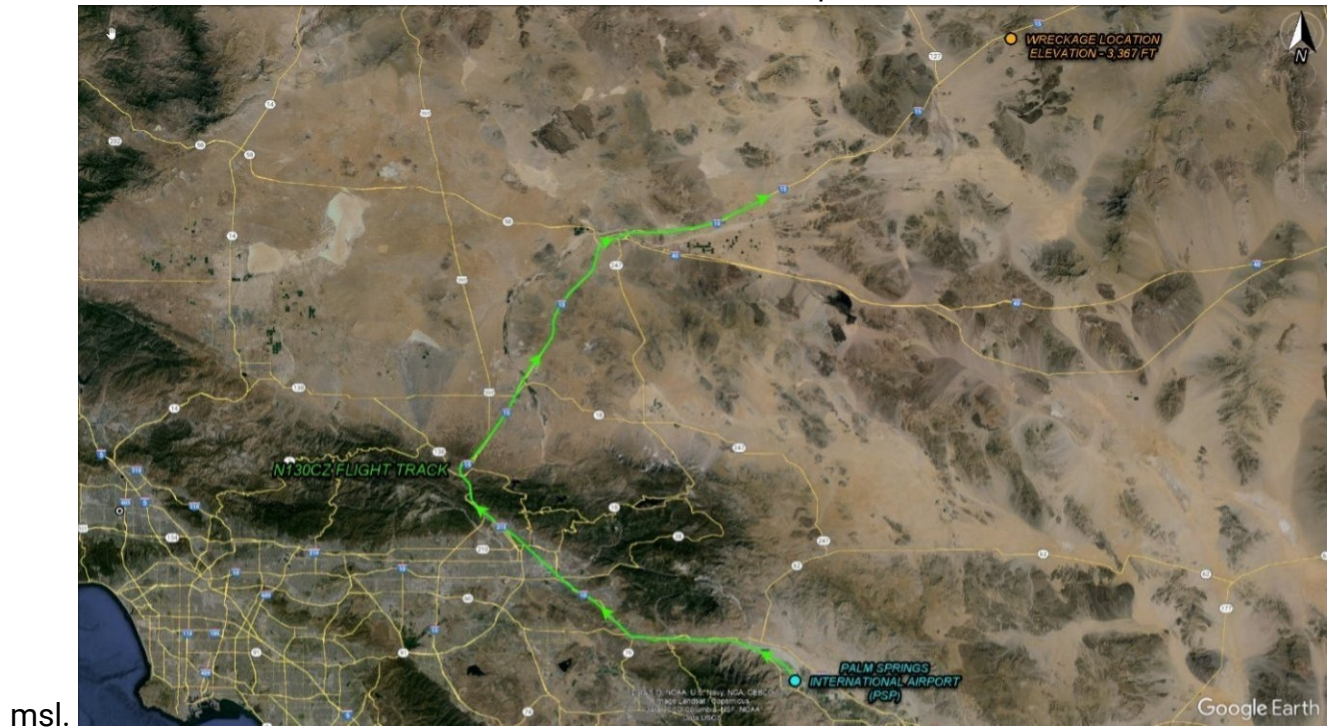
The helicopter followed I-15 toward the planned destination of BVU. After passing east of the Cajon Pass, the altitude of the helicopter varied between about 3,300 and 5,500 ft msl, and the ground speed varied between about 93 knots (kts) and 155 kts but maintained between 130 and 140 kts for most of the time. About 2146, ADS-B data was lost while the helicopter was about 24 miles east of Barstow, California, which was likely due to lower altitudes and terrain interference. The ADS-B lost data gap was about 47.5 miles long, and ADS-B data resumed

about 2206 near the Halloran Springs/I-15 freeway exit west of the accident location. The last ADS-B data points for the flight tracked east-southeast, gradually descended in altitude, and then increased in a rapid descent and airspeed (see figures 1 and 2). The accident site was located 0.31 miles east-southeast of the last ADS-B data point at an elevation of about 3,360 ft

Figure 1. Overhead view of ADS-B accident flight track.

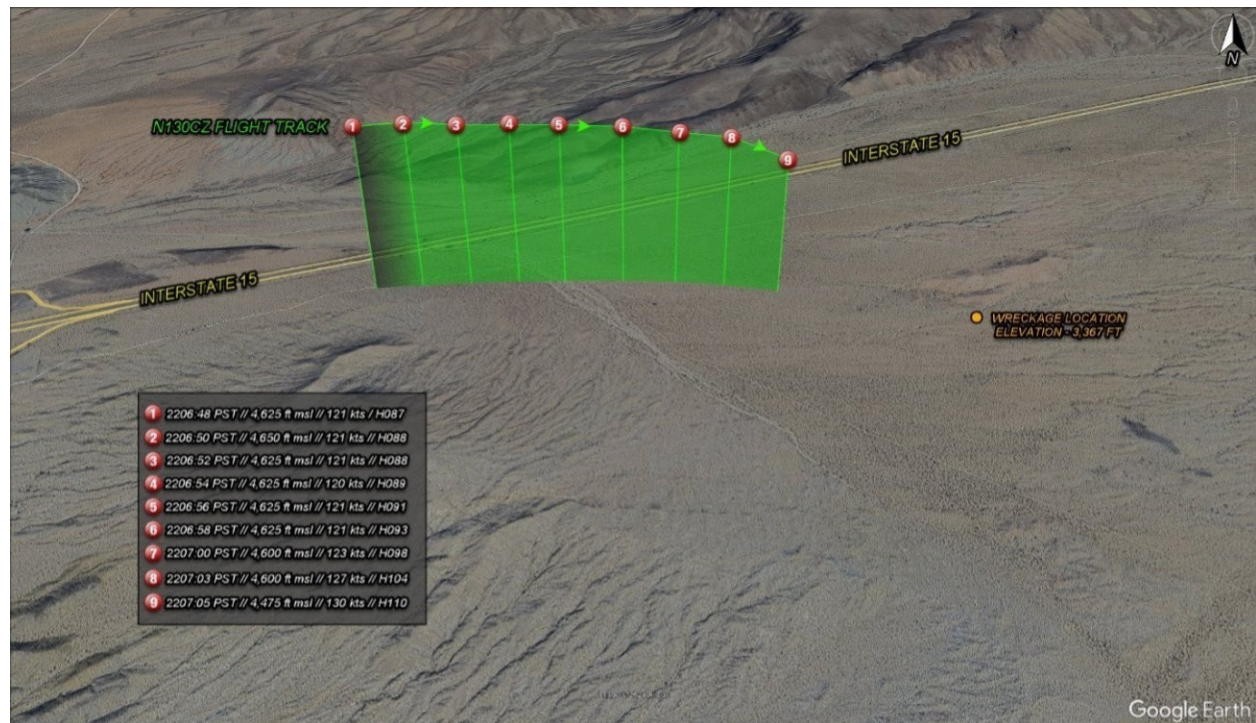
Figure 2. Final segment of flight track data with time, altitude (msl), ground speed, and heading information.

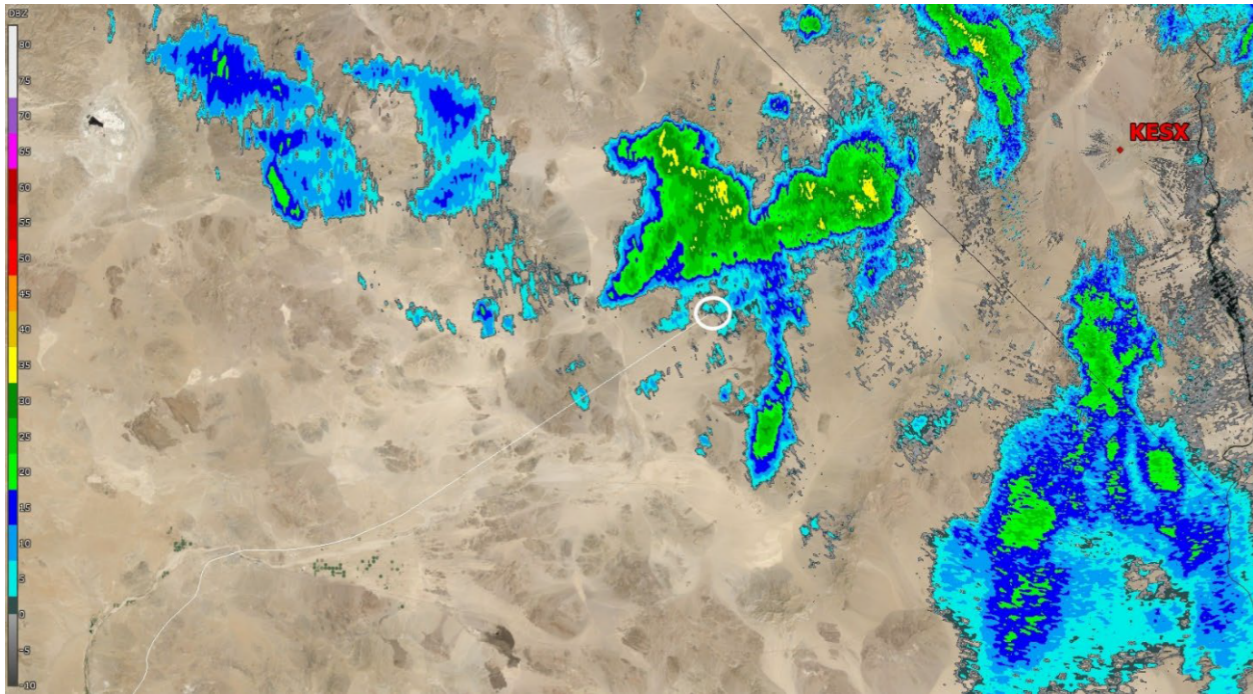
shown in figures 4 and 5. Based on standard refraction and beam width, the site would have seen altitudes above the accident location between 6,800 and 12,000 ft.

Figure 4. "Smoothed" base reflectivity product from a sweep initiated at 2206:05. The accident helicopter's flight track is marked by the thin white line and the accident location is denoted by the white circle.

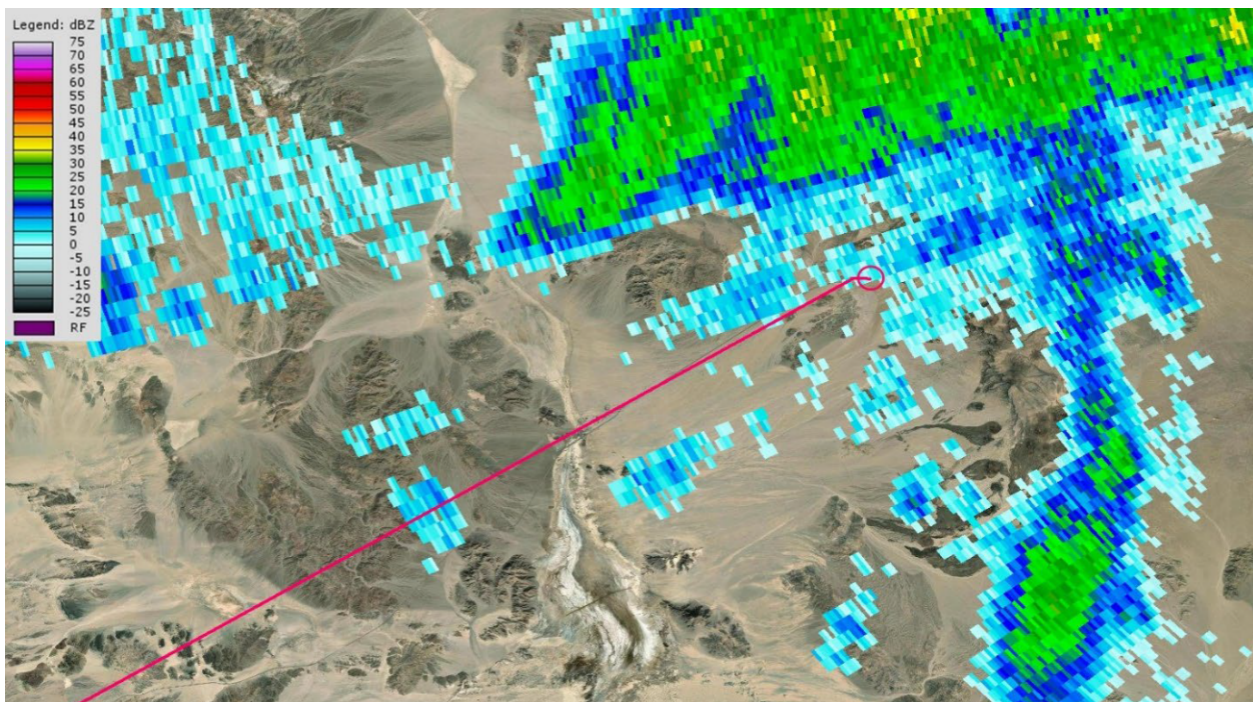
Figure 5. Unsmoothed base reflectivity product from a sweep initiated at 2206:05. The accident helicopter’s flight track is marked by the red line and the accident location is denoted by the red circle.

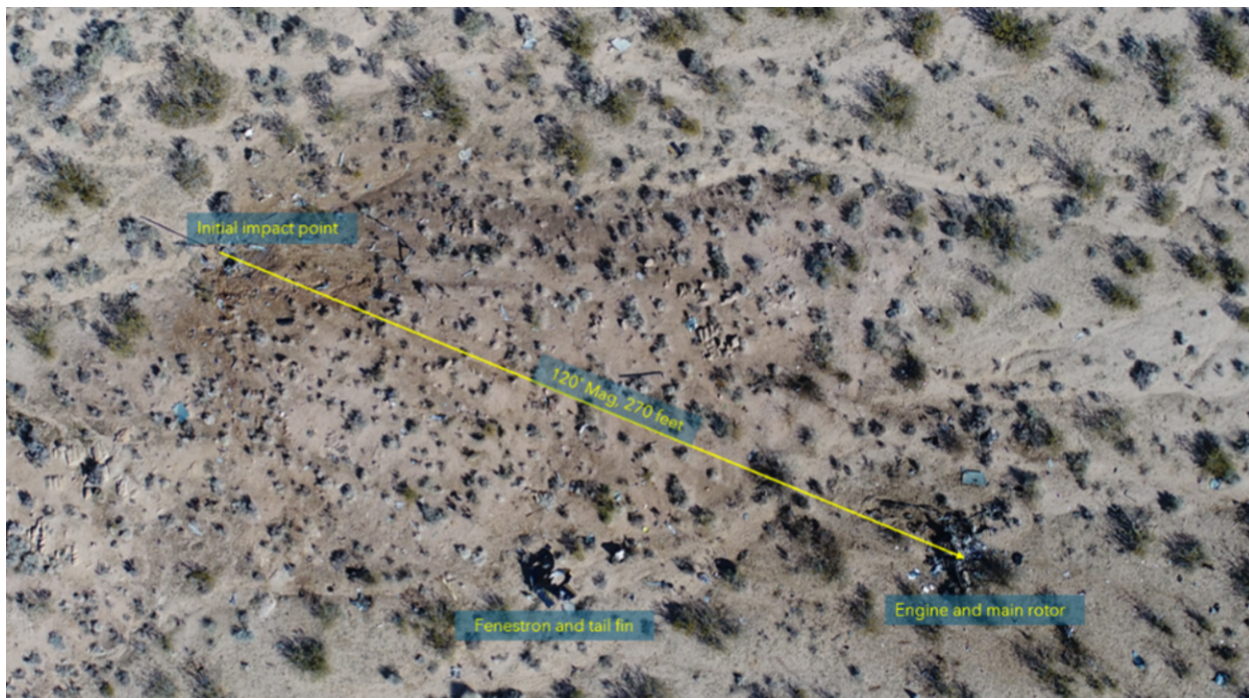
The wreckage was located at an elevation of about 3,360 ft in high mountainous desert and scrub-brush-covered terrain, and debris were scattered about 300 ft along a 120° magnetic heading from the initial impact point (see figures 6 and 7).

Figure 6. Overhead view of the accident site and wreckage distribution.

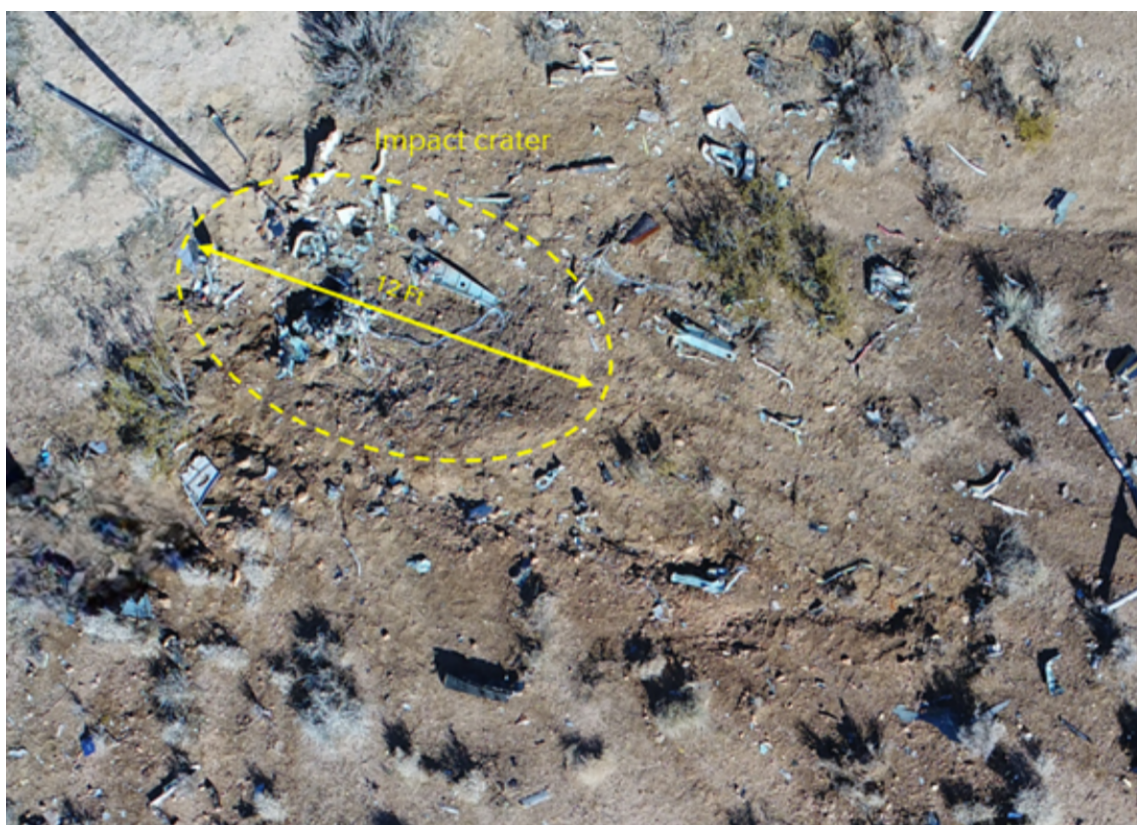
Figure 7. Overhead view of the initial impact area.

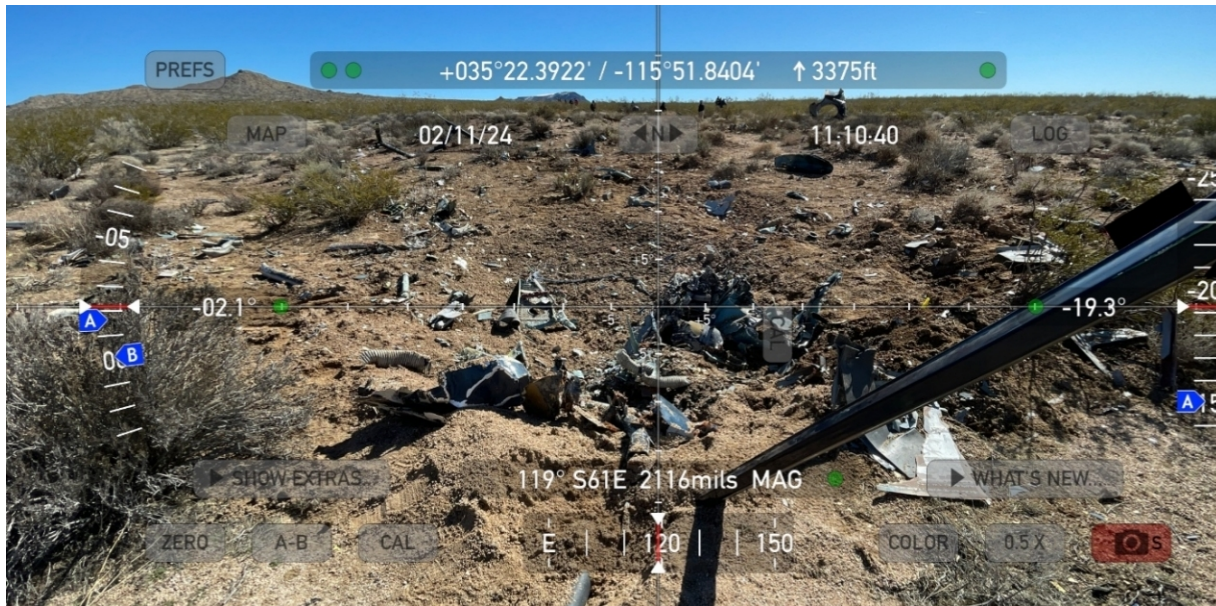
The initial impact point, which was a 1.5-ft-deep, 12-ft-long and 10-ft-wide ground crater, contained portions of the right landing gear skid, right skid step, cockpit wiring, and cabin floor structure. The right skid step protruded upward at a 45° angle at the most eastern edge of the ground crater (see figure 8). Immediately to the right of the crater was a ground divot consistent in the size and shape of the rotor head, with 2 main rotor blade impact marks extending from the divot.

Figure 8. Initial impact ground crater and debris field.

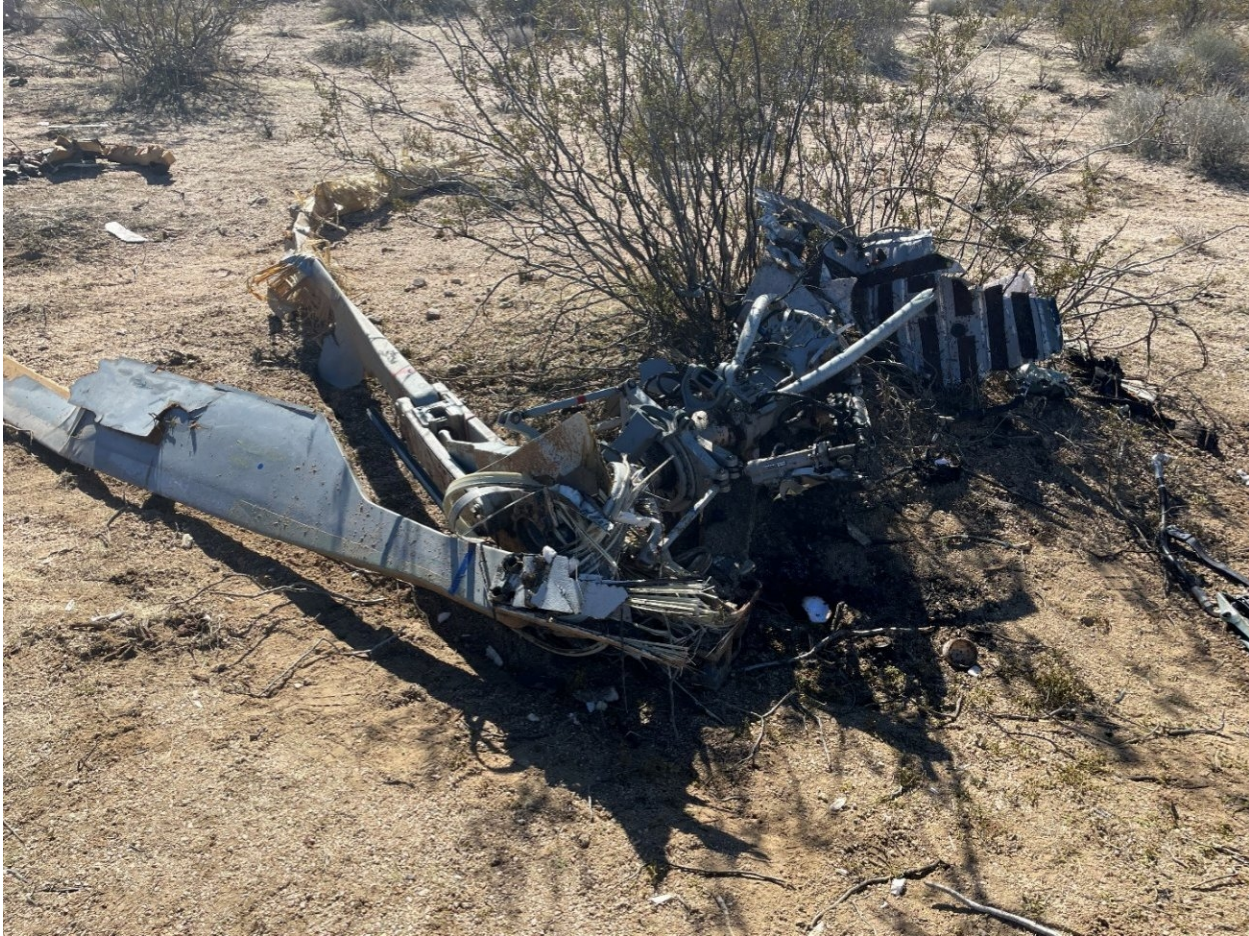
The aft section of the fuselage (center fuel tank area) and the forward tail boom section displayed fire damage, was coated with soot, and exhibited crushing signatures favoring the right side. The flight control tubes and linkages leading up to the flight control servos were fragmented and continuity could not be verified. All three pitch control links were attached at the swashplate and blade pitch change horns. The main rotor blades were fragmented and broomstrawed, and the blade sleeves and tips were present (see Figure 9).

Figure 9. Rotor mast and rotor head.

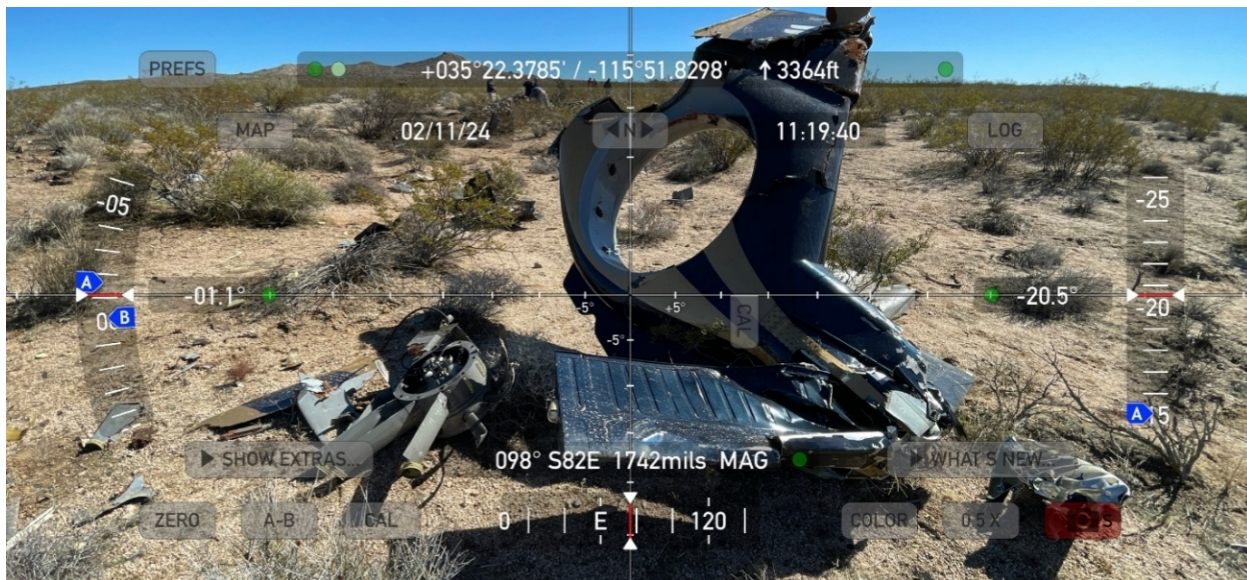
The fenestron tail section, with the tail fin and horizontal stabilizer separated from the forward part of the tail boom. All the fenestron blades remained in their hubs and the blade tips displayed chordwise scratches (see Figure 10).

Figure 10. Tail fin and fenestron.
