Aviation Investigation Preliminary Report

Location:	Kekaha, HI	Accident Number:	ANC24LA017
Date & Time:	February 27, 2024, 13:30 Local	Registration:	N633JH
Aircraft:	MD Helicopter 369E/500E	Injuries:	1 Serious, 4 Minor
Flight Conducted Under:	Part 135: Air taxi & commuter - Non-scheduled - Sightseeing

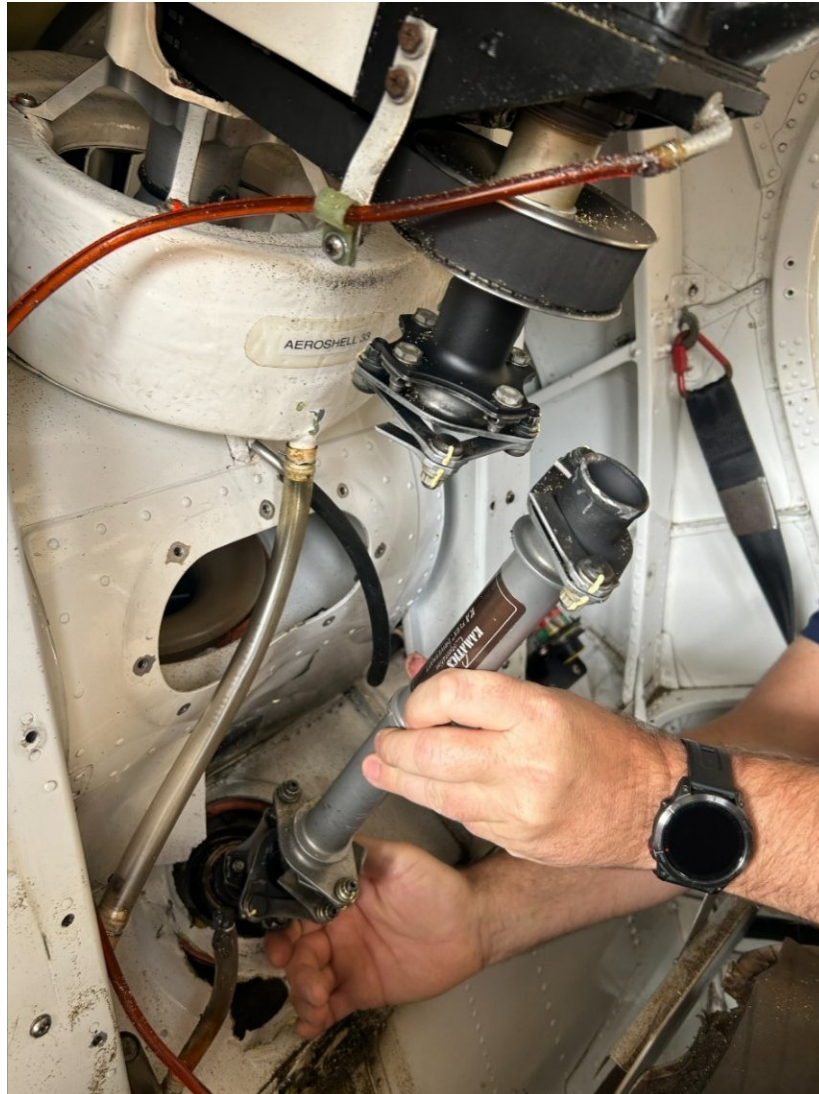
The helicopter wreckage was subsequently recovered from the remote beach site and transported to a secure location in Lihue, Hawaii. An initial Federal Aviation Administration postaccident examination revealed that the overrunning clutch and engine-to-transmission driveshaft were fractured. See Figure 1

Figure 1: Fractured main rotor drive shaft (Courtesy of FAA)
