# Aviation Investigation Preliminary Report

<b>Location:</b>	Bellevue, WA	<b>Incident Number:</b>	WPR24FA103
<b>Date &amp; Time:</b>	March 5, 2024, 17:04 Local	<b>Registration:</b>	N927CS
<b>Aircraft:</b>	CIRRUS DESIGN CORP SR22T	<b>Injuries:</b>	2 None
<b>Flight Conducted Under:</b>	Part 91: General aviation - Instructional

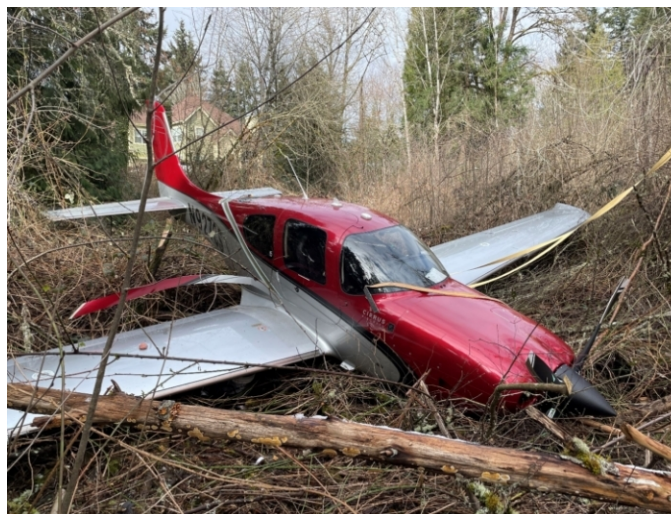
Figure 1: Front view of airplane.

Examination of the incident site revealed that the airplane impacted terrain about 4 miles northeast of the departure end of runway 34. The airplane came to rest upright in an approximate 10° nose low attitude, on a heading of about 066° magnetic, at an elevation of about 417 ft msl.
