Aviation Investigation Preliminary Report

Location:	Houston, TX	Accident Number:	DCA24FA120
Date & Time:	March 8, 2024, 07:58 Local	Registration:	N27290
Aircraft:	Boeing 737-8	Injuries:	166 None
Flight Conducted Under:	Part 121: Air carrier - Scheduled

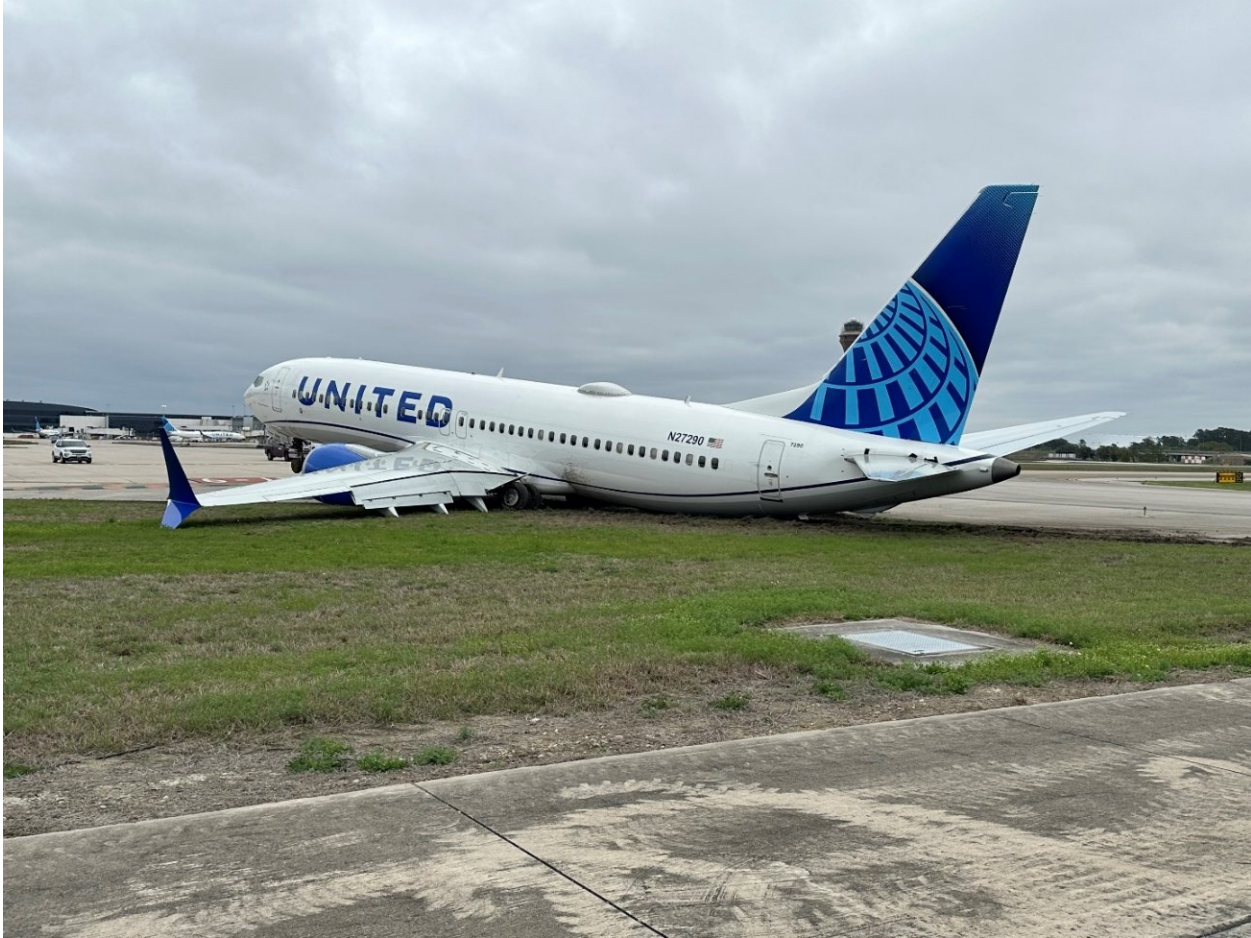
During the turn onto the taxiway, he felt the fuselage and rudder/brake pedals begin to shake violently. He briefly released the brake pressure and the shaking ceased. He then reapplied aggressive brake pressure and the shaking resumed. The airplane slid off the runway and the left MLG tires and nose wheels tires entered the grass before the airplane came to a rest with its left wing low.

Figure 1. Photograph showing the final resting position of the airplane.

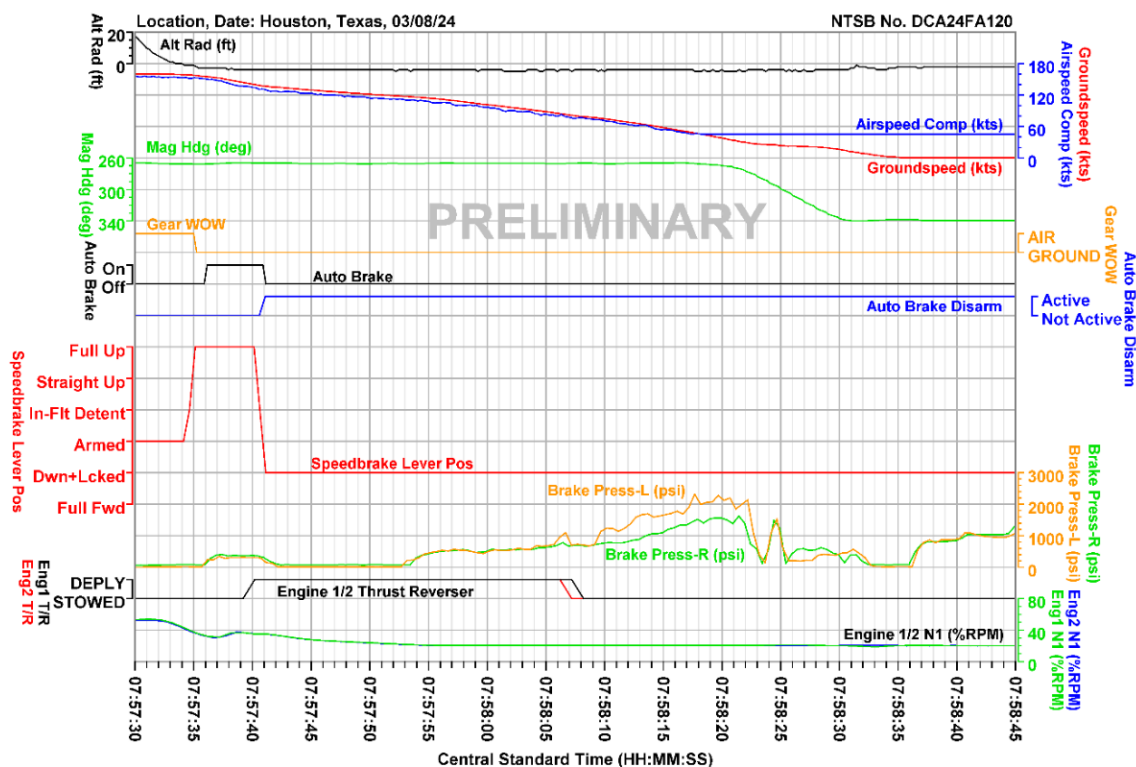
Data from the DFDR was sent to the NTSB’s Vehicle Recorder Laboratory in Washington, DC, for analysis. A preliminary review of data has been completed and a plot showing the braking parameters is shown in figure 3. Data showed that at touchdown the speed brake lever position [Speed Brake Lever Pos] and auto brake parameters were full up and on for about 5 seconds before transitioning to down and locked and off for the remainder of the landing rollout.

The engine thrust reversers were deployed for the left and right engines for about 27 and 26 seconds respectively at idle reverse. The left and right brake pressure increased to their maximum pressure consistent with aggressive manual braking before and as the airplane’s heading changed consistent with a right turn.

Figure 3. Plot of the FDR data from the accident landing.

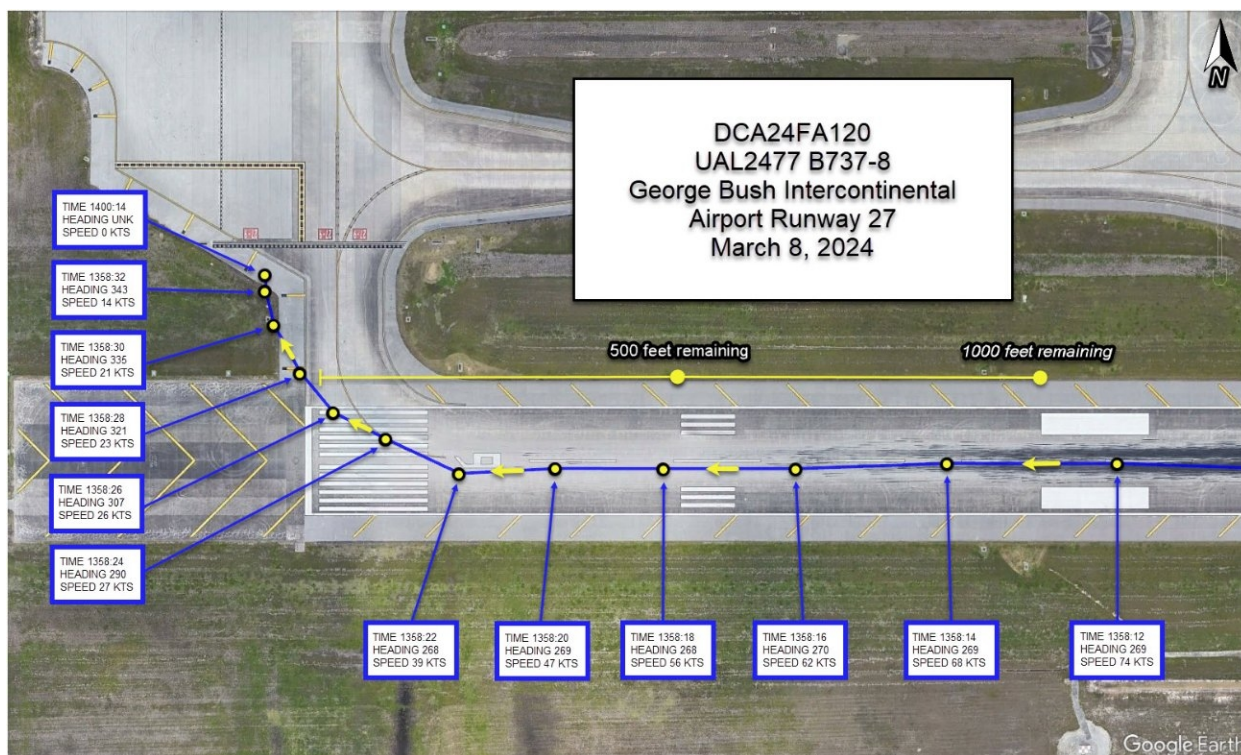
Certified ADS-B data, which records more accurate latitude and longitude data than the DFDR, was provided to the NTSB by the FAA. Analysis of the ADS-B and DFDR data shows that the airplane touched down about 1,000 feet from the runway threshold with a groundspeed of about 158 knots. With about 1,000 ft and 500 ft of runway remaining the airplane groundspeeds were about 72 kts and 57 kts respectively. The right turn to exit the runway was initiated at about 39 kts groundspeed and the aircraft departed the end of the paved surface at about 22 kts (figure 4).

Figure 4. Accident airplane's landing rollout time, heading and speed from ADS-B data overlaid on a Google Earth image of runway 27 and taxiway SC at IAH. Yellow arrows indicate direction of travel.
