# Aviation Investigation Preliminary Report

<b>Location:</b>	Madras, OR	<b>Accident Number:</b>	WPR24FA105
<b>Date &amp; Time:</b>	March 10, 2024, 15:03 Local	<b>Registration:</b>	N3264W
<b>Aircraft:</b>	Piper PA-32-260	<b>Injuries:</b>	2 Fatal
<b>Flight Conducted Under:</b>	Part 91: General aviation - Personal

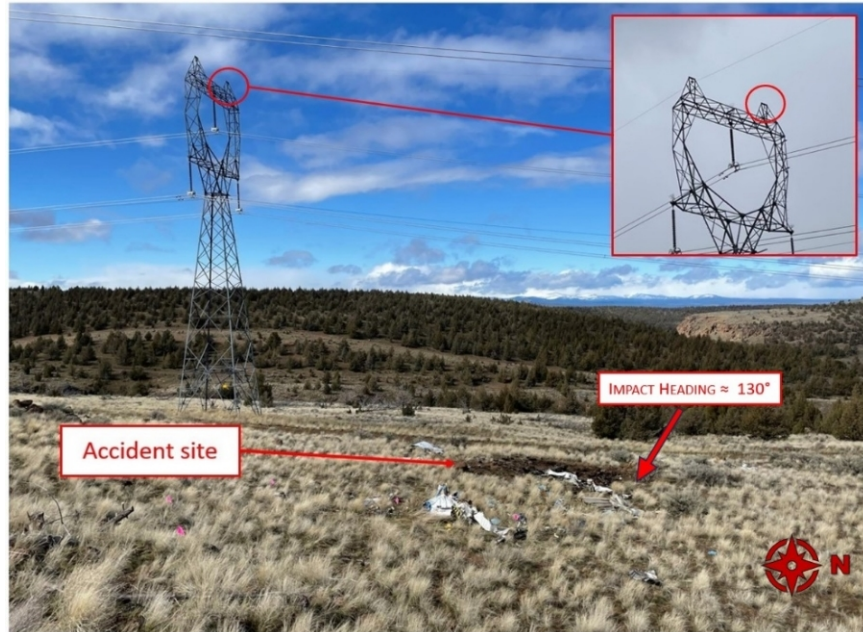
Figure 1: Accident Site Diagram

Examination of the accident site revealed that the airplane struck a static wire that spanned between two 100-ft tall high tension powerline towers, and subsequently impacted terrain between the towers. The debris path measured approximately 300 ft from the initial point of impact with the ground and was oriented on an approximate heading of about 130° magnetic.

All the major structural components of the airplane were located within the wreckage debris path. A portion of the static wire was found near the right wing.
